CCP Annual Inspection Report

Brickhaven No. 2 Mine Tract A Structural Fill DWM Permit 1910, DEMLR Permit 19-25

Charah, Inc.

January 2017

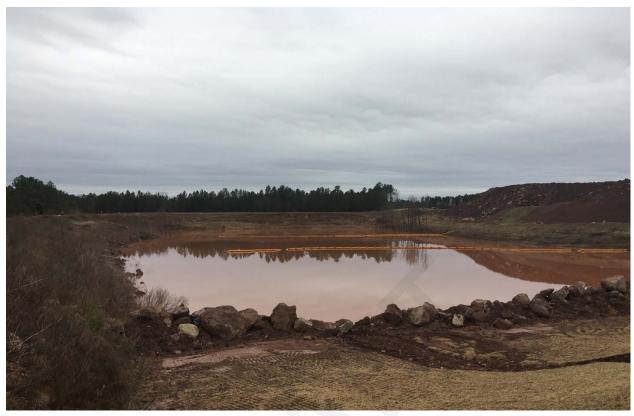
Charah manages stormwater generation by the application of interim cover soils were CCP has been placed above the perimeter containment elevations. Additionally, subcells have valves installed in the leachate collection pipes to cordon off areas with no CCP placement so stormwater runoff can be treated as stormwater. At the time of this inspection, all slopes draining outside of the containment were covered with soil as shown in photos 2 through 4. Overall, the areas with interim cover appeared to have adequate soil cover and showed no signs of operational or structural concern. Soils placed on final slopes were seeded to prevent erosion and exhibited a good stand of vegetation that was functioning as intended. No signs of CCP release were observed. Interim cover had been placed on the top of the Cell 1 area where final CCP grades had been reached as shown in photos 5 through 8. This area exhibited no signs of erosion and was scheduled to be seeded soon. Some minor ponding was observed on the top of Cell 1 after the recent rain event which will be corrected prior to the upcoming closure work. No instabilities were observed as a result of the minor ponding. At the time of this inspection, the stormwater runoff was being directed to the mine lake area as shown in photo 1 where Charah was actively treating the ponded water to required discharge turbidity levels.

1. Mine pond collecting stormwater runoff from the cell 1 and 2 areas.

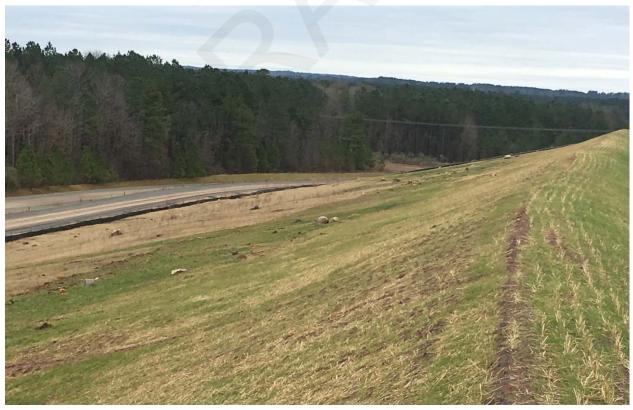
2. Interim cover soil and vegetation along the eastern slope of cell 1.

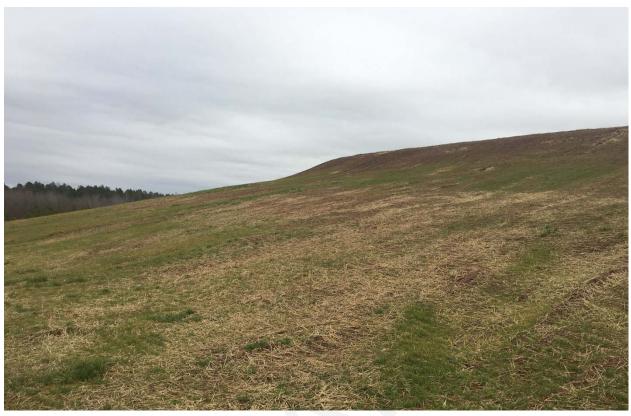
3. Northern side of cell 1.

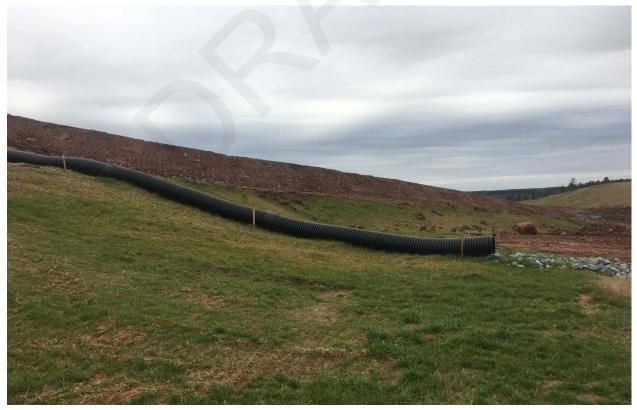
4. Slope drain on the northern side of cell 1.

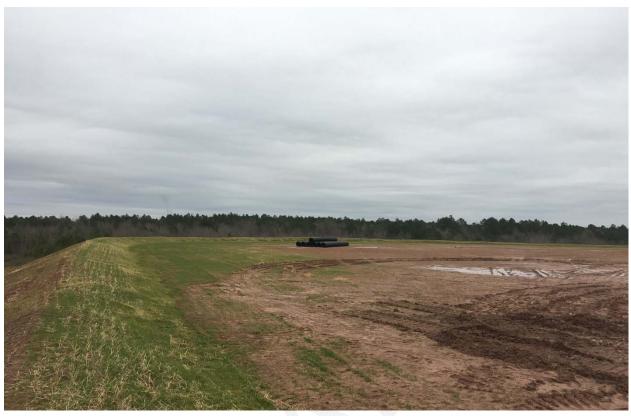
5. Standing on the north end of the top of cell 1 looking east.

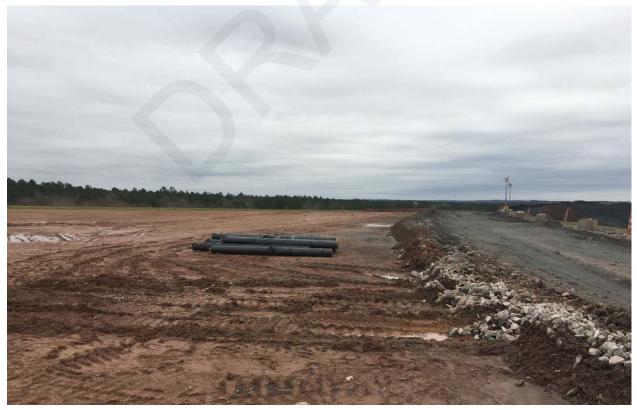
6. CCP haul road on top of cell 1 looking south.

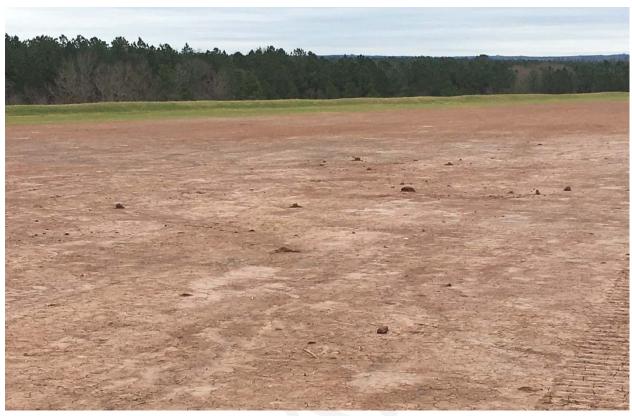
7. Interim cover soil and grassed diversion berm for stormwater segregation on top of cell 1.

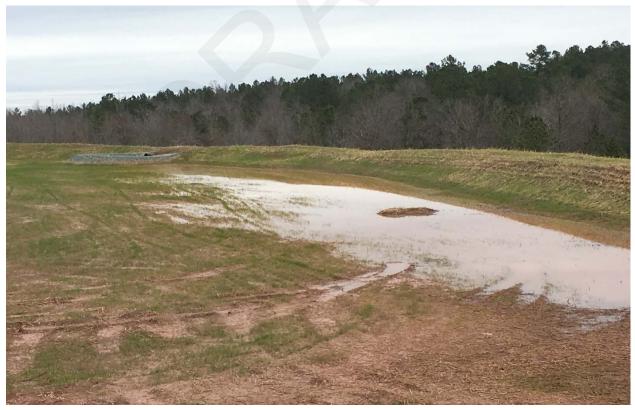
8. Drainage diversion berm and down drain inlet on top of cell 1 interim cover.

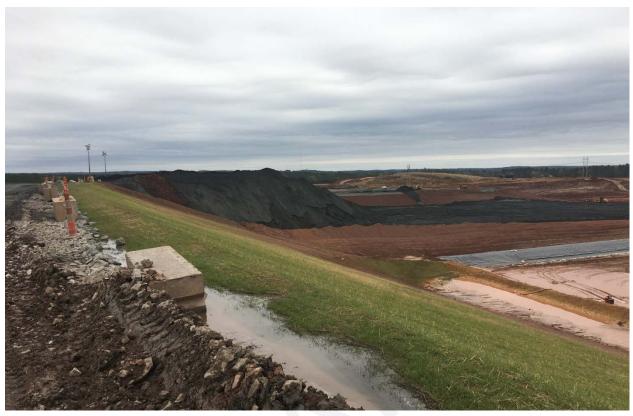
9. Standing on the cell 1 CCP haul road looking across cell 2 to the south.

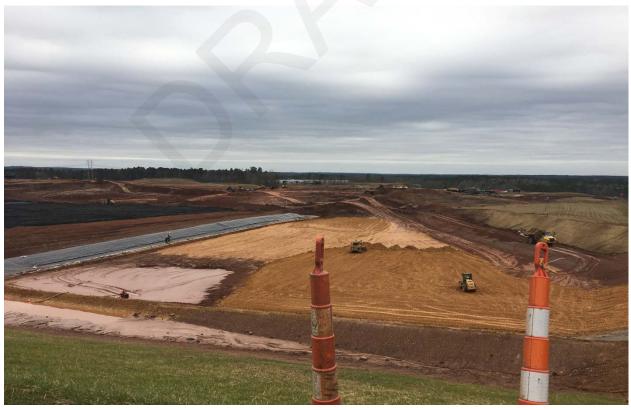
10. Standing on cell 1 looking west over cell 2, subcell 2A.

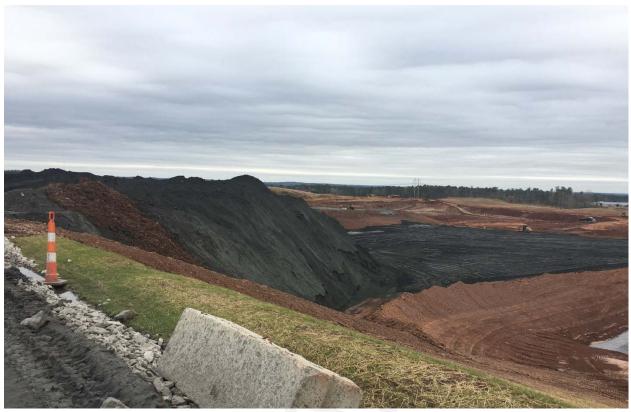
A temporary stockpile was created in the Cell 2, subcell 2B area against Cell 1. This temporary stockpile is used for decanting wet CCP loads and during wet conditions when compacting the material is impossible. The plan of action is to push this material across Cell 2, subcell 2B in 12-inch compacted lifts when the material is dry enough to obtain the required compaction. Preparation work was being performed in the subcell 2B area at the time of inspection in order to begin moving the temporary stockpile materials into place. The temporary stockpile slopes appeared to be placed at their angle of repose. Some sloughing was occurring at the toe of the stockpile. The toe of the stockpile was well within the lined containment area.

11. Standing on cell 1 looking at the temporary CCP stockpile in cell 2, subcell 2B.

Based on the site inspection, no structural weaknesses were observed in the compacted CCP material. As stated above, the temporary stockpile did exhibit some sloughing since it resides in an uncompacted state. Charah was beginning to move the stockpile into subcell 2B however, in the future, Charah should work to limit the size of any uncompacted stockpiles and must monitored them closely for instabilities so any issues arising can be addressed immediately. There were no signs of exterior or interior erosion rills that could potentially lead to instability.

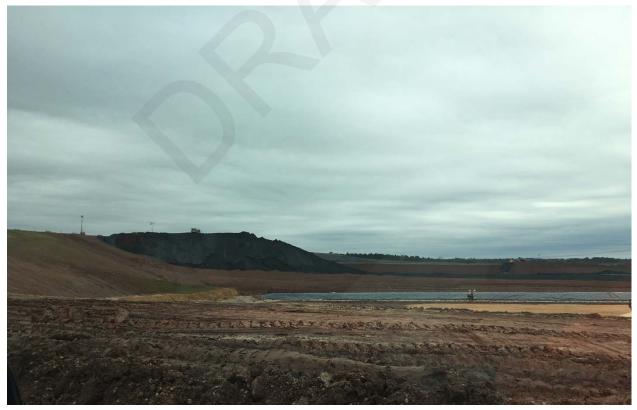
12. Looking across cell 2, subcell 2A at the temporary stockpile in subcell 2B.

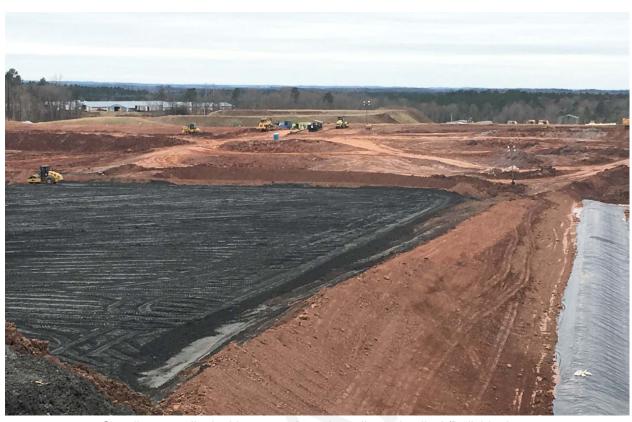
13. Standing on cell 1 looking west along the cell 2, subcell 2A/B divider berm.

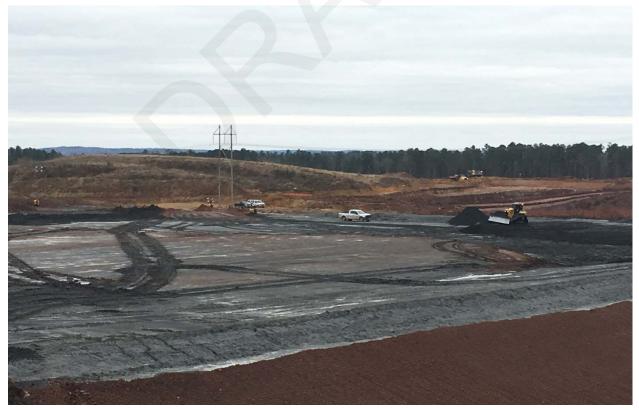
14. CCP placement in cell 2, subcell D facing the southern entrance road.

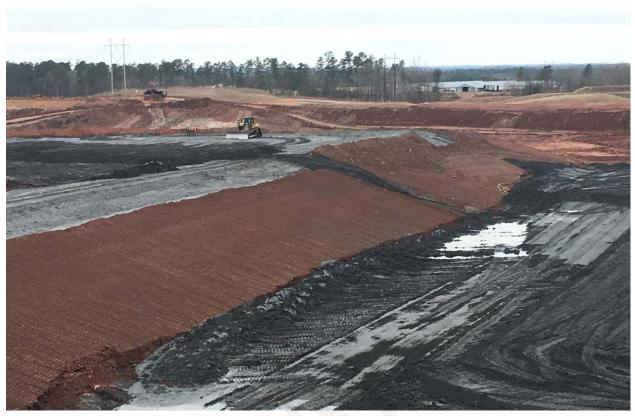
15. CCP placement in cell 2, subcells C and D.

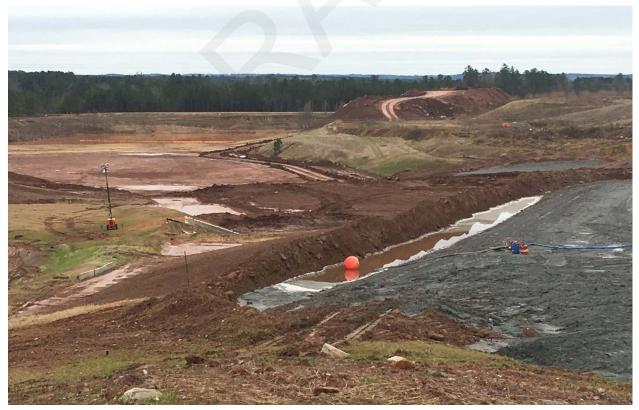
Operationally Charah manages leachate generation by limiting the area of exposed CCP to rain through the placement of interim cover soils. They also use soil to collect, control and direct leachate runoff from active placement areas as seen on photo 16. In this photo you can see that Charah is pumping from the collection area back to the leachate collection system. Areas

16. Leachate collection during CCP placement in cell 2, subcell D.

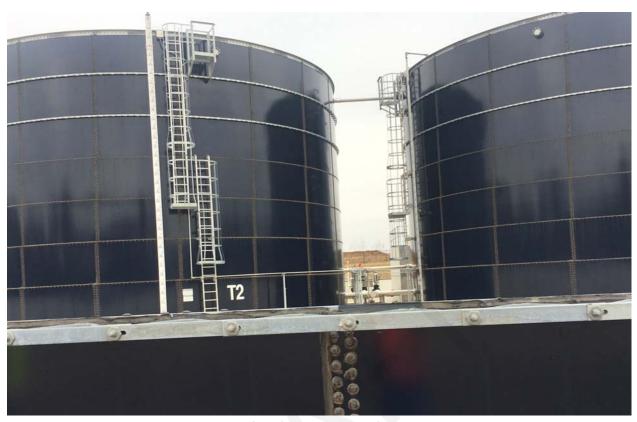
The leachate management system for the cells includes a series of perforated HDPE pipes within the lined area that drain to a sump in Cell 1with two pumps installed to pump leachate to two onsite storage tanks. Refer to photo 17 to see the leachate enclosure at the sump and storage tanks respectively. The leachate enclosure and tanks exhibited no signs of leakage at the time of the inspection and the leachate collection pipes were in good working order. The leachate tanks contained leachate from a recent storm event and were actively being drained into tanker trucks for transportation to one of the approved disposal locations. Pump 1 was currently off and service had been called. Pump 2 was actively running. The leachate enclosure display showed Pump 2 was pumping 715 gpm which is outside of its pump curve. This suggested that calibration and/or maintenance should be performed on the flow meter. Charah had scheduled a calibration service to be conducted by the end of January. It was confirmed that this service was performed. The display also indicated high levels of leachate in the structural fill as a result of recent storm events. The permit does allow elevated leachate levels temporarily during storm events and active pumping was occurring to draw down the levels. The display showed a total flow of 13,233,044 gallons to date. The system was operating within its pressure range and the transducers were reading within their range.

17. Leachate storage tanks.
