CCP Annual Inspection Report

Brickhaven No. 2 Mine Tract A Structural Fill
DWM Permit 1910, DEMLR Permit 19-25

Charah, Inc.

Moncure, North Carolina
October 2016

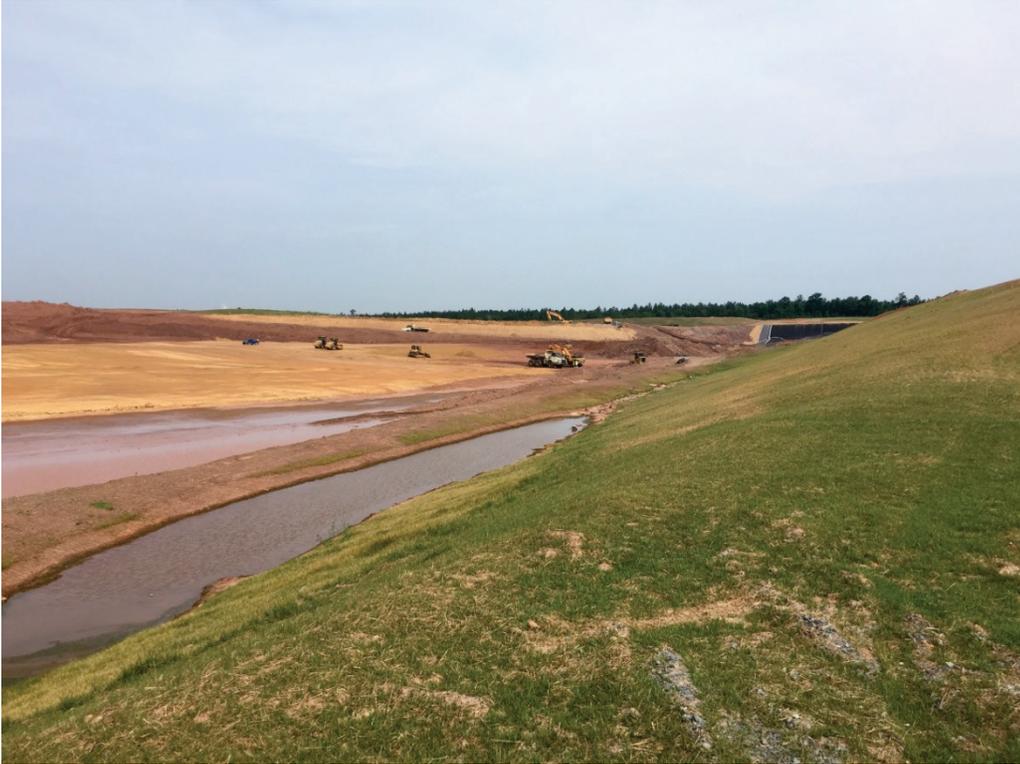
1. Cell 1 stormwater segregation

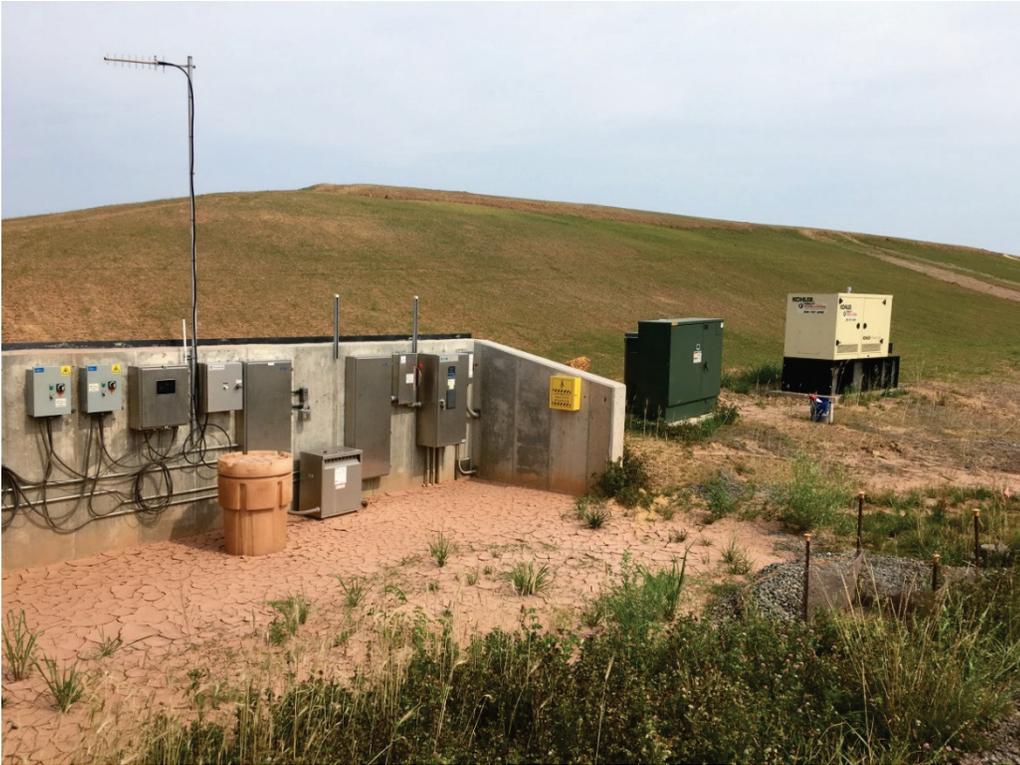
2. Cell 1 leachate enclosure and drop inlet

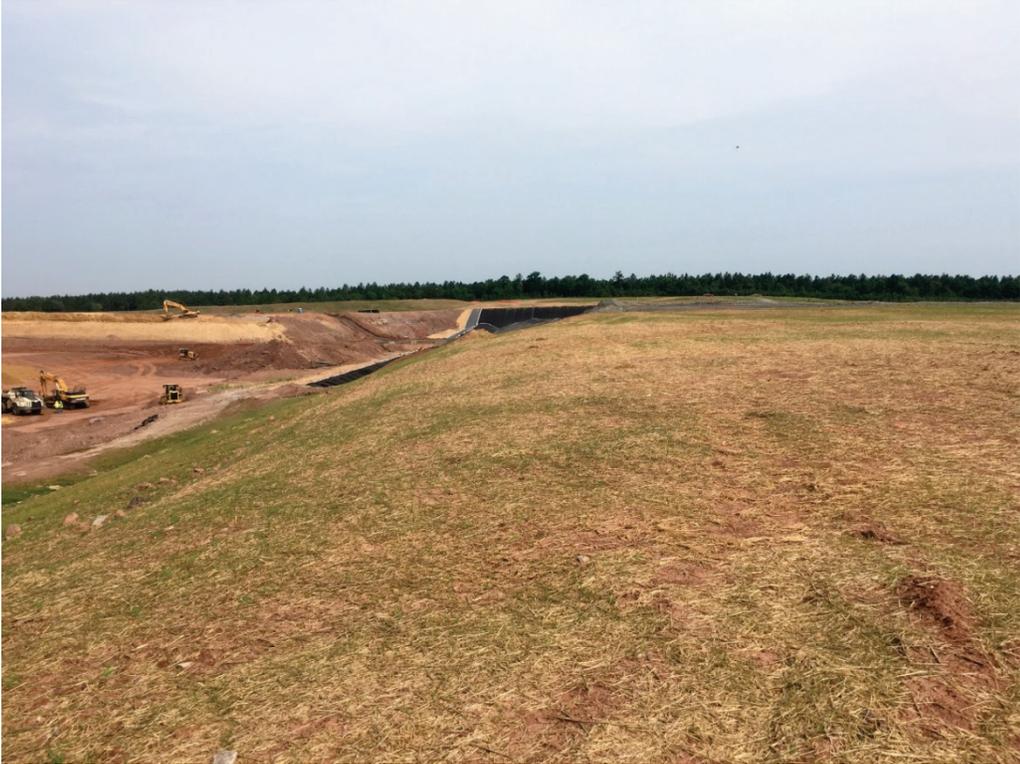
3. Interim cover and seeding of top deck areas on the south side of Cell 1

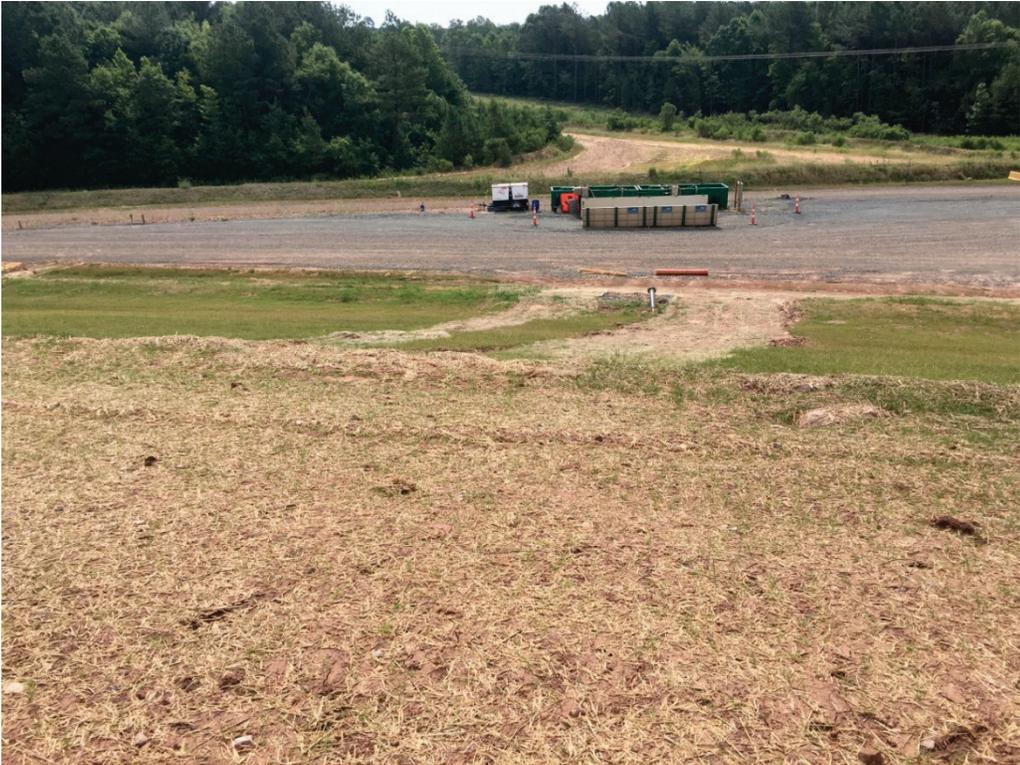
Based on the site inspection, no apparent or potential structural weaknesses were observed. As stated above, continued monitoring and minor repairs should be completed to address rill and gully erosion before it becomes a potential structural fill weakness. Much of the site's interior rill erosion will be addressed as the structural fill operation continues. This interior rill erosion has limited potential of creating a structural weakness. There were no signs of exterior erosion rills but onsite staff should continue to monitor for any developments.

4. Erosion repairs on the eastern slope of Cell 1

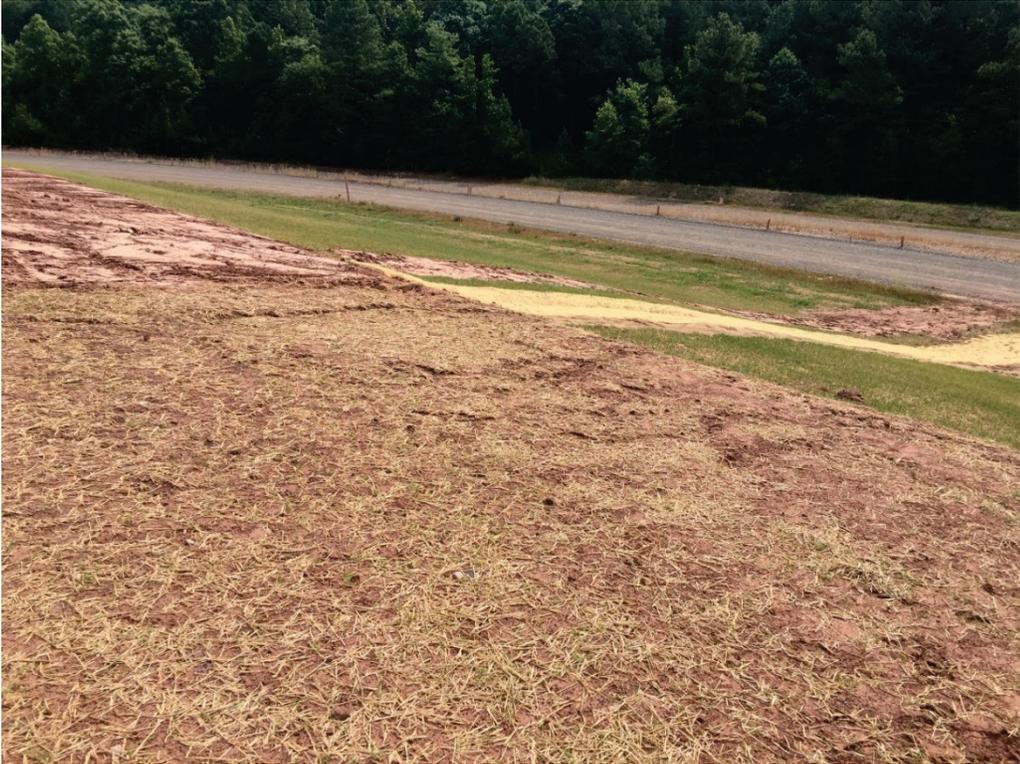
5. Erosion repairs on the eastern slope of Cell 1

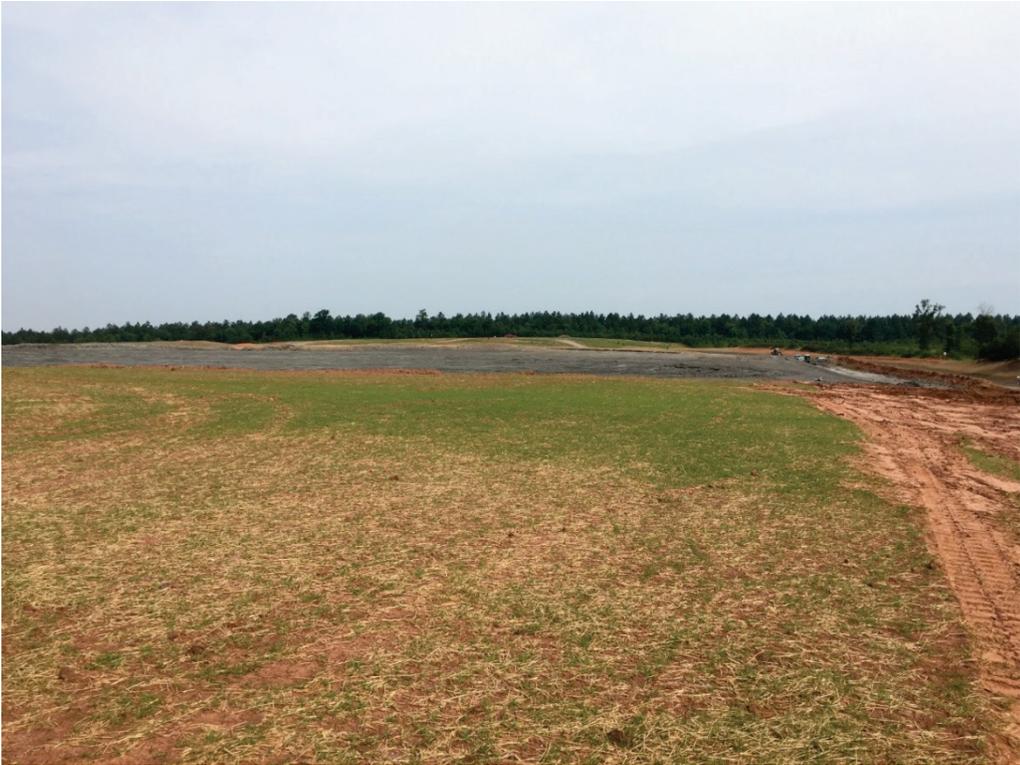
6. Transition from final covered areas to active CCP placement

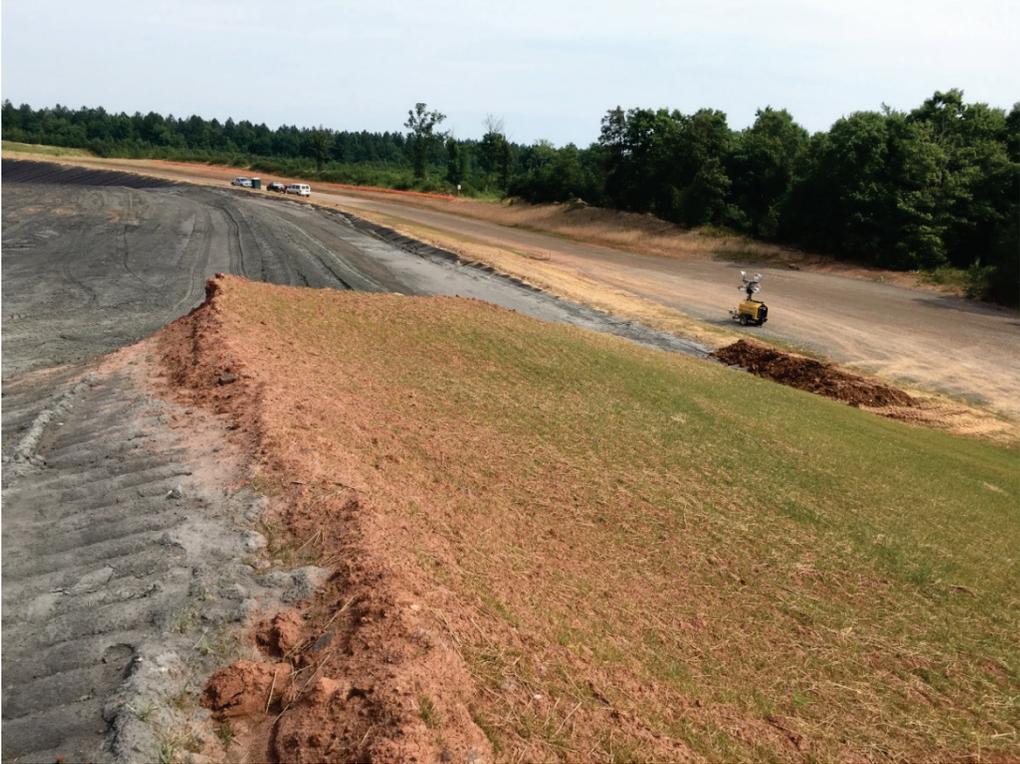
7. Transition from final covered areas to active CCP placement

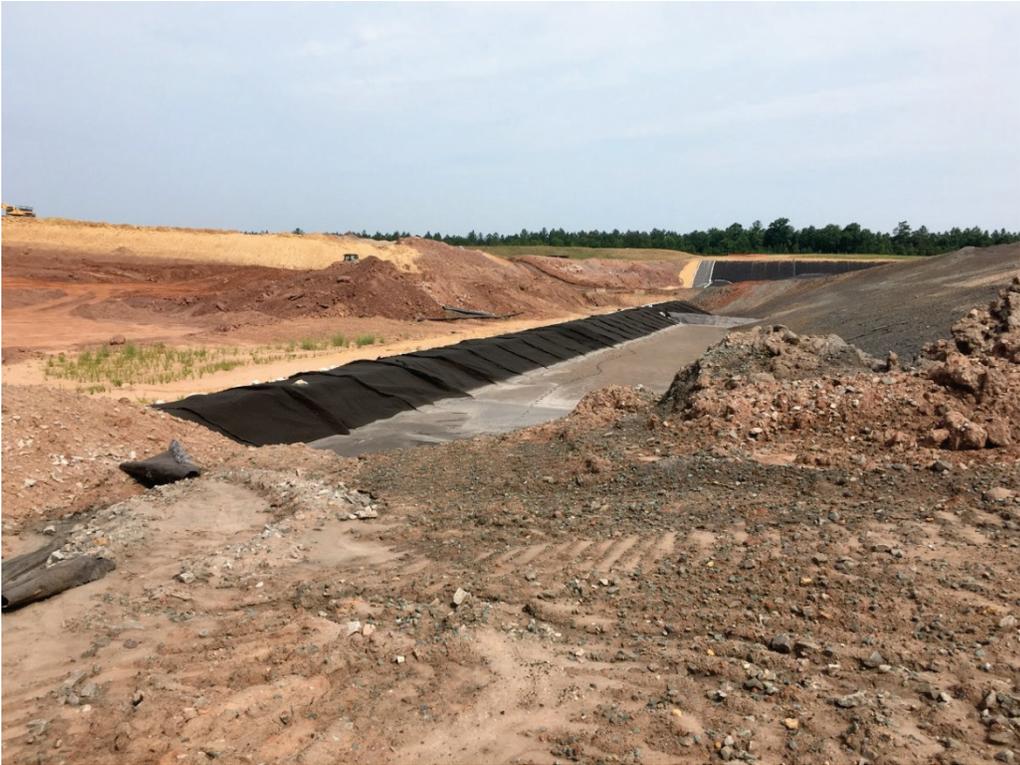
8. Offset from the Cell 1-2 divider berm for leachate management

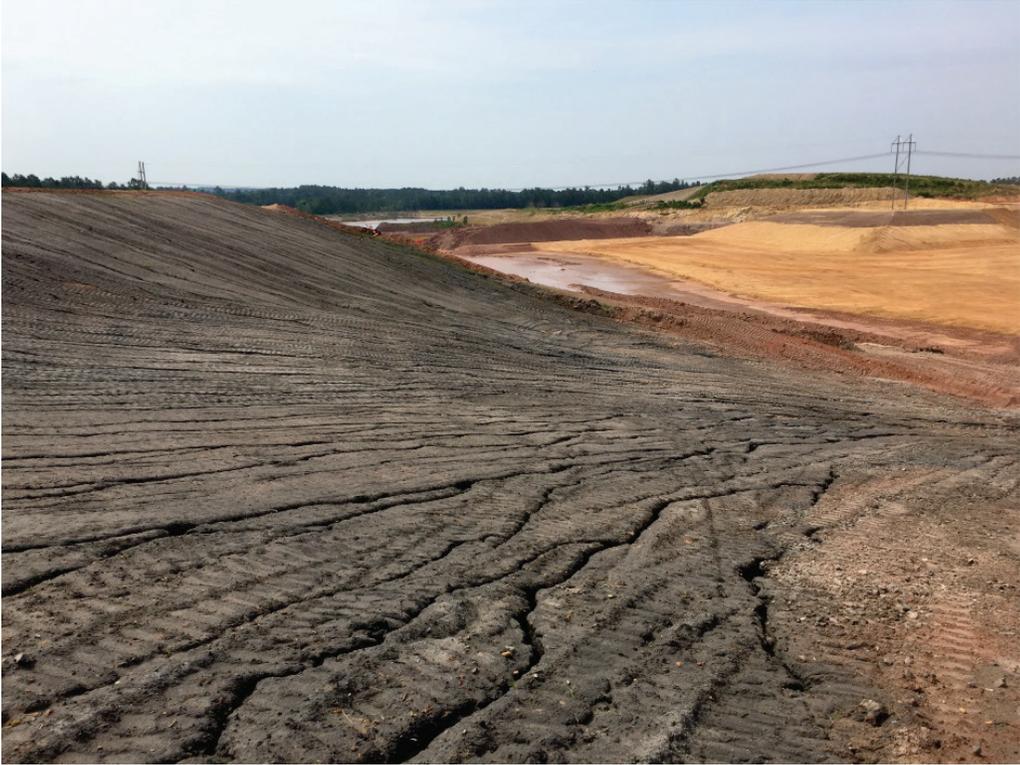
9. Tracked interim CCP surface to prevent erosion

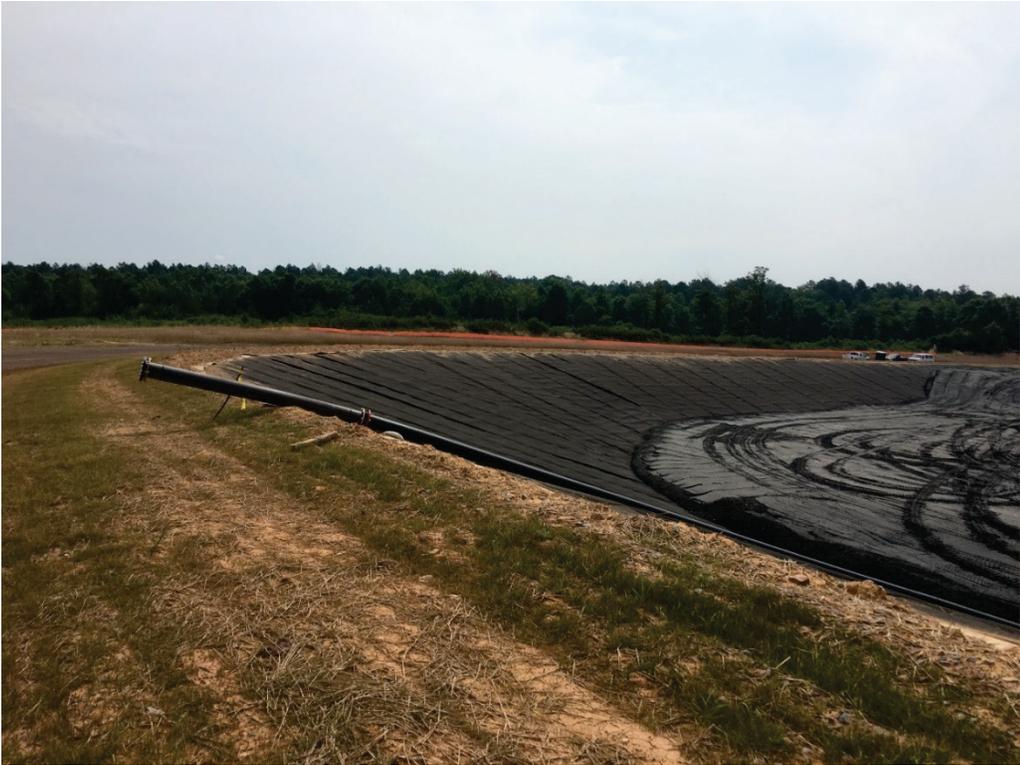
10. Leachate cleanout pipe on the northern end of Cell 1

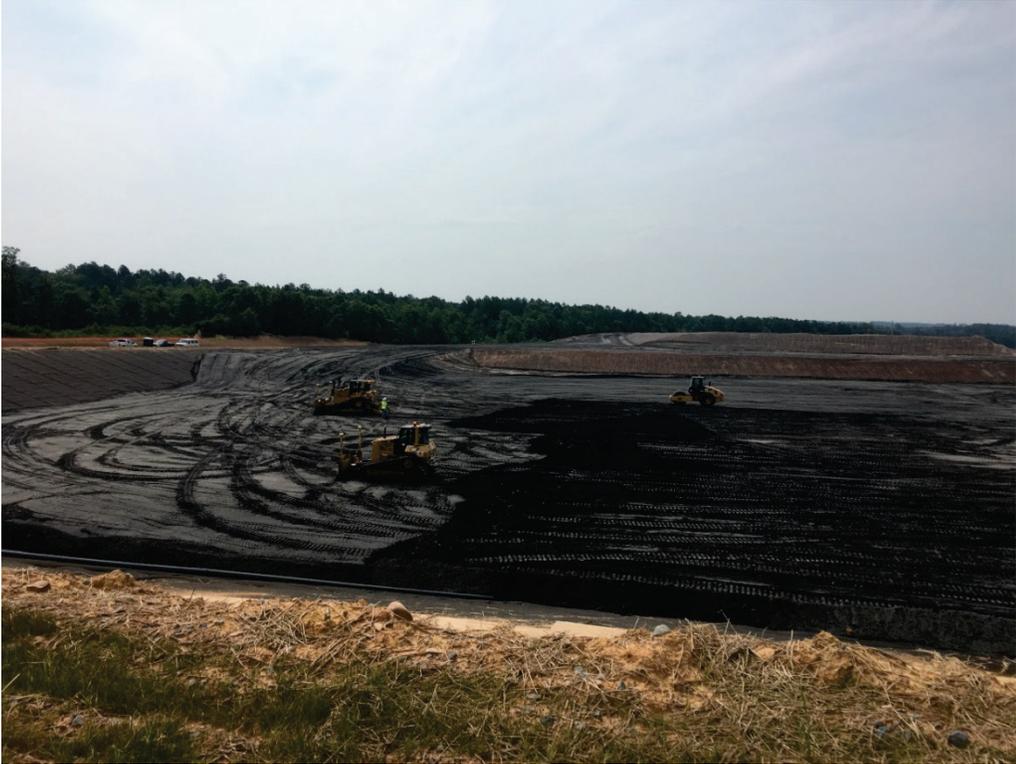
11. CCP placement in compacted lifts

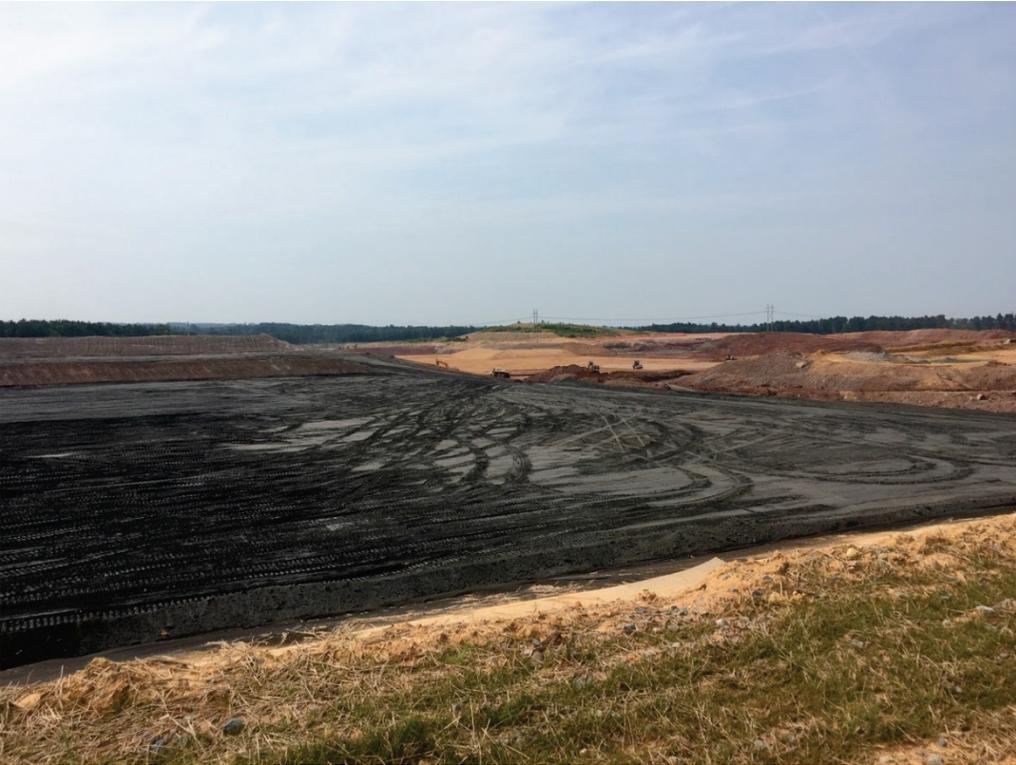
12. Lift placement for CCP
