CCP Annual Inspection Report

Brickhaven No. 2 Mine Tract A Structural Fill
DWM Permit 1910, DEMLR Permit 19-25

Charah, Inc.

February 2018

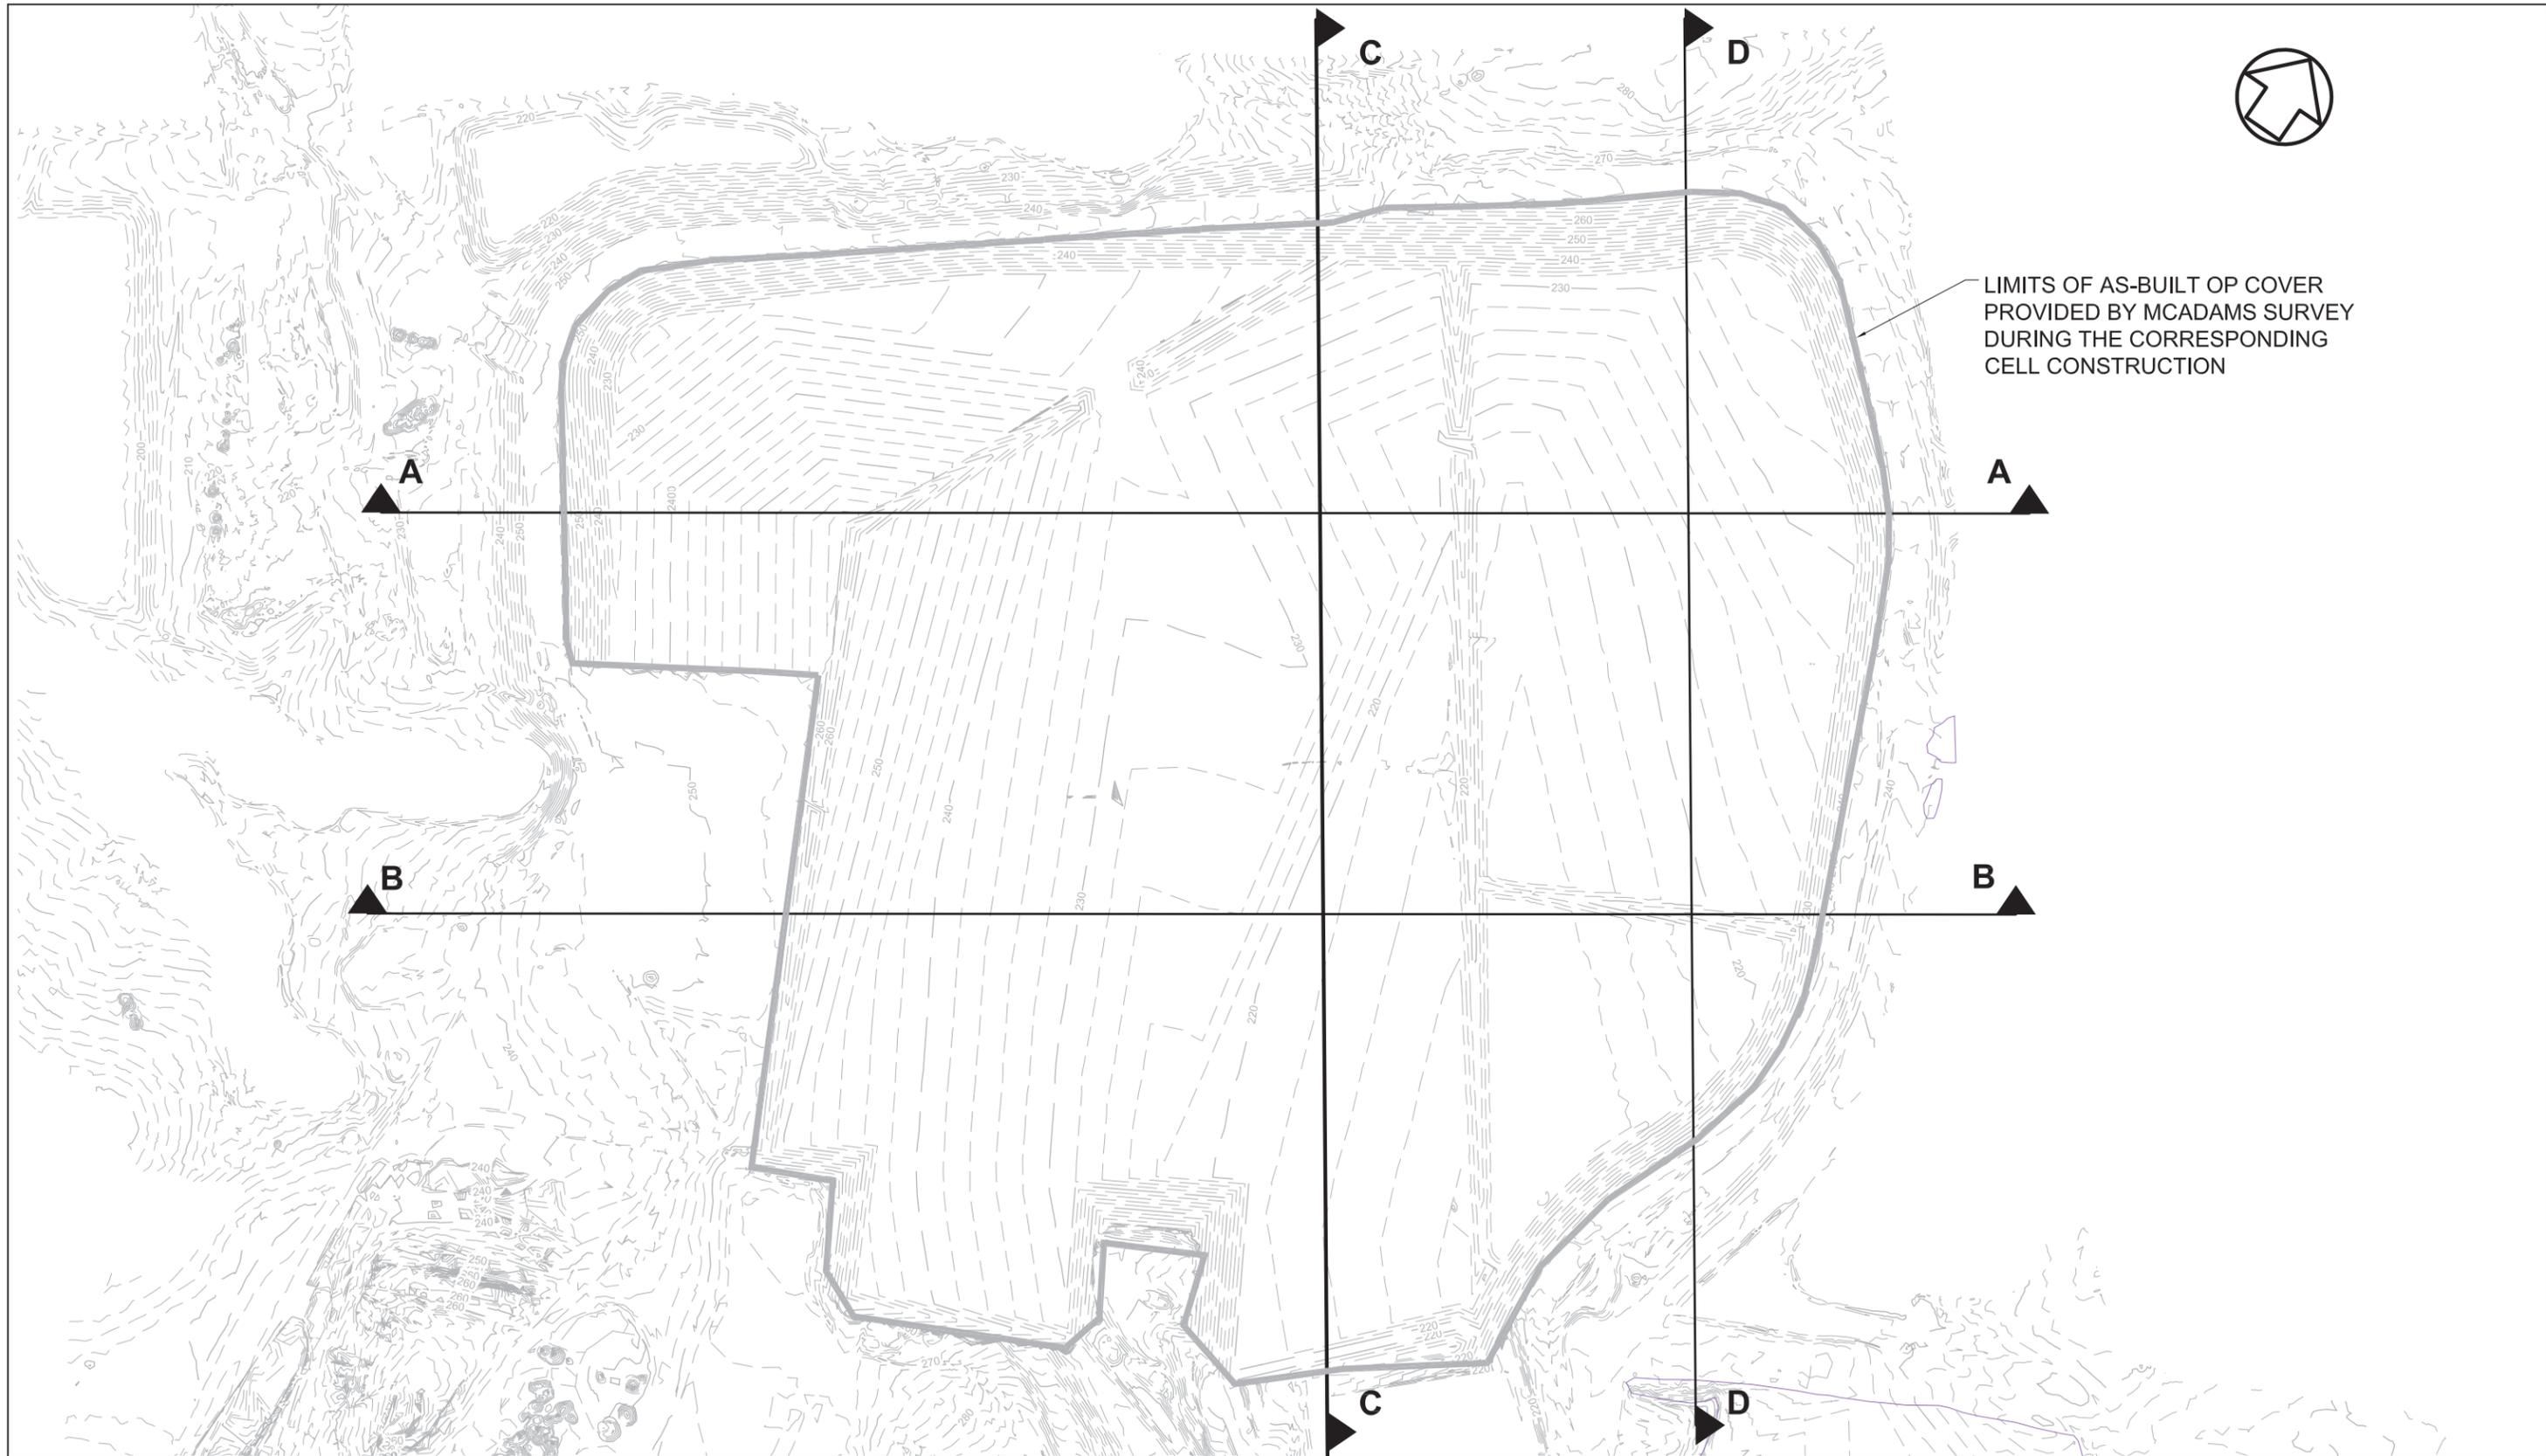
FIGURE
1

**SECTION LOCATION MAP
AS-BUILT TOP OF LINER**

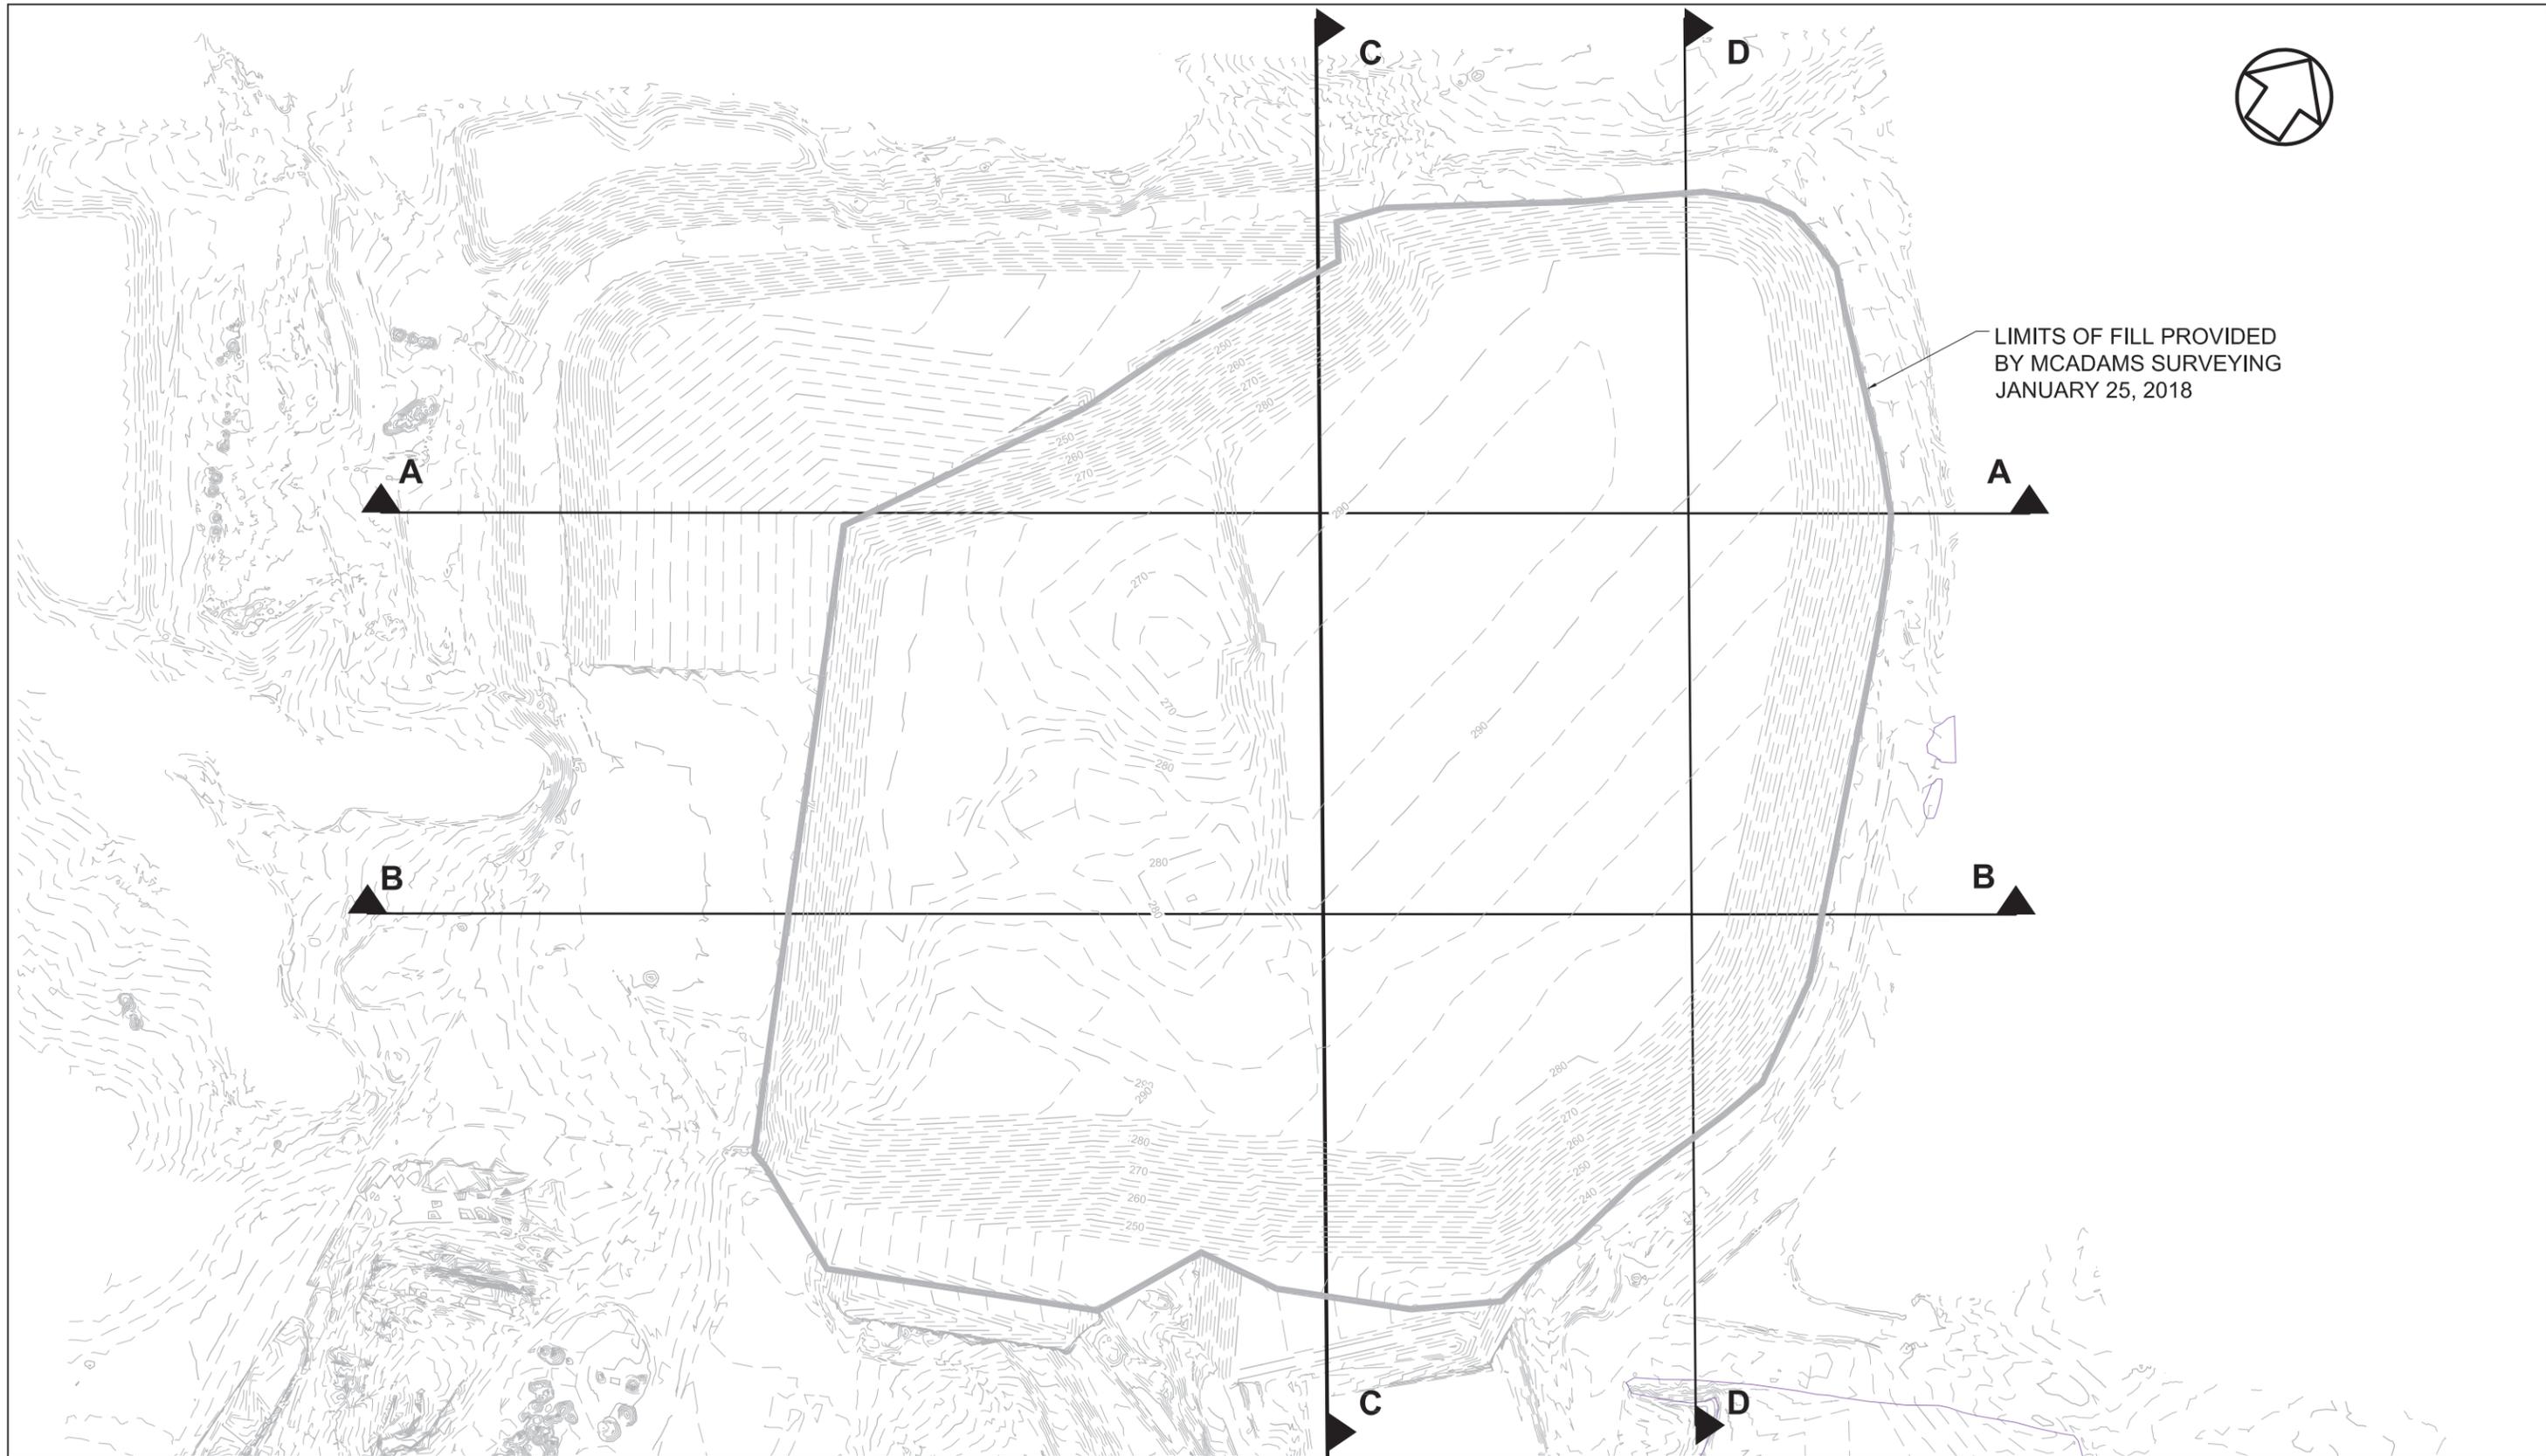
FIGURE
2

**SECTION LOCATION MAP
TOP OF FILL 2018**

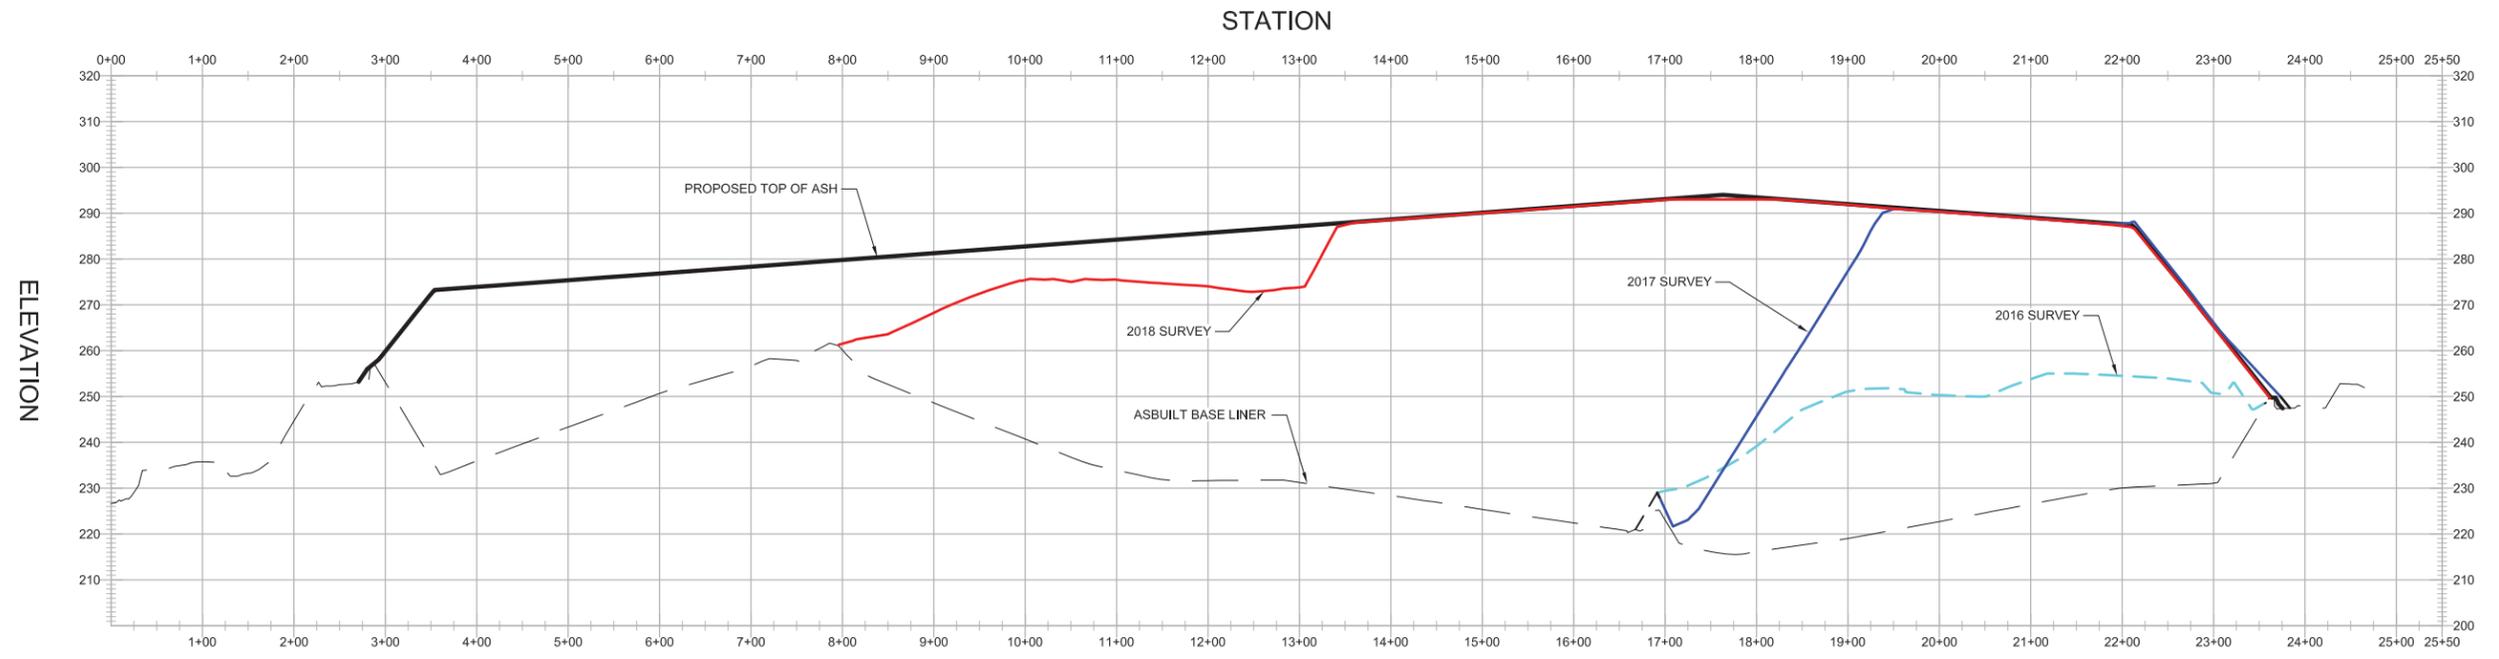
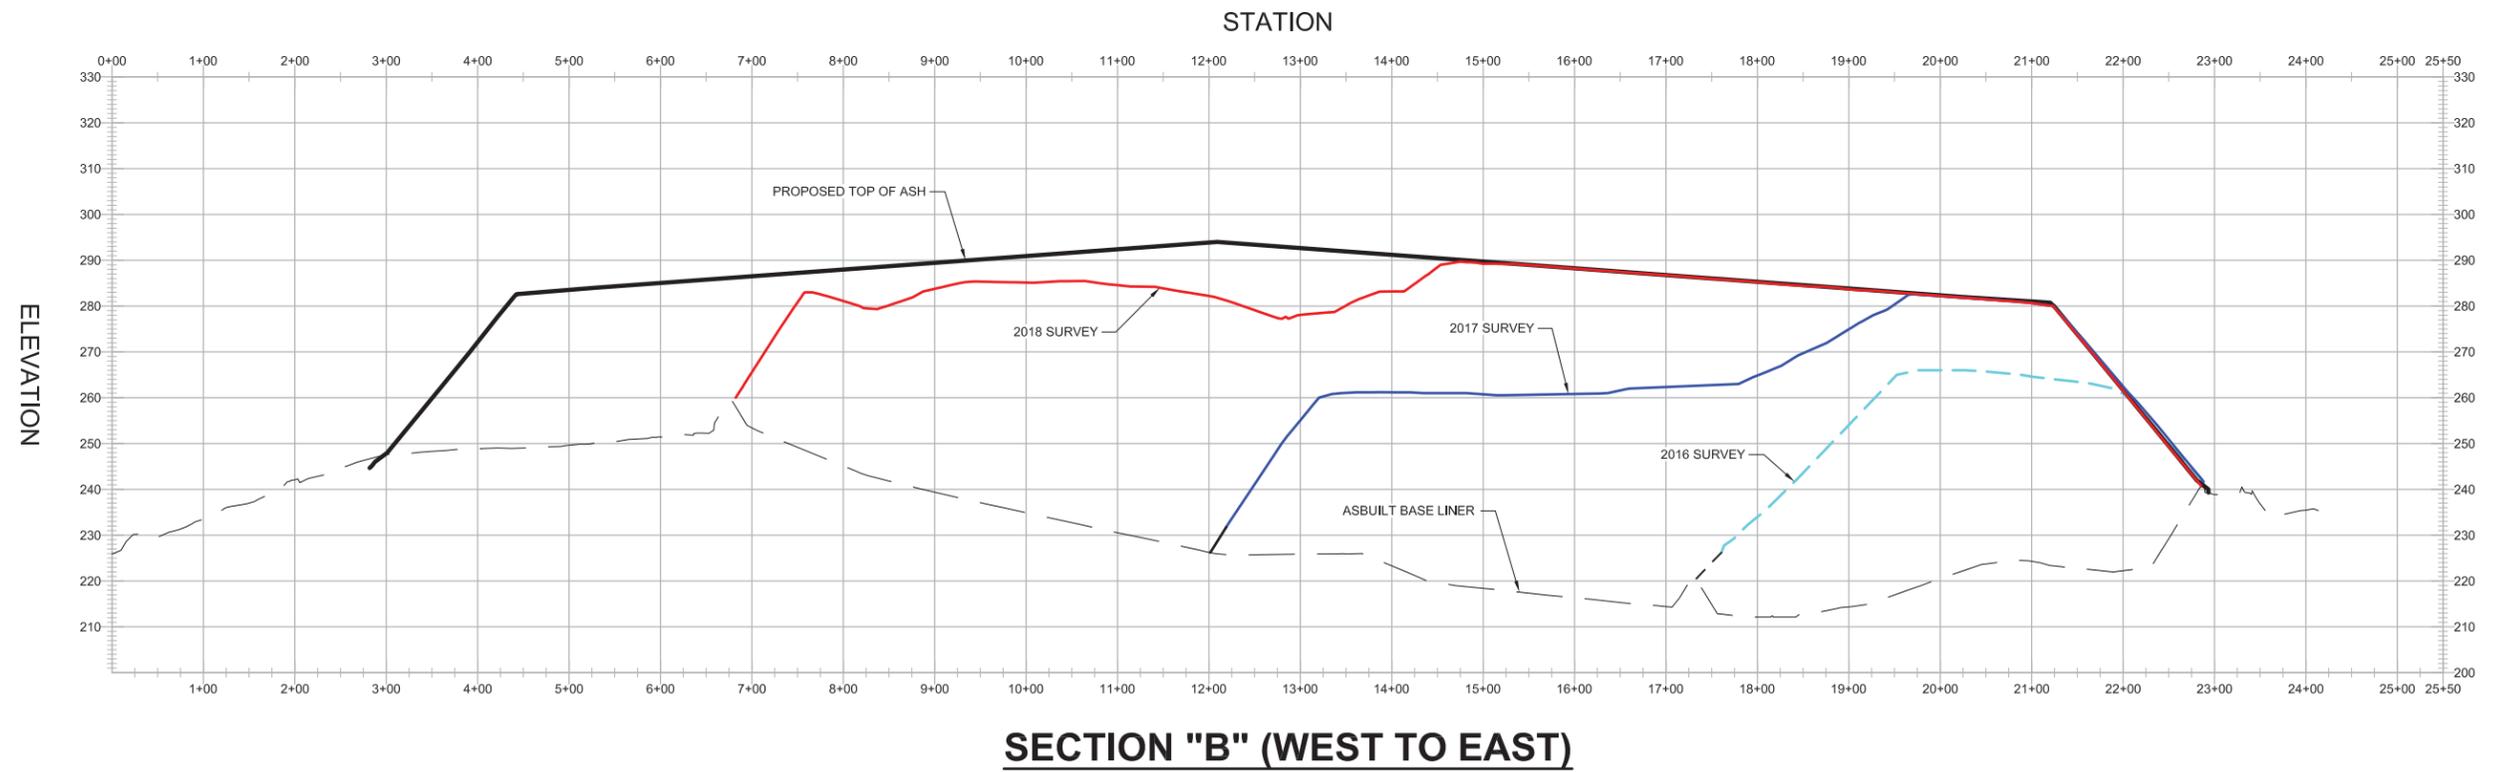
FIGURE
3

and D). The in-place amount of CCP at that time was 2,179,304 cubic yards. Since that time, the structural fill has expanded into Cell 2, Subcells A, E, F and G and the in-place volume has increased to 4,549,539 cubic yards. Refer to the cross-section drawings in Appendix A to see the changes in the geometry of the structural fill. The site inspection included an evaluation of the following site features.

SECTIONS

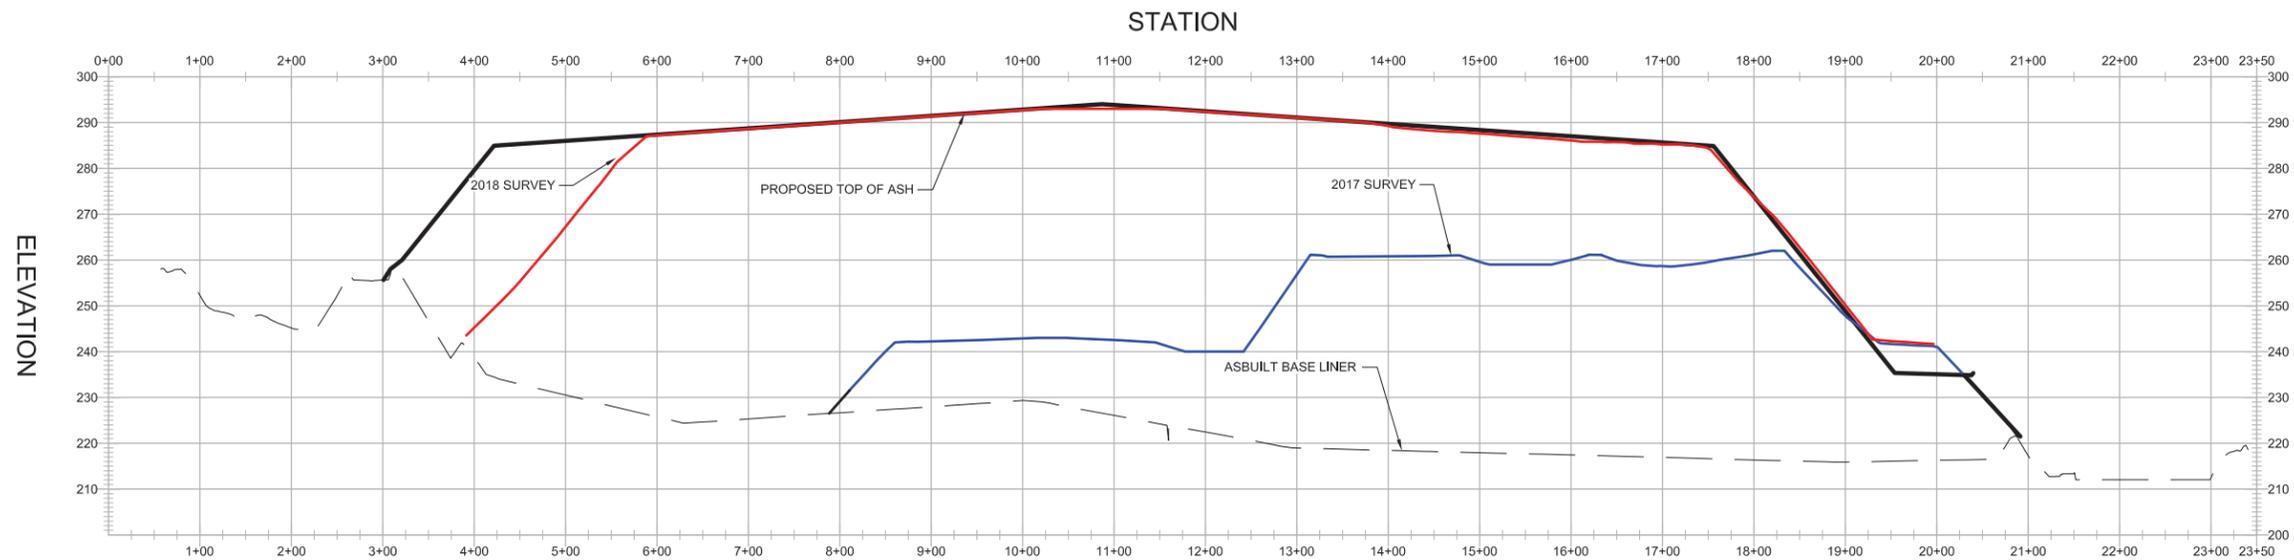
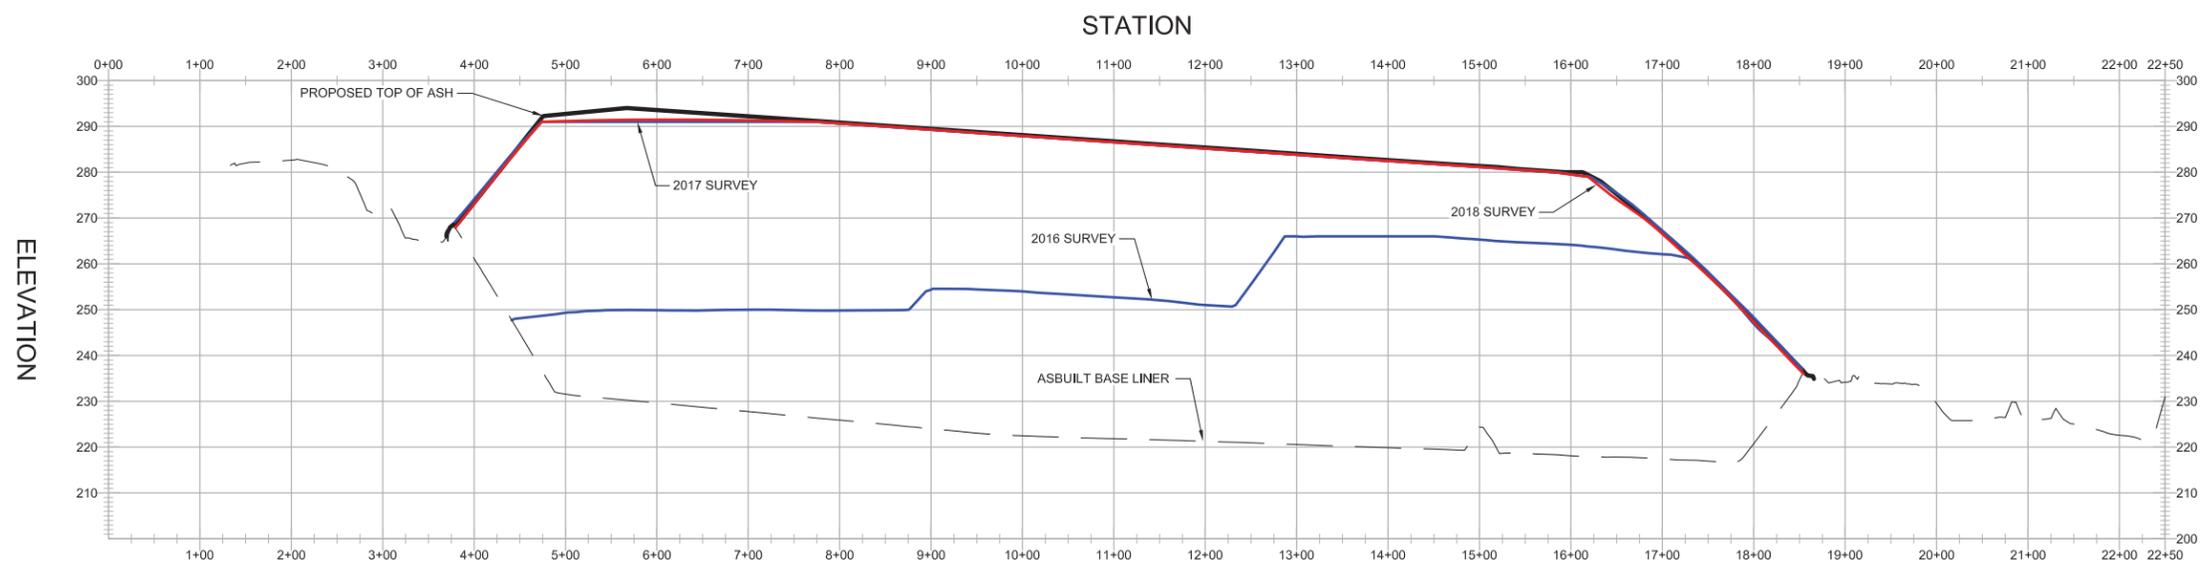
DATE
2/2018
FIGURE
4

The January 17, 2018 as-built survey was provided by McAdams Company and shows the current development of the structural fill. HDR has provided cross-sections in the Appendix showing the changes in geometry between the 2017 and 2018 inspection reports.

SECTIONS
MONCURE, NC

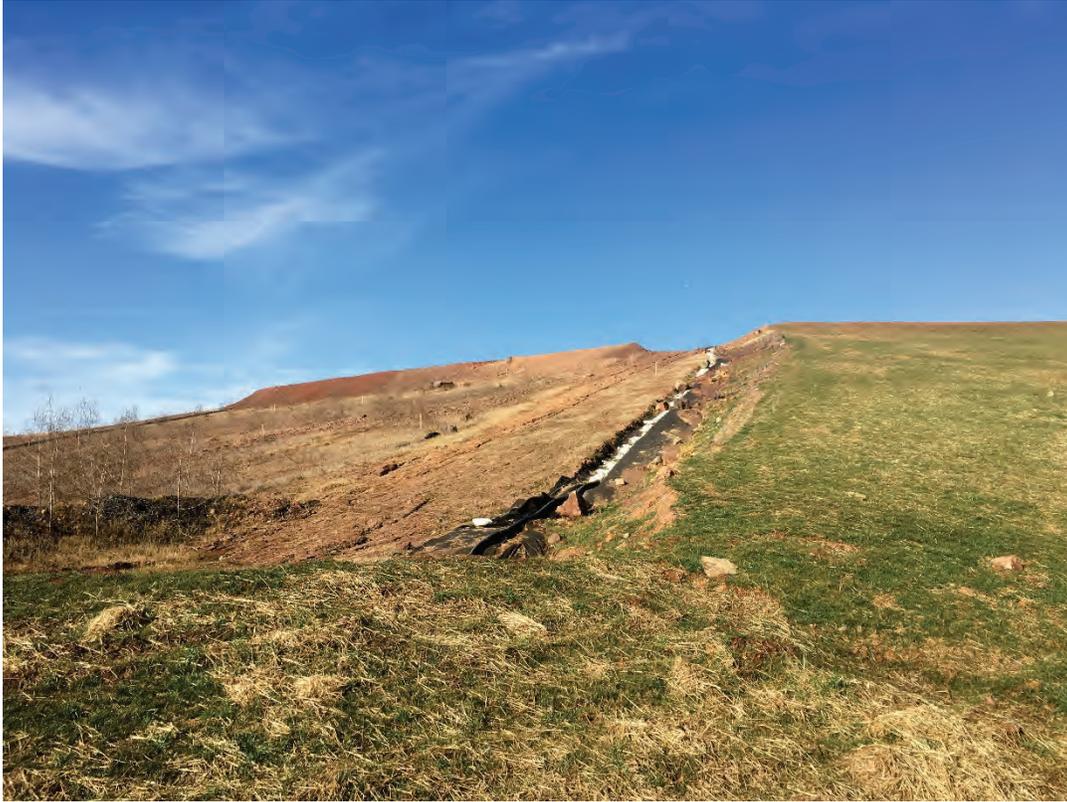
Charah uses the application of interim cover in the CCP active areas to segregate stormwater from leachate. Perimeter diversion berms constructed at the top of the exterior slopes direct stormwater runoff to slope drain inlets. These pipes discharge outside of the lined structural fill into stormwater conveyance measures that drain to either the mine lake or sediment basins onsite. Photos 11, 19, and 20 show the inlets of drainage pipes collecting runoff from the interim or final cover soil area. At the time of this inspection, all slopes draining outside of the containment were covered with soil as shown in photos 2 through 4. Overall, the areas with interim cover appeared to have adequate soil cover and showed no signs of operational or structural concern. Soils placed on final slopes were seeded to prevent erosion and exhibited a good stand of vegetation that was functioning as intended. No signs of CCP release were observed. Interim cover had been placed on the top of the Cell 1 and 2 area where final CCP grades had been reached as shown in photos 5 through 8. This area exhibited no signs of erosion and had vegetation established. Some minor ponding was observed on the top of Cell 1 after the recent rain event which will be corrected prior to the upcoming closure work. No instabilities were observed as a result of the minor ponding. At the time of this inspection, the stormwater runoff was being directed to the mine lake area as shown in photo 1 where Charah was actively treating the ponded water to required discharge turbidity levels.

1. Closure extents near leachate enclosure

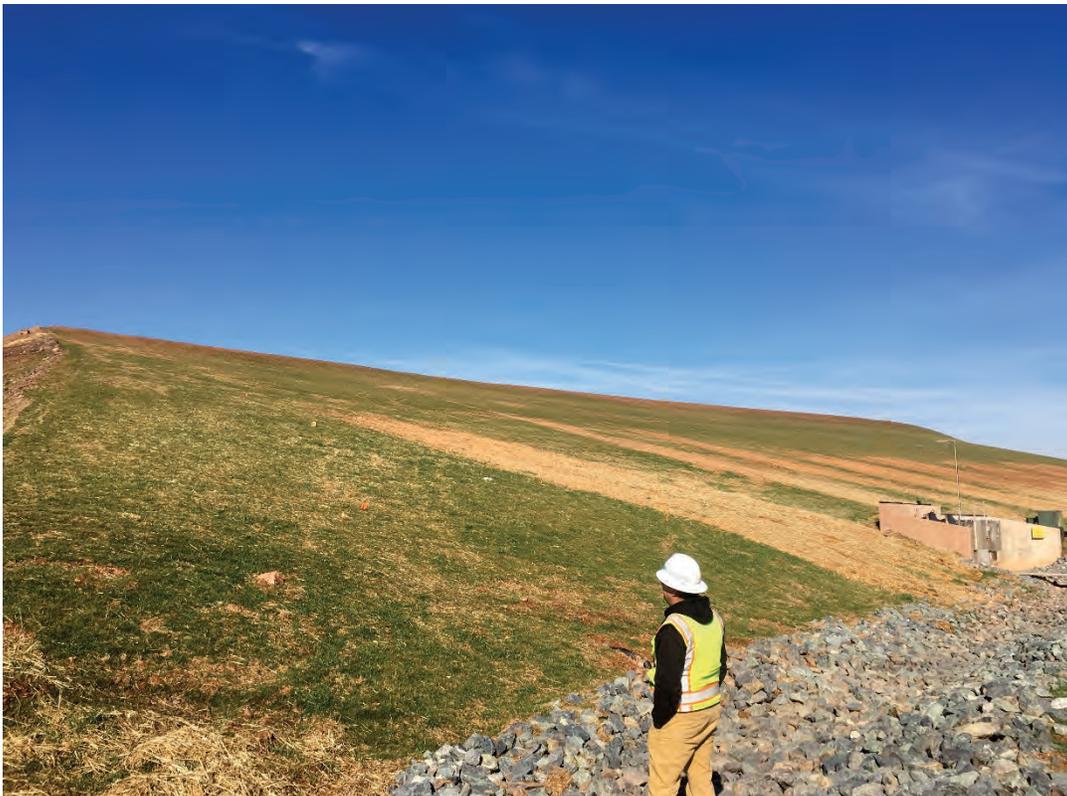
2. Vegetation on closed side slope above the leachate enclosure

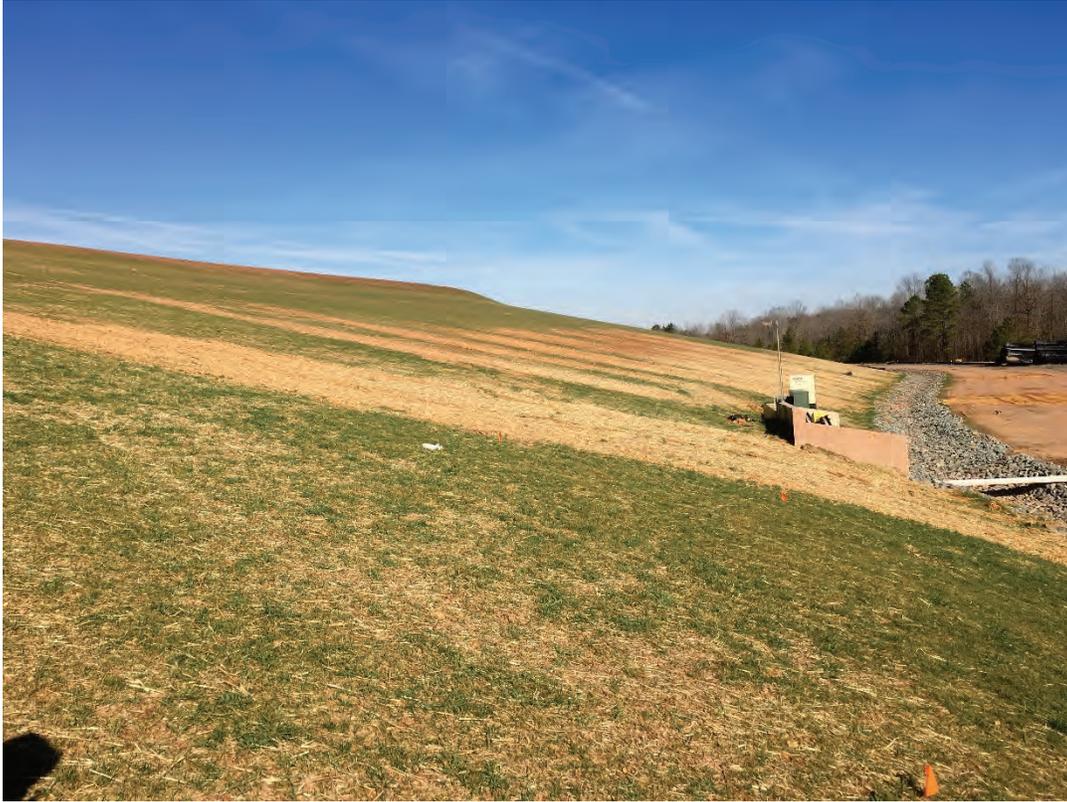
3. Vegetation on closed side slope above the leachate enclosure

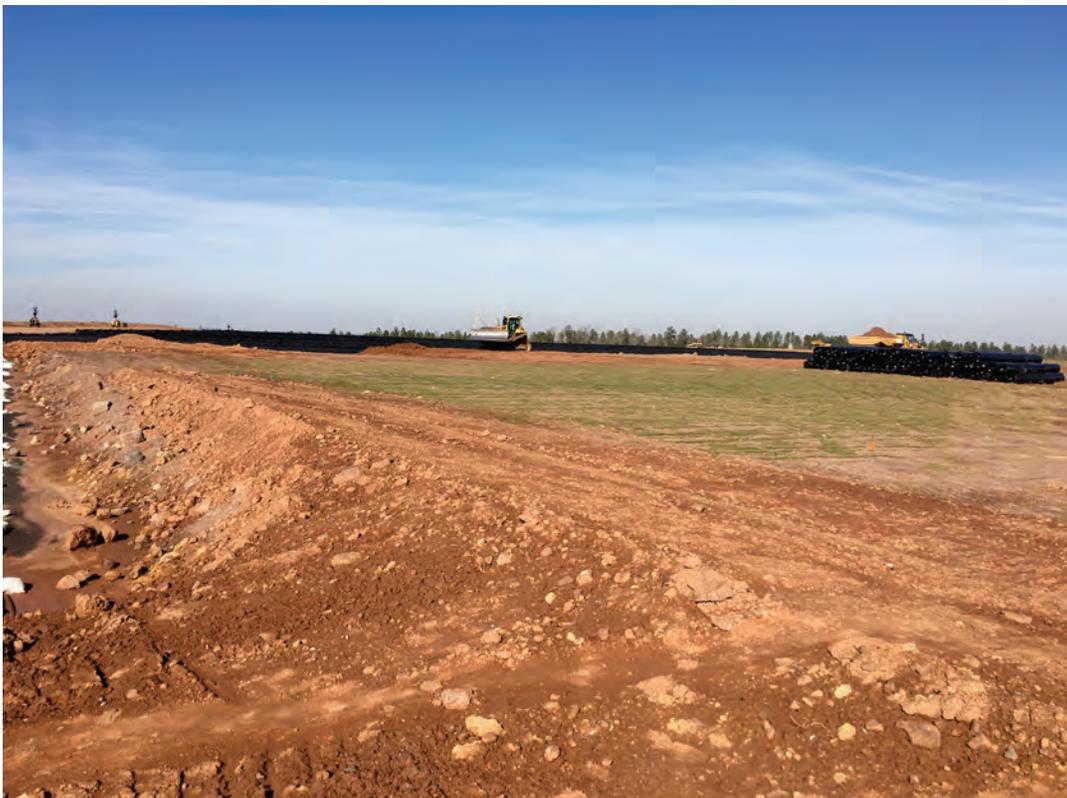
10. Soil cap placement above Cell 2

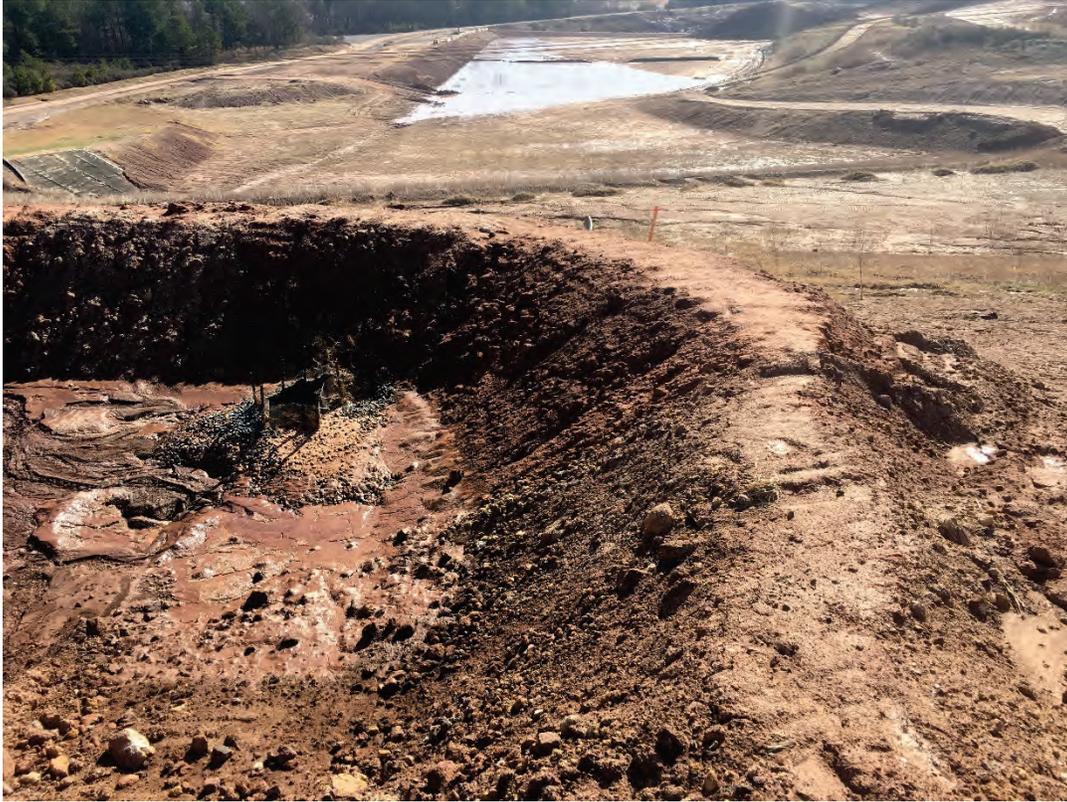
11. Stormwater drainage on top of Cell 2 capped areas

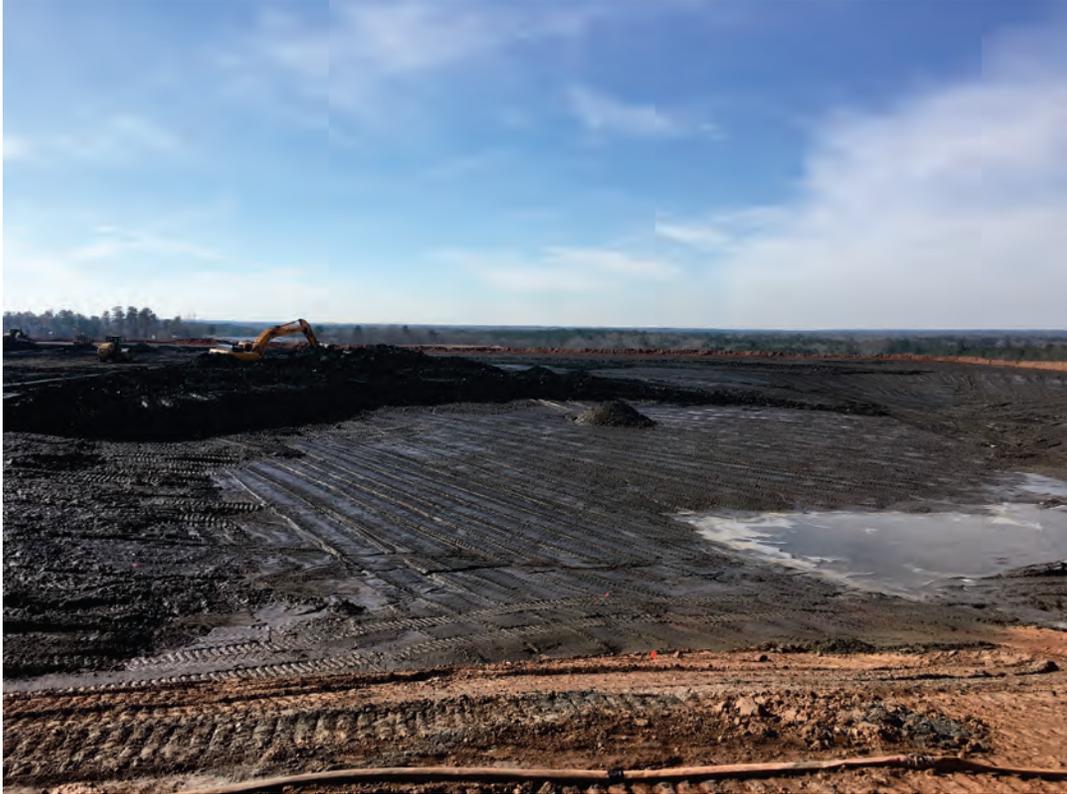
15. Leachate draining to a wick drain in Cell 2

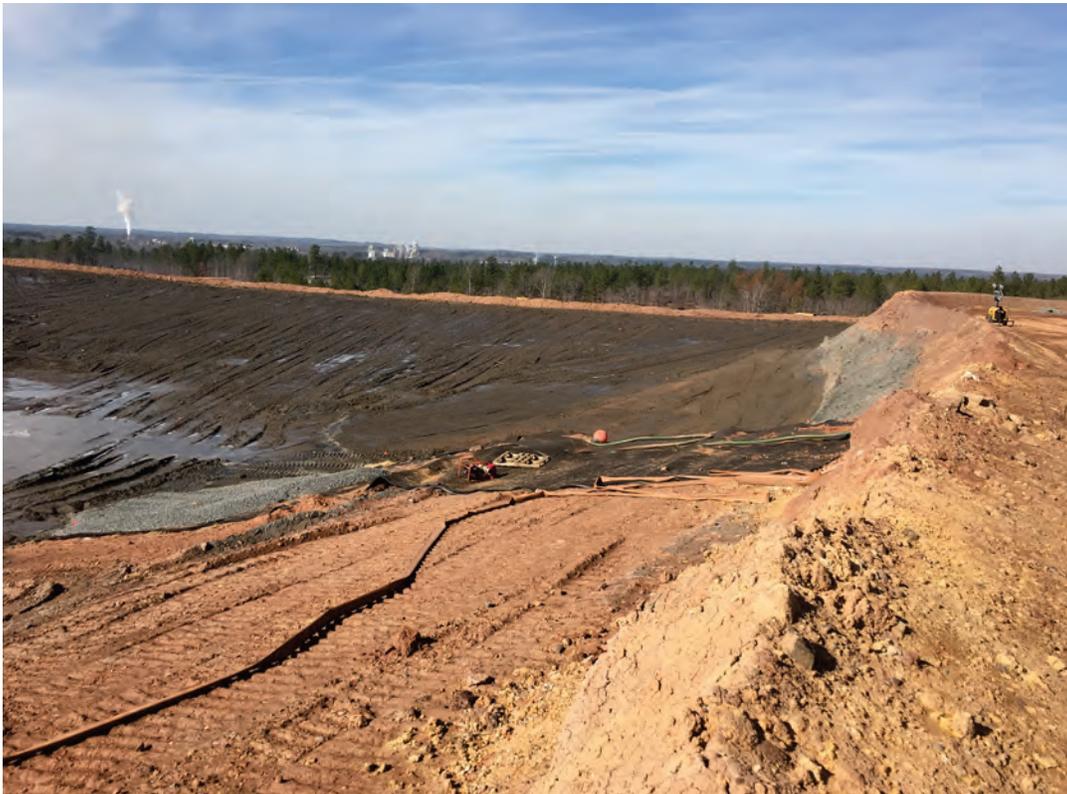
16. Divider berm to prevent run-on from capped areas into the ash

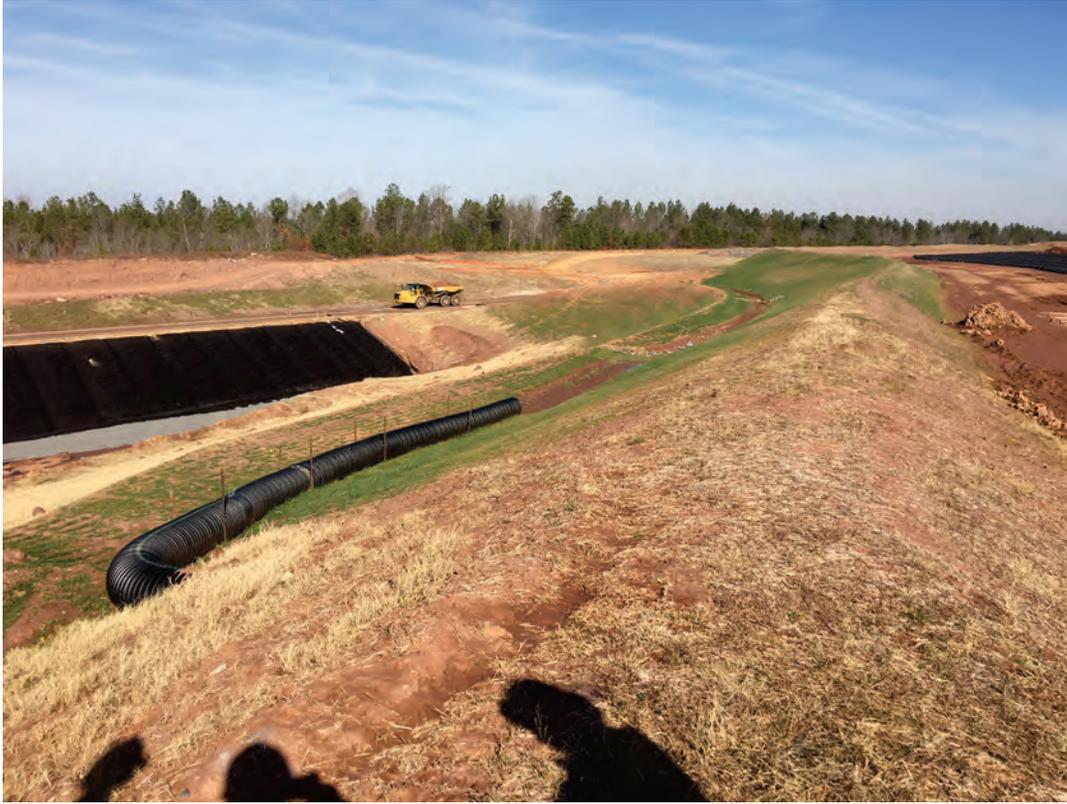
19. Stormwater drainage from capped Cell 2 areas

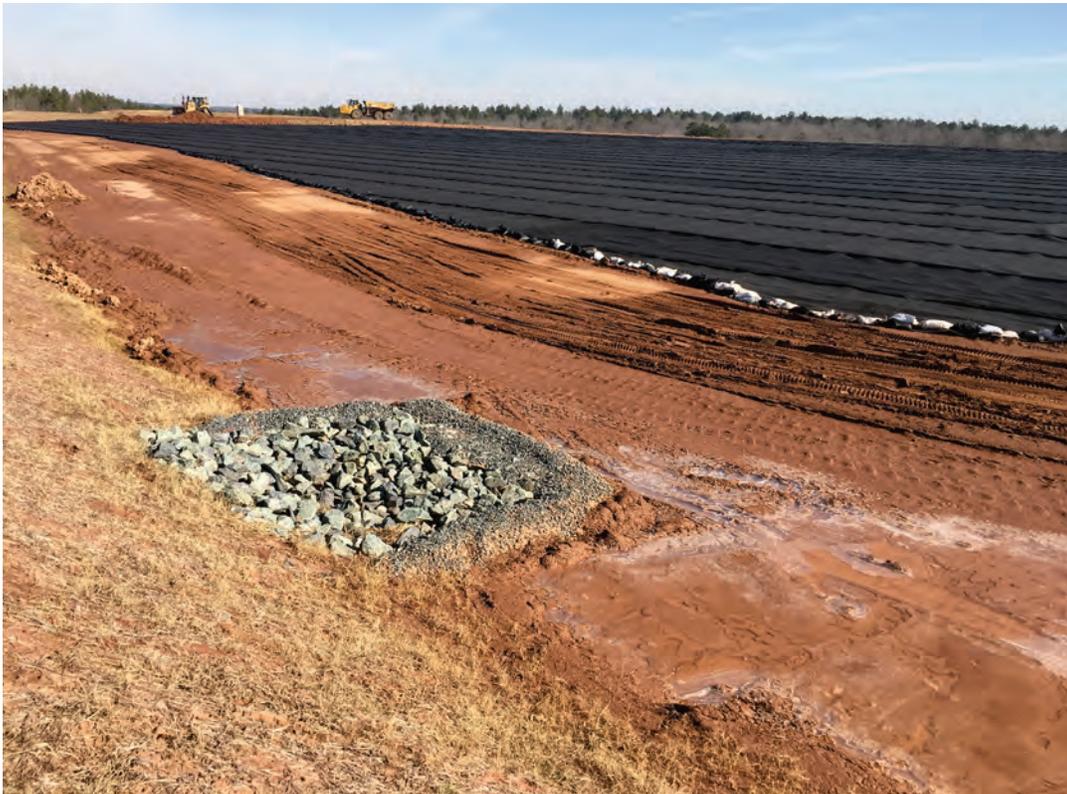
20. Drainage pipe inlet on top of Cell 2

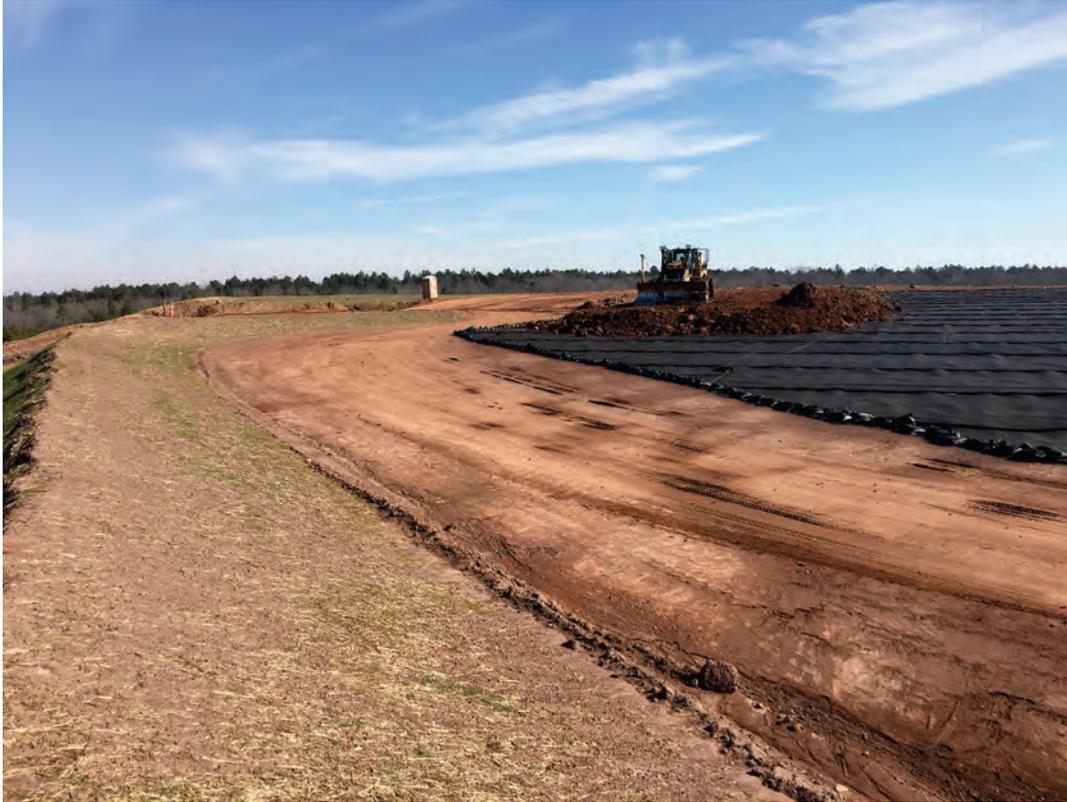
Operationally Charah minimizes leachate generation by limiting the area of exposed CCP to rain through the placement of interim cover soils. When final CCP grades have been reached on exterior slopes Charah covers the area with a minimum 1 foot thick interim soil cover. This soil may be removed prior to final cap installation. Additionally, Charah constructs soil berms around the top of the slopes to prevent leachate runoff from active placement areas as seen on photo 16. Additionally, Charah has placed geocomposite wick drains with stone in the CCP fill area to collect and transmit leachate to the leachate system as shown in photo 15. Charah has also initiated closure activities in the Cell 1 and 2 areas where final CCP grades have been achieved. Photos 21 and 22 show the closure activities.

21. Cap soil placement in Cell 2
