CCP Annual Inspection Report

Brickhaven No. 2 Mine Tract A Structural Fill
DWM Permit 1910, DEMLR Permit 19-25

Charah, Inc.

February 2018

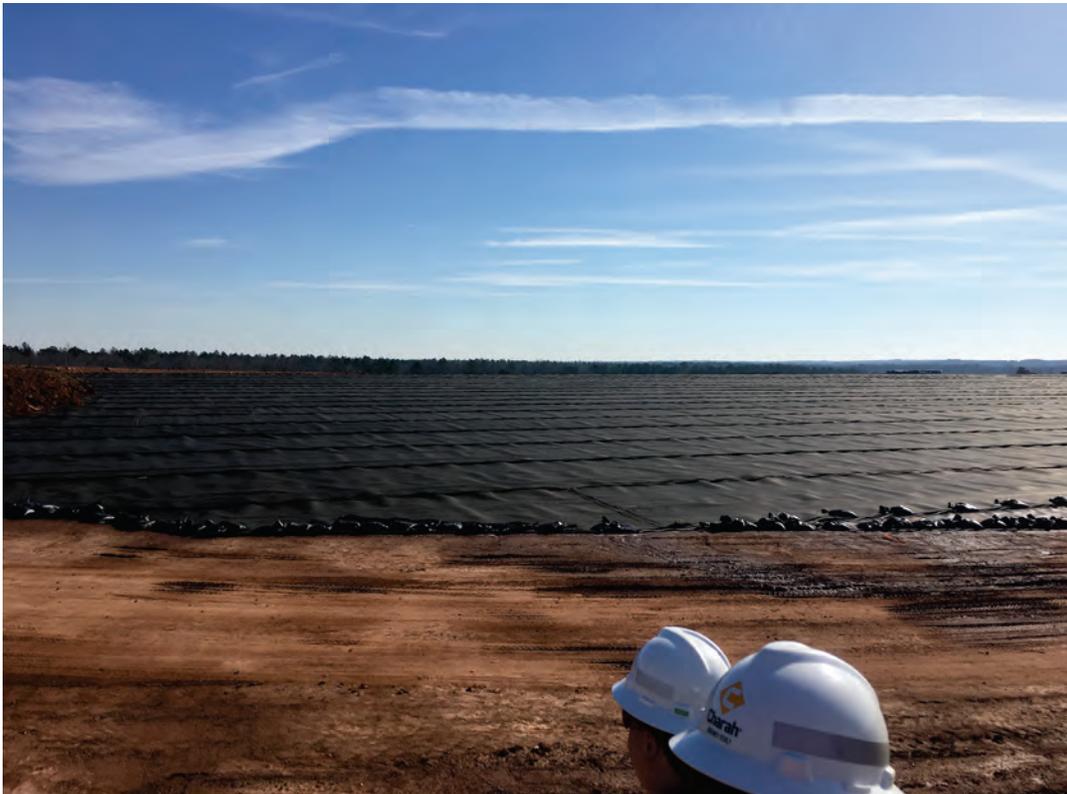
Operationally Charah minimizes leachate generation by limiting the area of exposed CCP to rain through the placement of interim cover soils. When final CCP grades have been reached on exterior slopes Charah covers the area with a minimum 1 foot thick interim soil cover. This soil may be removed prior to final cap installation. Additionally, Charah constructs soil berms around the top of the slopes to prevent leachate runoff from active placement areas as seen on photo 16. Additionally, Charah has placed geocomposite wick drains with stone in the CCP fill area to collect and transmit leachate to the leachate system as shown in photo 15. Charah has also initiated closure activities in the Cell 1 and 2 areas where final CCP grades have been achieved. Photos 21 and 22 show the closure activities.

22. Cell 2 closure extents

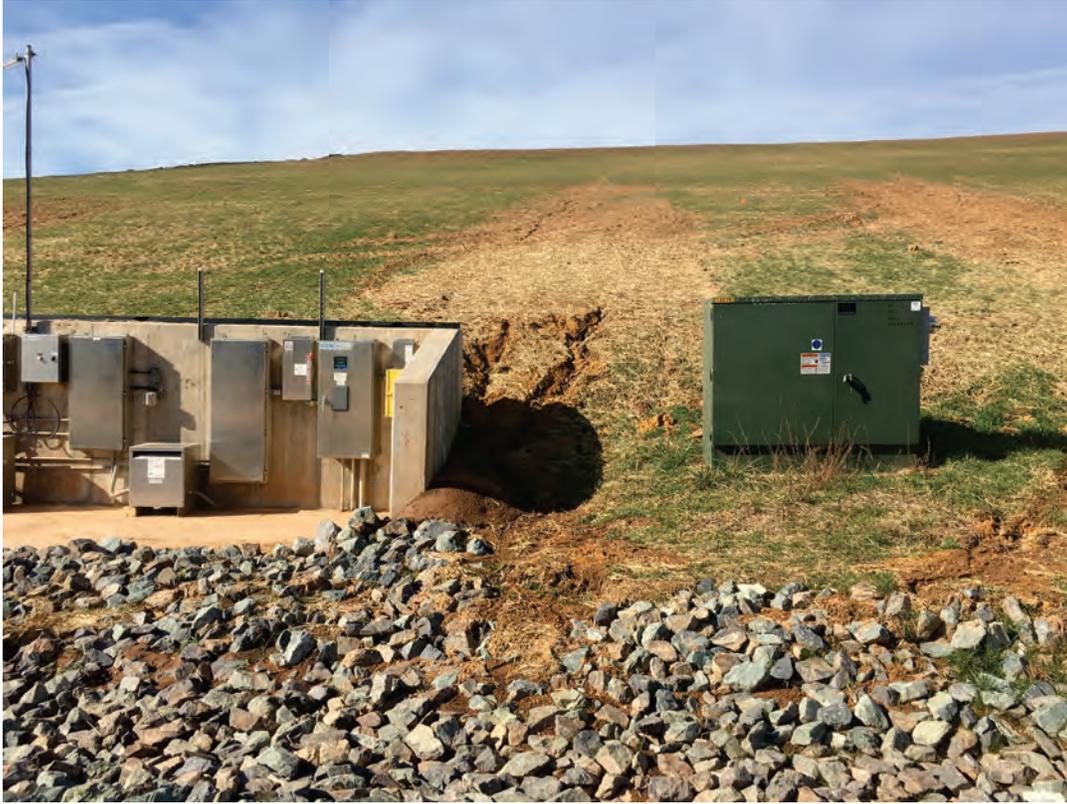
27. Slight erosion at the leachate enclosure

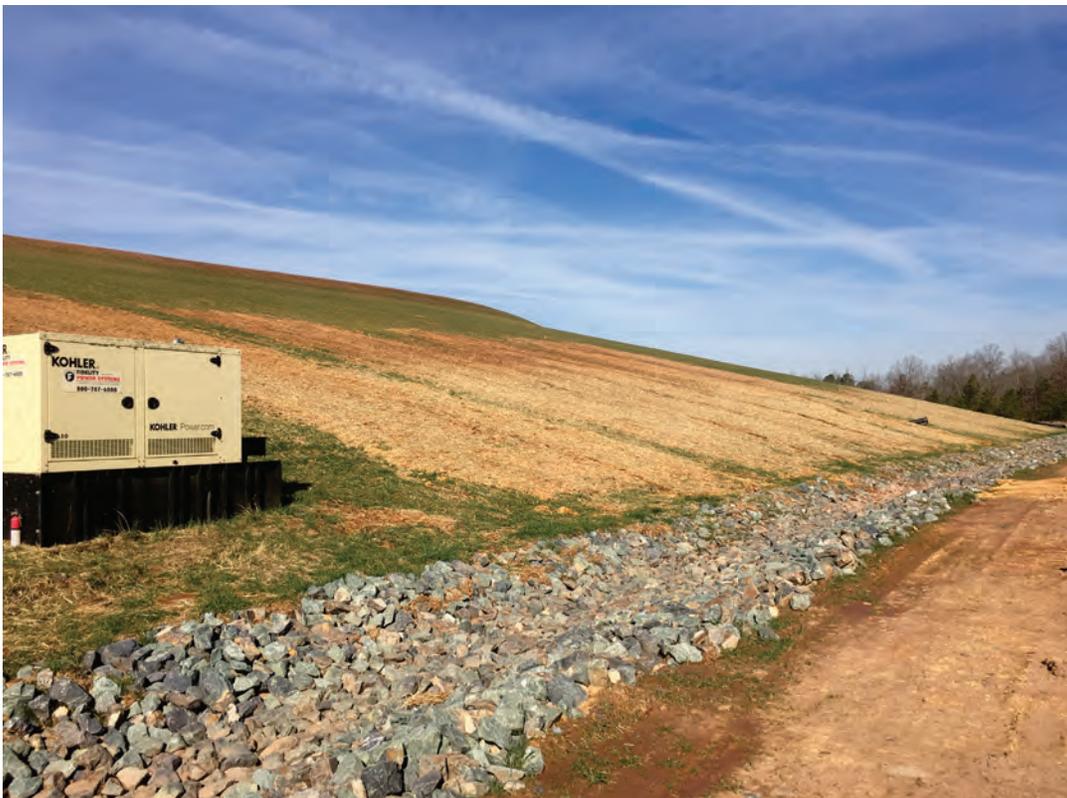
28. Repaired areas on closed slopes

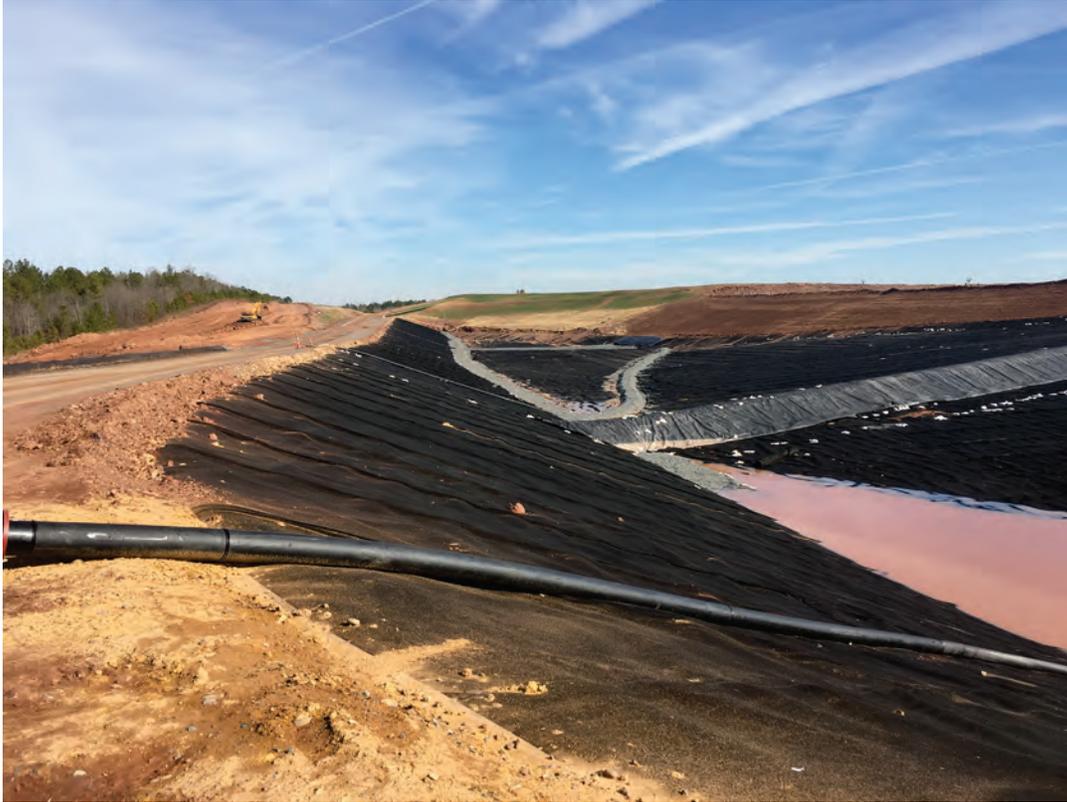
stormwater management system. Photos 31 and 32 show stormwater segregation in the newly constructed Cell 6, Subcells A and B.

31. Cell 6 sump looking east

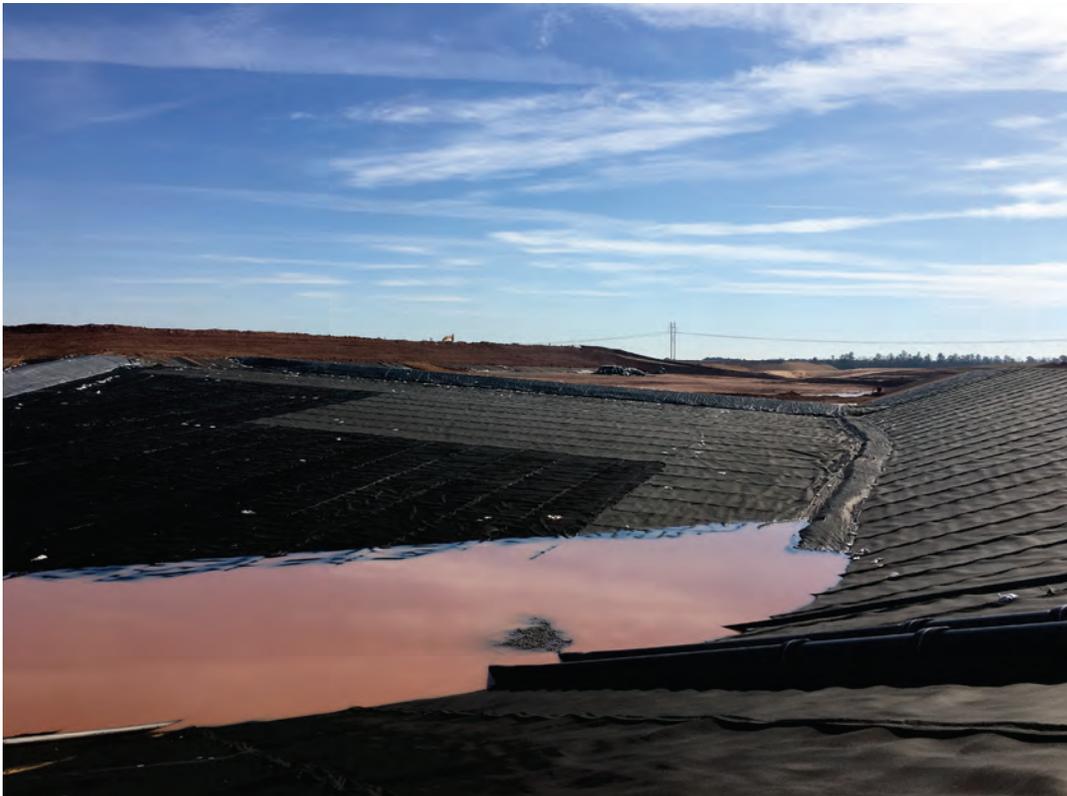
32. Cell 6 sump looking south
