# CCP Annual Inspection Report

Brickhaven No. 2 Mine Tract A Structural Fill  
DWM Permit 1910, DEMLR Permit 19-25

Charah, Inc.

*Moncure, North Carolina*  
January 2019

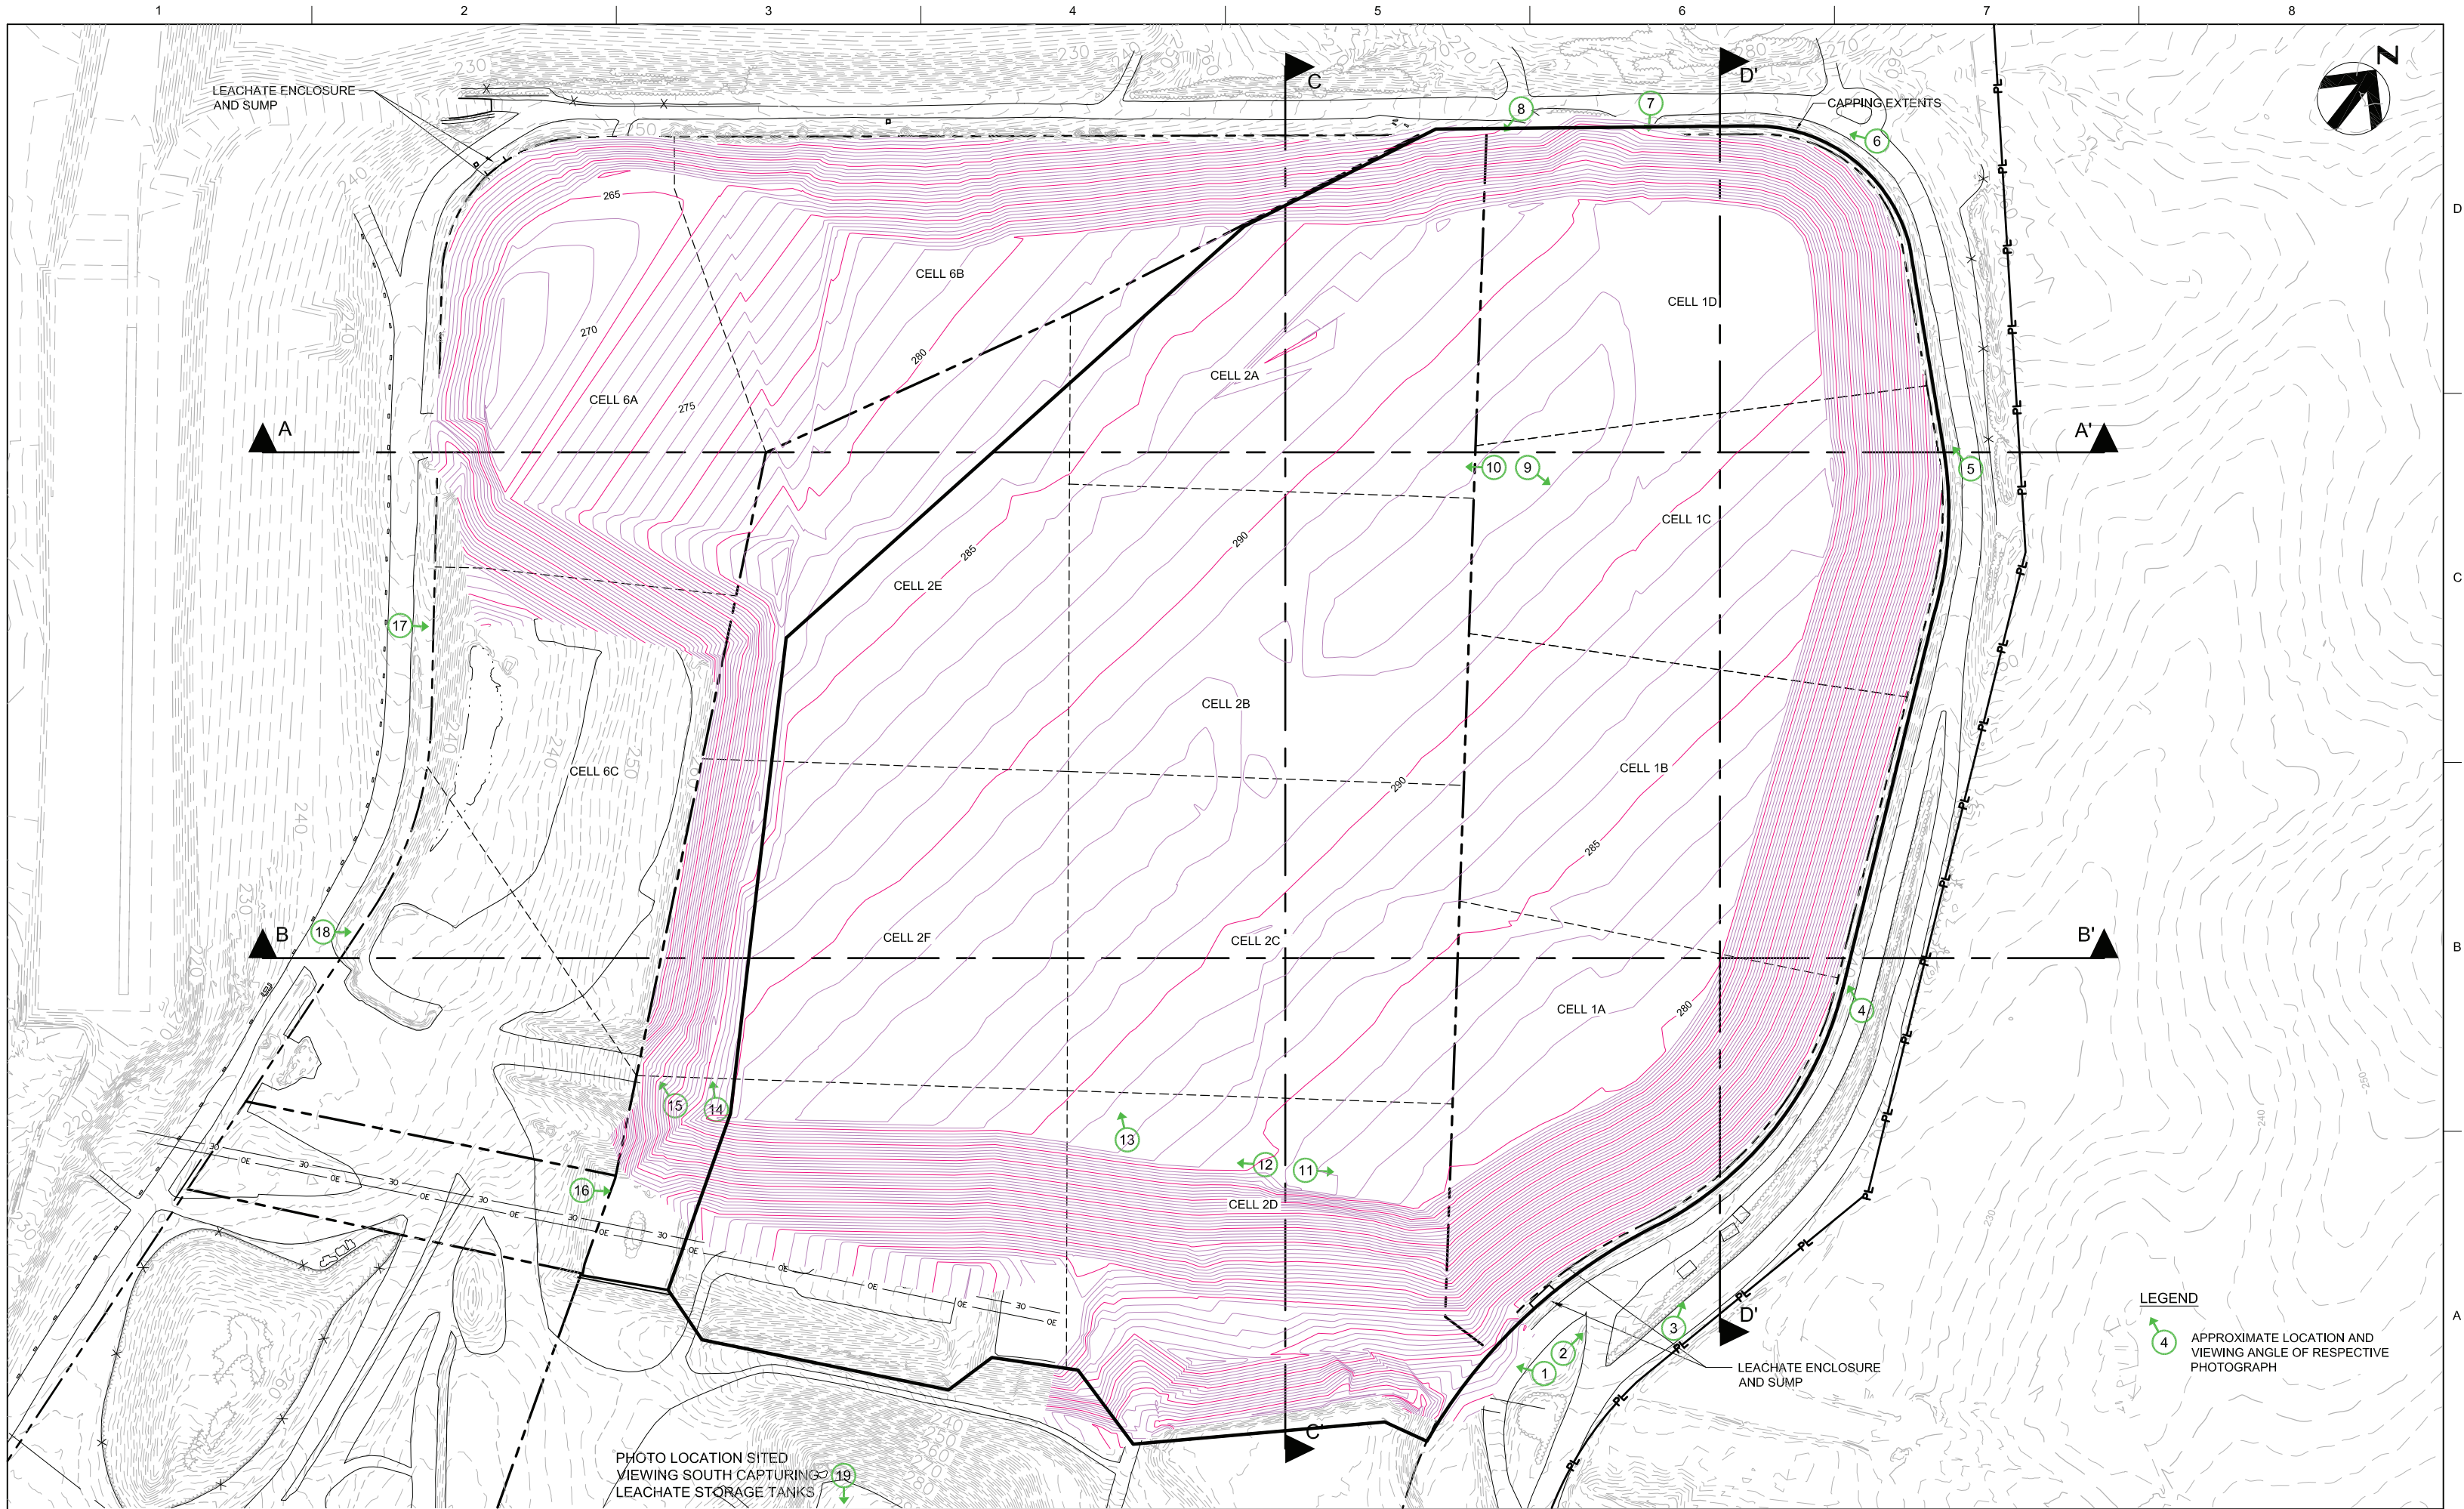
FIGURE  
2

Operationally Charah minimizes leachate generation by limiting the area of exposed CCP to rain through closure capping or the placement of interim cover soils to shed water to the stormwater system. Figure 2 shows the extent of closure capping activities at the time of this inspection. When final CCP grades have been reached, and before there is enough area to begin closure, Charah will cover the CCP with interim soil cover to limit CCP contact water. This soil may be removed prior to final cap installation. Photo 14 shows the transition from the closure cap to the interim cover soils along the Cell 2/6 boundary. Additionally, Charah constructs soil berms to

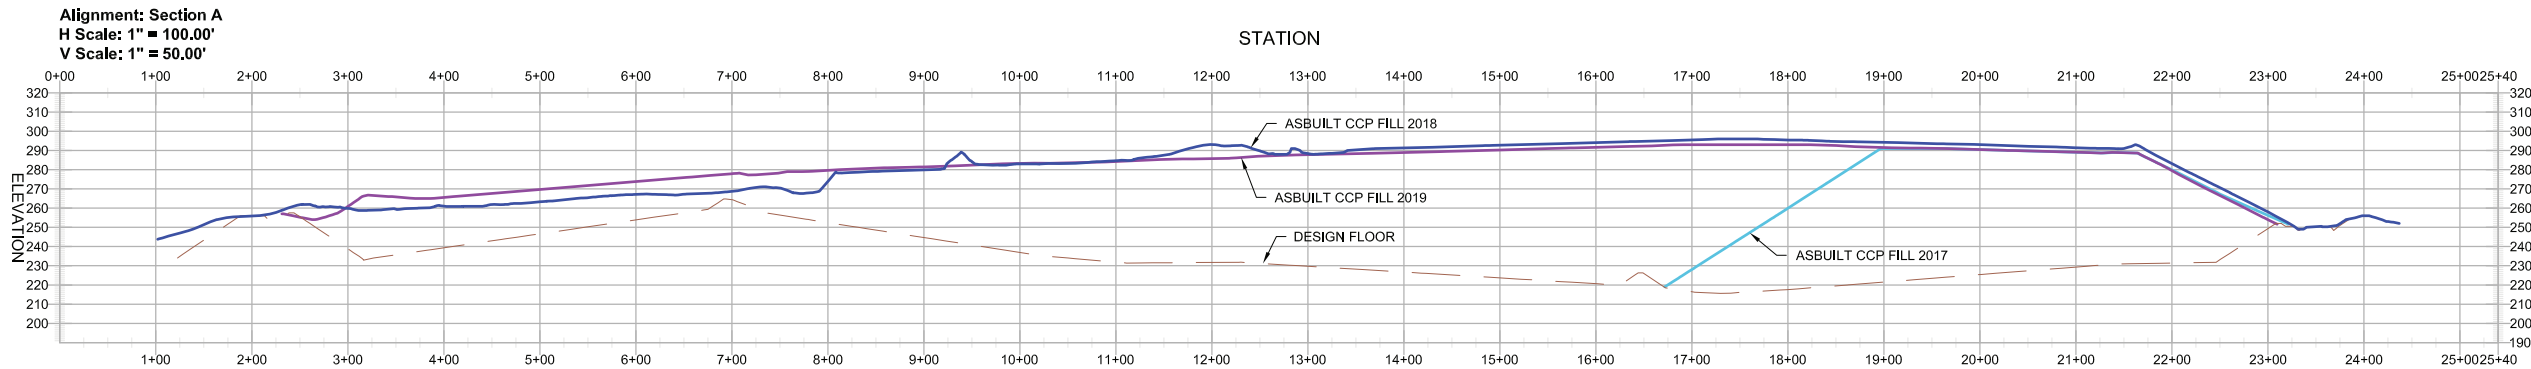
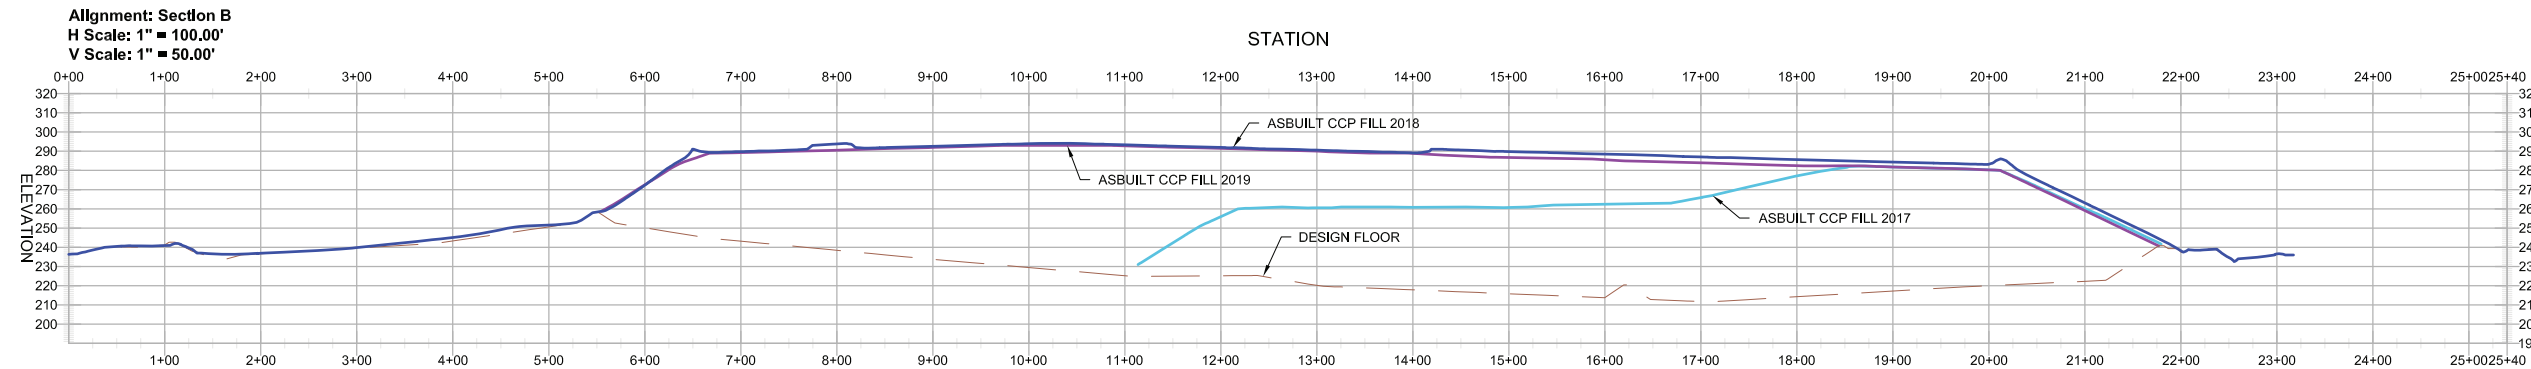
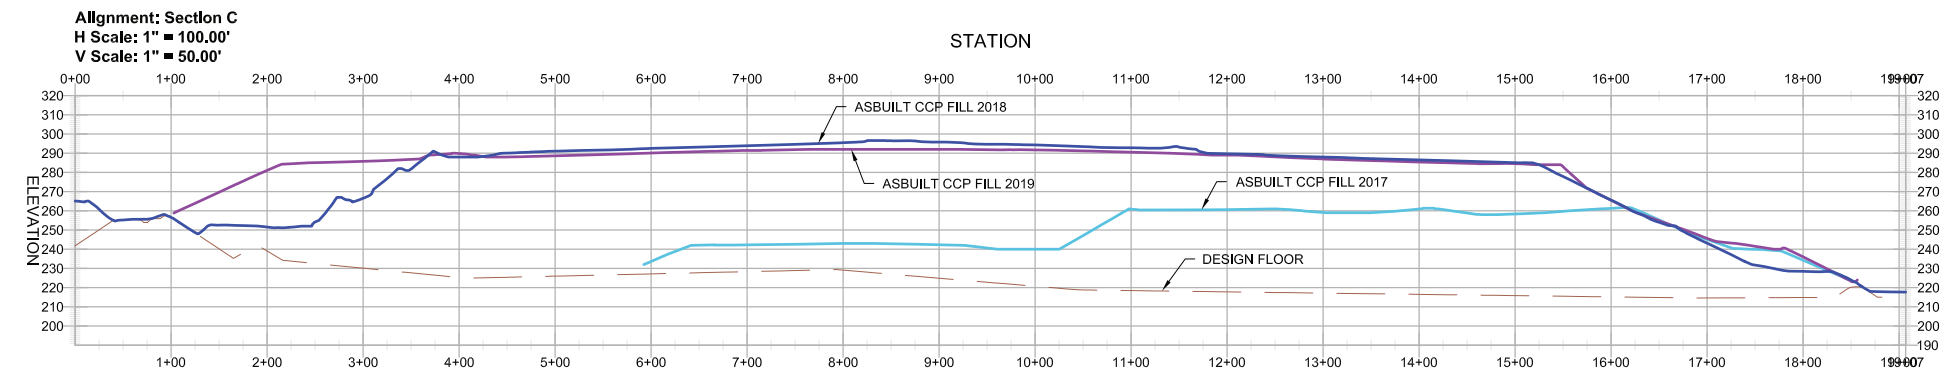
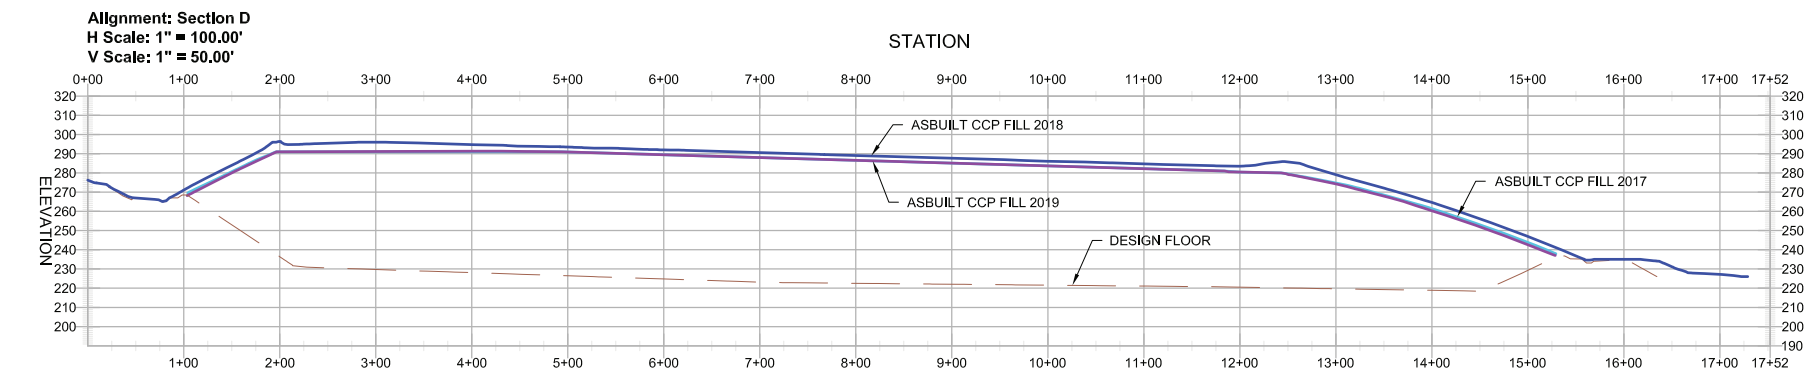
FIGURE  
3

The as-built survey was provided by McAdams Company and shows the current development of the structural fill. HDR has provided cross-sections in the Appendix showing the changes in geometry between the 2018 and 2019 inspection reports.

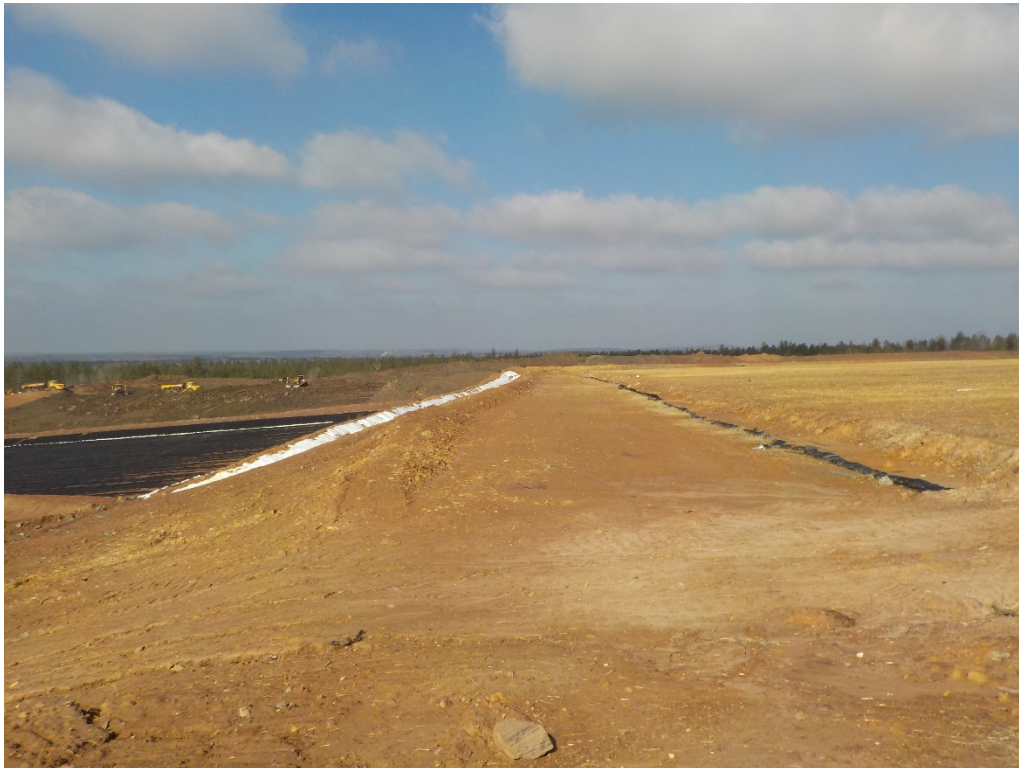
**Photo 14 - Southern access road looking northwest at operations in 6B**

Facility access from Moncure-Flatwood road is controlled by a staffed gate requiring check in and check out of visitors. CCP arrives via railroad and is unloaded onto off-road dump trucks in a lined area and then hauled to the active CCP containment area. Stone access ramps are constructed and maintained to provide access from the unloading area to the lined containment area. Currently, the structural fill has two roads to access the top of the CCP structural fill. One road, shown in Photo 8, enters from the north at the Cell 1D/2A interface and the other, shown in Photo 14, enters from the south into the Cell 2G area.

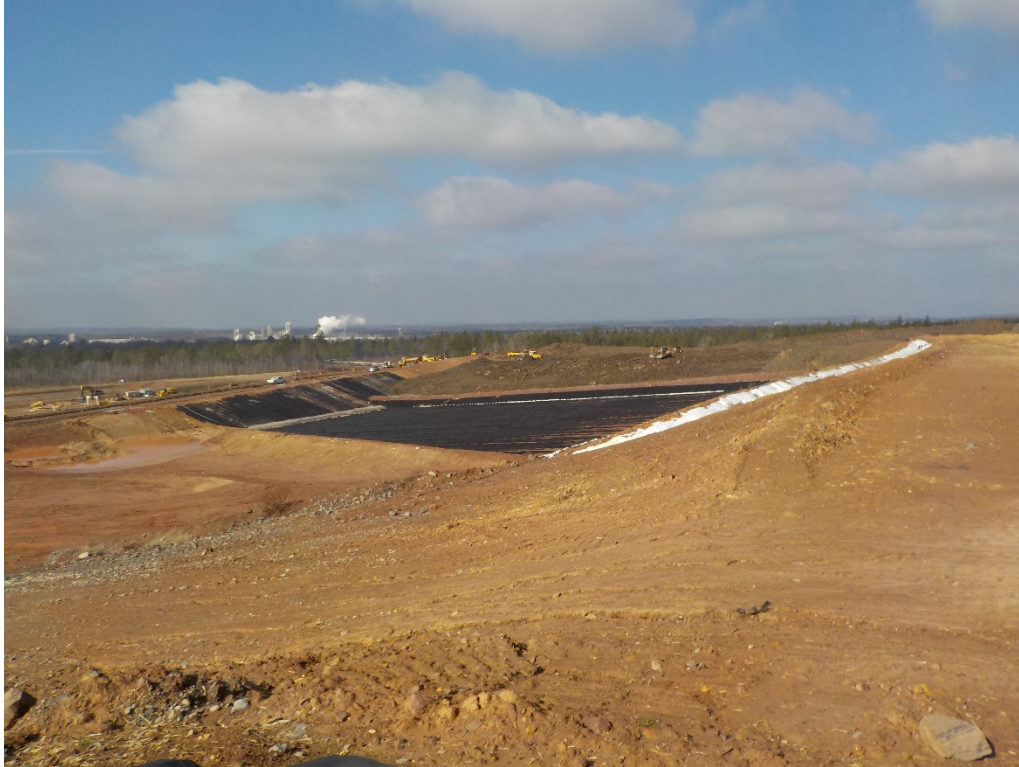
**Photo 15 - Southern access road looking at 6C**

The leachate management system for the structural fill includes a series of perforated HDPE pipes within the lined area that drain to either a sump in Cell 1 or a sump in Cell 6. The stone wrapped pipe in Subcell 6C can be seen in Photo 15. Both sumps have two pumps installed to pump leachate to three onsite storage tanks. At the Cell 1 sump the smaller primary pump had been pulled for maintenance. The larger secondary pump was actively pumping at approximately 41 gallons per minute. The Cell 6 sump was not actively pumping as the liquid level in the sump was below the start elevation. The leachate enclosures and tanks exhibited no signs of leakage at the time of the inspection. The leachate tanks contained leachate and were actively being drained into tanker trucks for transportation to one of the approved disposal locations. Refer to Photos 2 and 19 to see the leachate system components. The site's records indicate approximately 98,323,000 gallons of leachate have been generated since November 2015. The system was operating within its pressure range and the transducers were reading within their range.

Stormwater for newly constructed cell areas are managed by the installation subcell divider berms and valves installed in the leachate piping at the divider berms. This allows Charah to isolate the stormwater generated in each subcell and pump to the site stormwater management system. Photos 15, 17 and 18 show stormwater segregation in the newly constructed Cell 6C.

The site inspection included monitoring of CCP placement, spreading, and compacting in an active portion of the structural fill. The day of the inspection, CCP material was being pushed from a stockpile in Cells 6A and B into the Cell 6C area. The CCP was being spread in thin lifts as shown in Photo 15 and 17. No wind-blown CCP was observed during spreading and compacting operations. The observed CCP operations appeared to be carried out in a safe and competent manner.

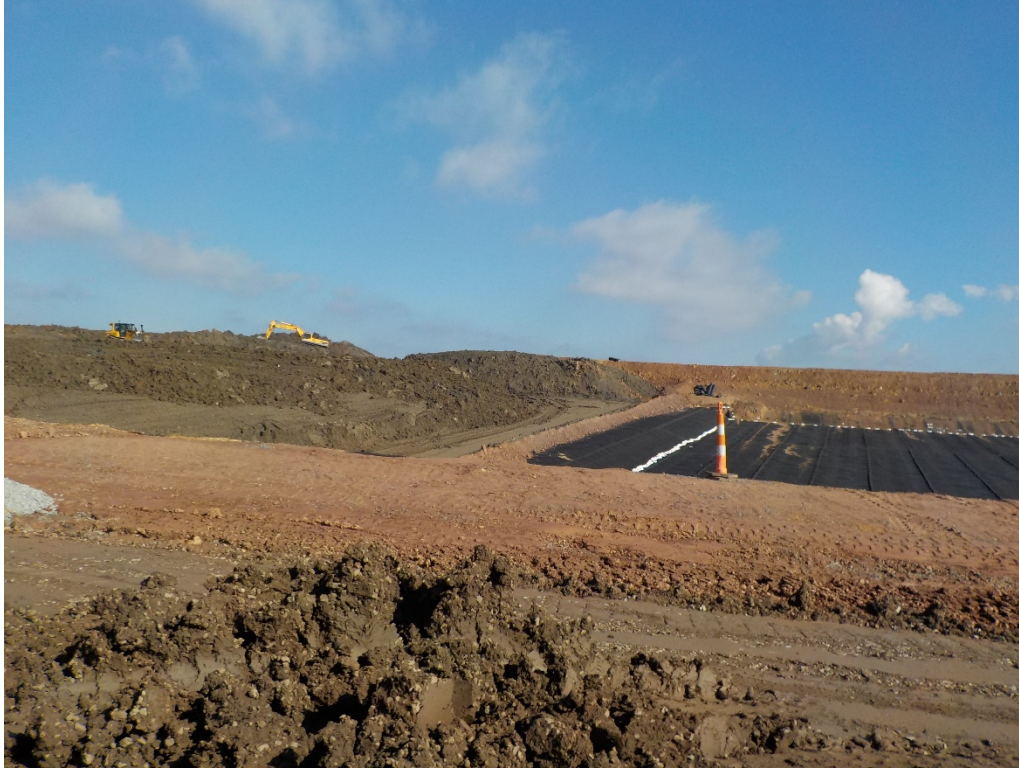
Photo 17 - 6B/C divider berm looking east

prevent leachate runoff from active placement areas as seen in Photo 17 along the subcell 6B/C divider berm.
