CCP Annual Inspection Report

Brickhaven No. 2 Mine Tract A Structural Fill
DWM Permit 1910, DEMLR Permit 19-25

Charah, Inc.

February 2019

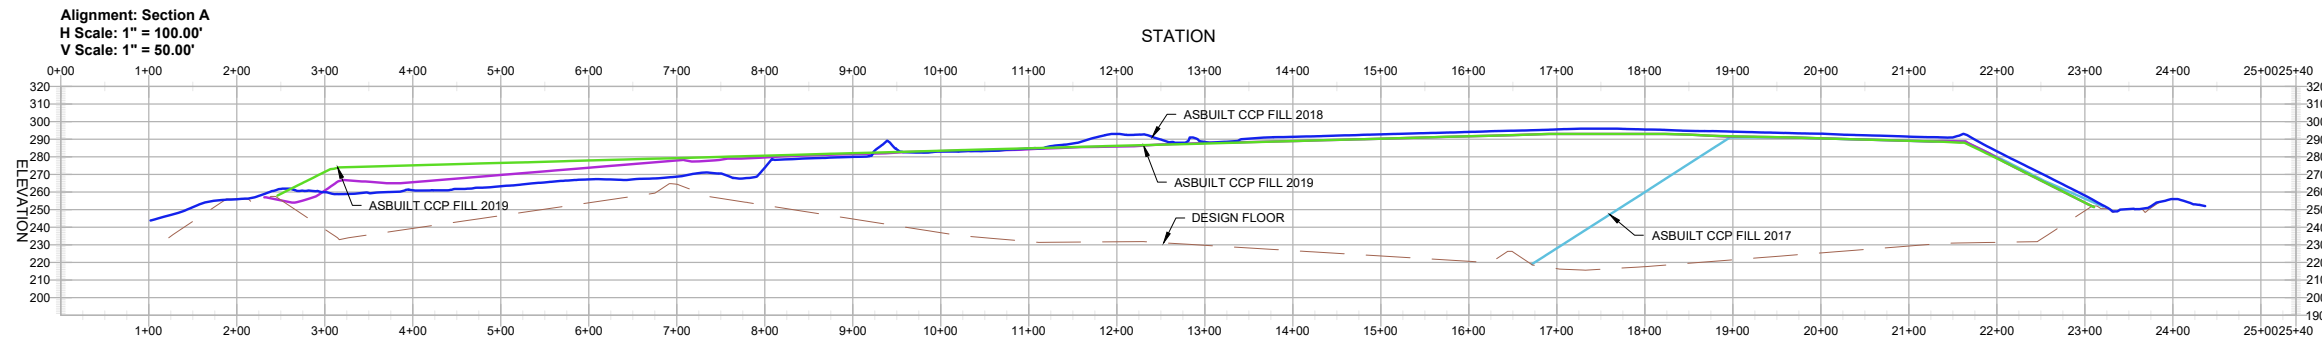
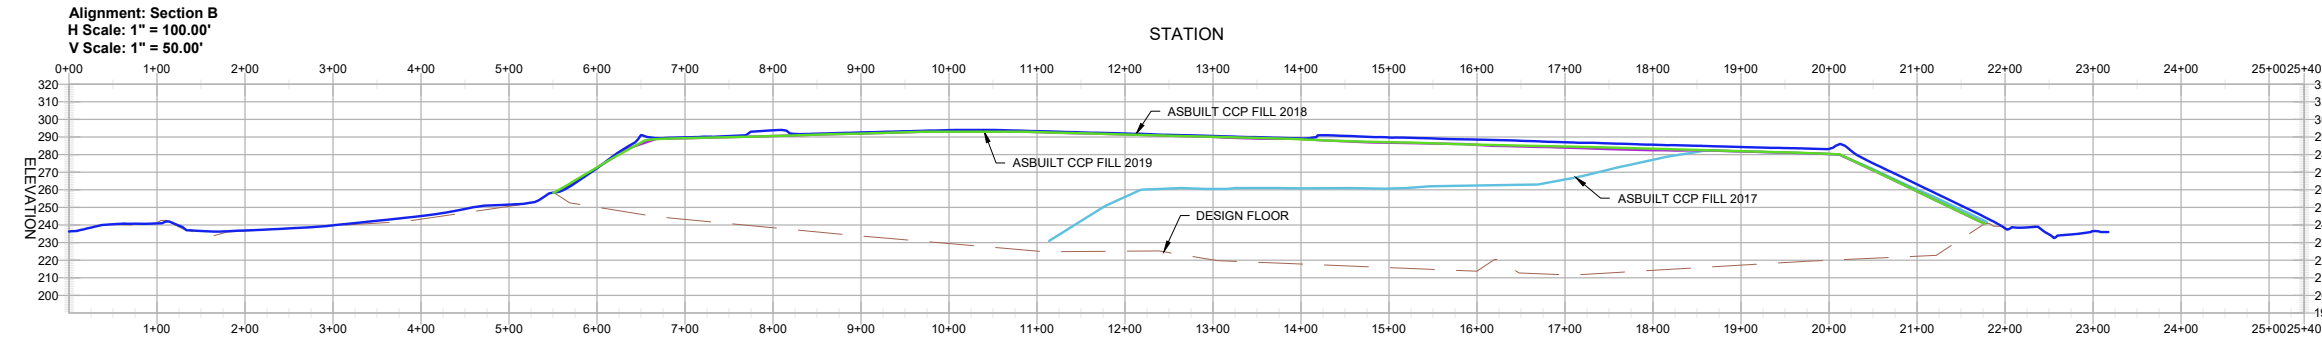
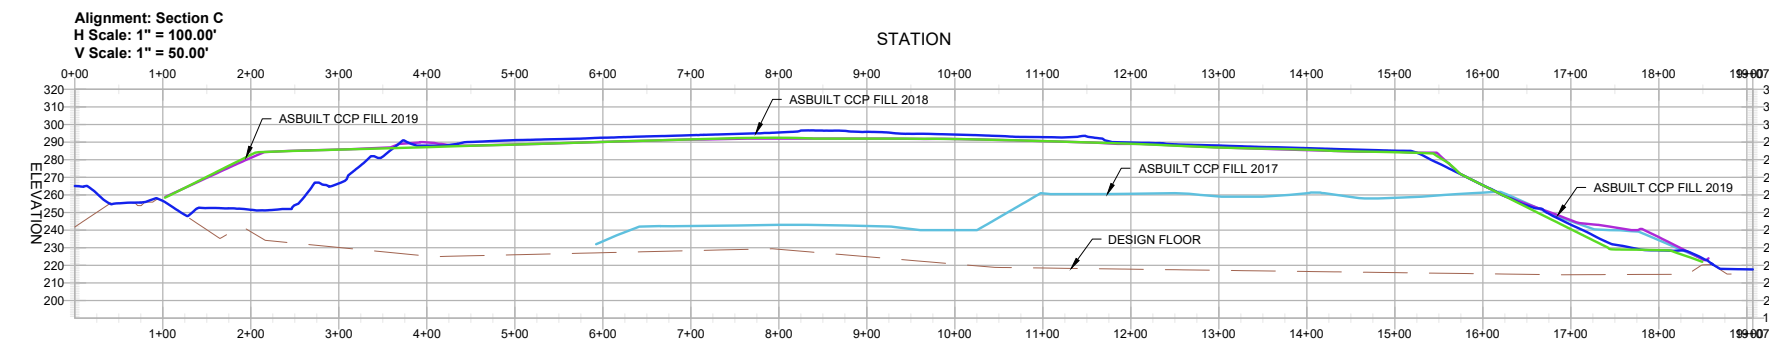
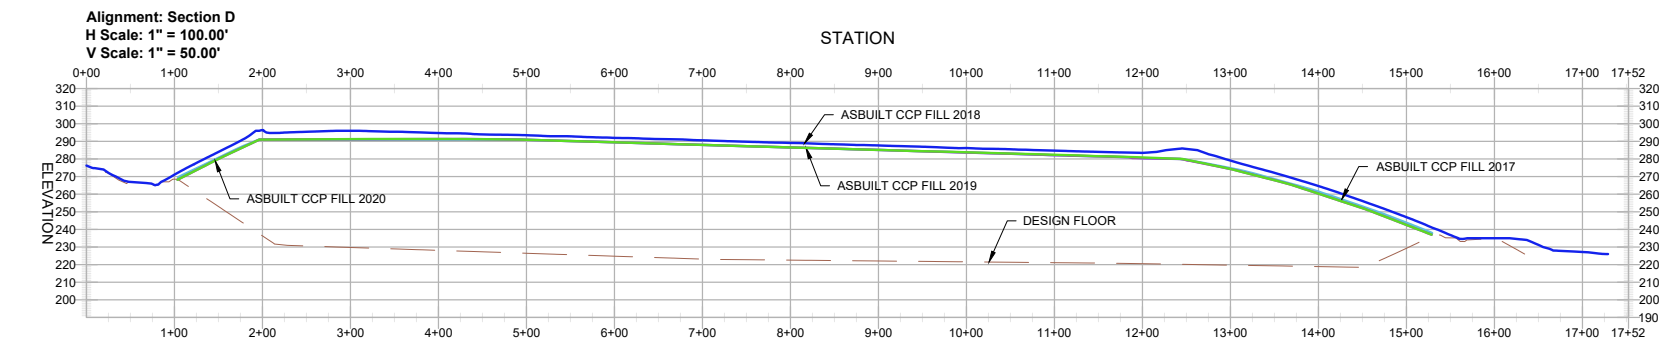
SITE SECTIONS

The site inspection included monitoring of the closed CCP structural fill. The as-built survey was provided by McAdams Company and shows the final development of the structural fill. HDR has provided cross-sections in Appendix A showing the changes in geometry between the 2018 and 2019 inspection reports.

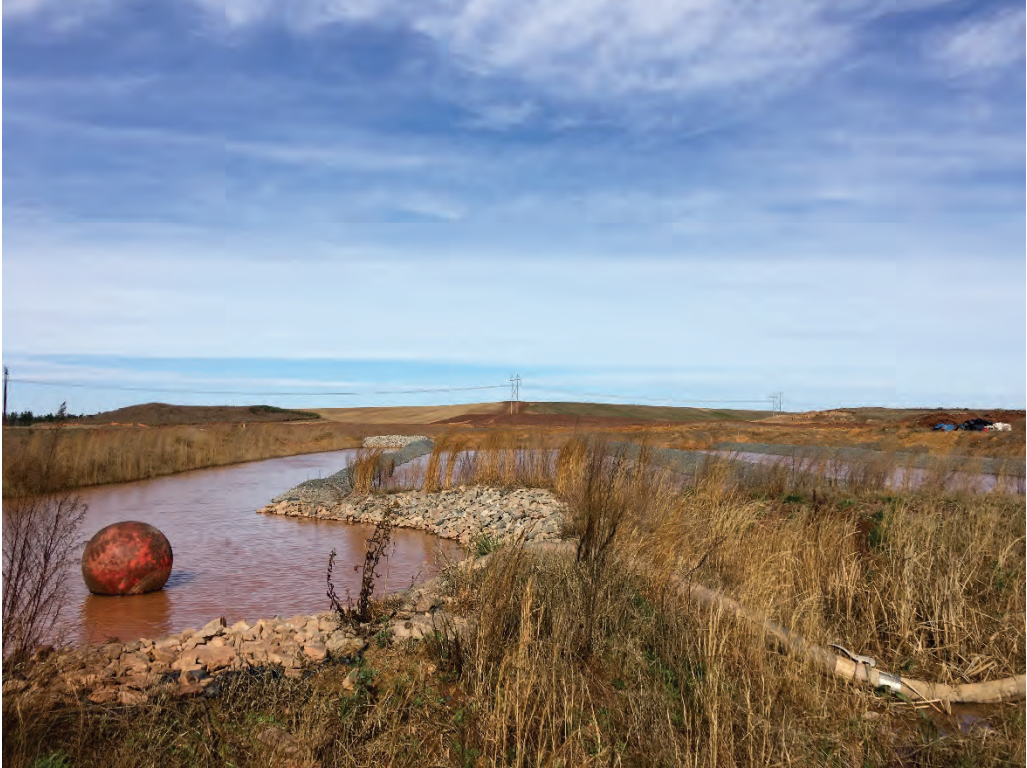
Photo 2

Facility access from Moncure-Flatwood Road is controlled by a staffed gate requiring check in and check out of visitors. CCP would arrive via railroad, unloaded onto off-road dump trucks in a lined area and then hauled to the active CCP containment area. Stone access ramps are constructed and maintained to provide access to the top of the lined structural fill. The entire structural fill area is encompassed by a stone road that connects to the front entrance gate and leachate management facilities. Due to recent closure capping activities the perimeter road near the structural fill was disturbed and needed to be re-established as shown in Photo 1. The structural fill has two roads to access the top of the CCP structural fill. One road enters from the north at the Cell 1D/2A interface and the other enters from the south into the Cell 2G area shown in Photo 2.

- Complete seeding of the capped areas beneath the power lines
- Fix erosion rills near the Cell 6 enclosure and seed.
- Re-establish the stone access road on the northern side of the structural fill.

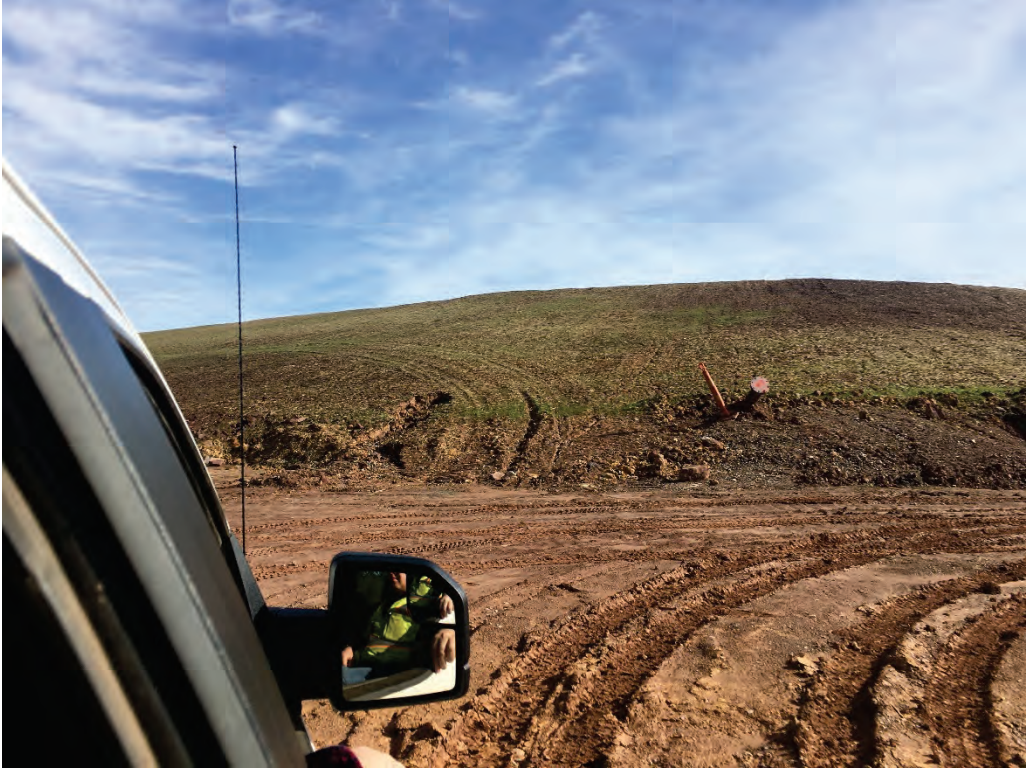
At the time of this inspection, all slopes had been recently capped with a composite liner system and covered with soil. There were some areas exhibiting erosion rills as shown in Photo 5 taken just east of the Cell 6 sump enclosure and on the slope near the Cell 2G access road as shown

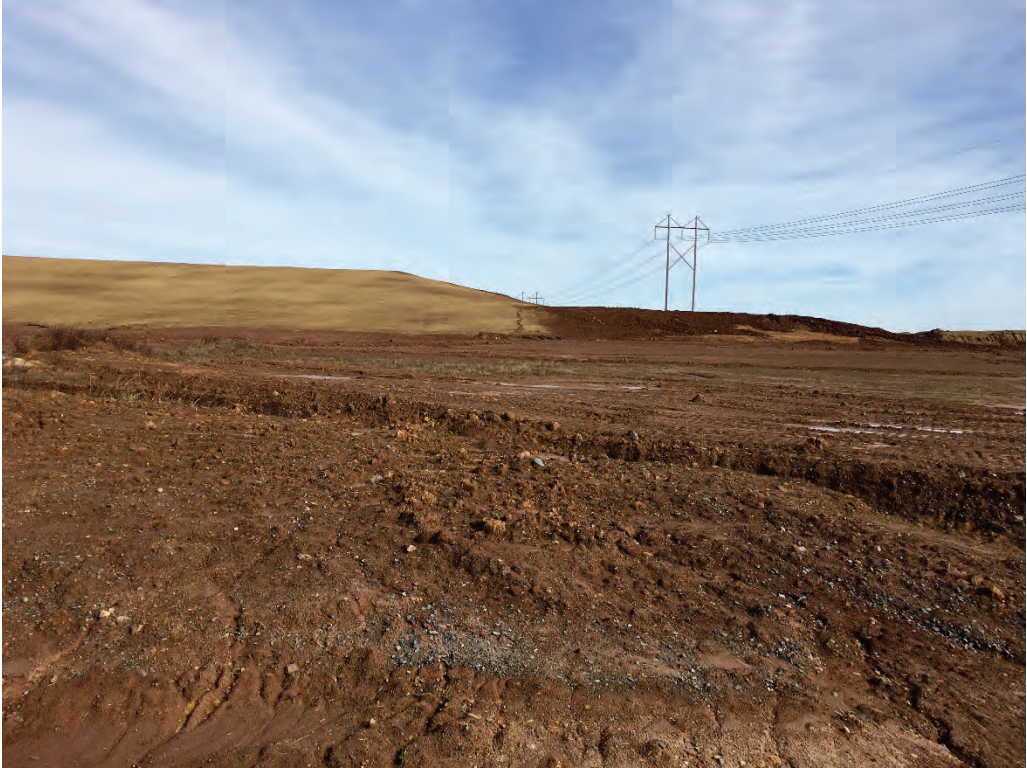
on Photo 6. Photo 6 also shows the capped area requiring seeding beneath the power lines and the unconstructed subcell 6D area. For the remainder structural fill Photos 7 through 11 show good vegetation growth. Photos 12 through 14 show the performance of the permitted sediment basins. All basins were observed to contain the stormwater and function properly.
