# CCP Annual Inspection Report

Brickhaven No. 2 Mine Tract A Structural Fill

DWM Permit 1910, DEMLR Permit 19-25

February 2023

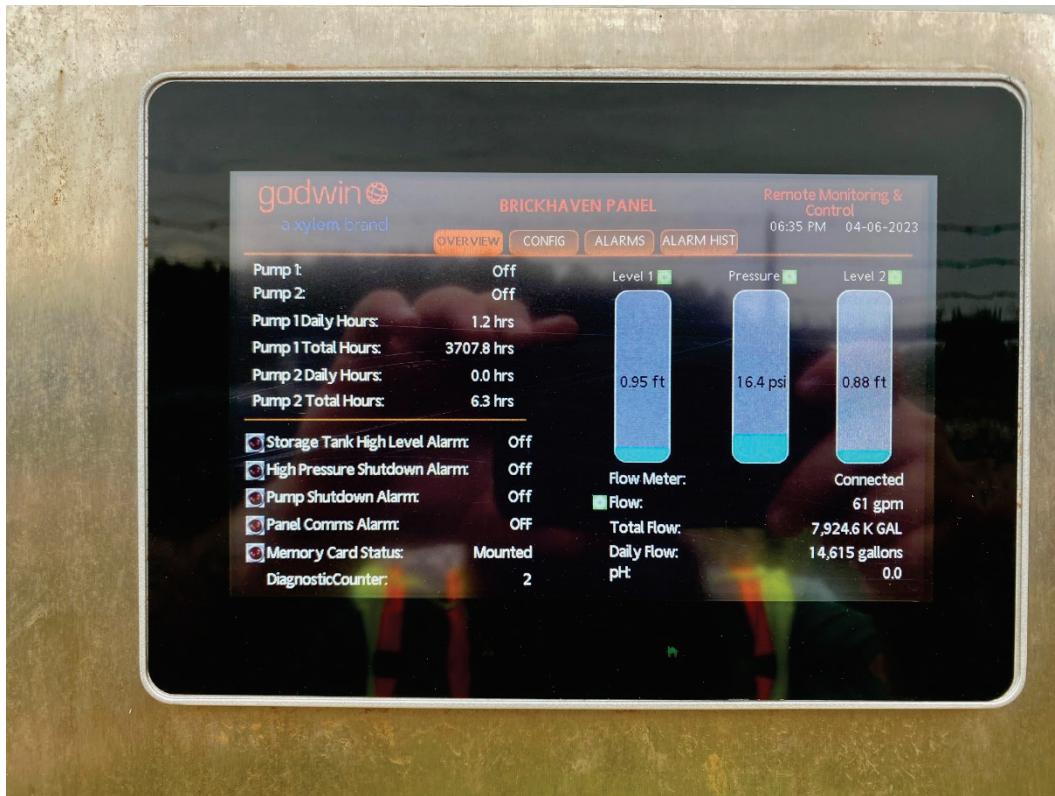
Photo 3a Cell 1 Level (April 6, 2023)

sump in Cell 6. Both sums have two pumps installed to pump leachate to three onsite storage tanks. Site staff turned both sums on to pump to the tanks at the time of the inspection. At the initial site inspection, the Cell 1 sump panel reported leachate levels at 4.53 ft and the Cell 6 sump reported leachate levels at 6.40 feet. The pumps for both cells were fixed and documented to have the Cell 1 level to 0.95 ft and Cell 6 level to 11.2 inches on April 6, 2023.

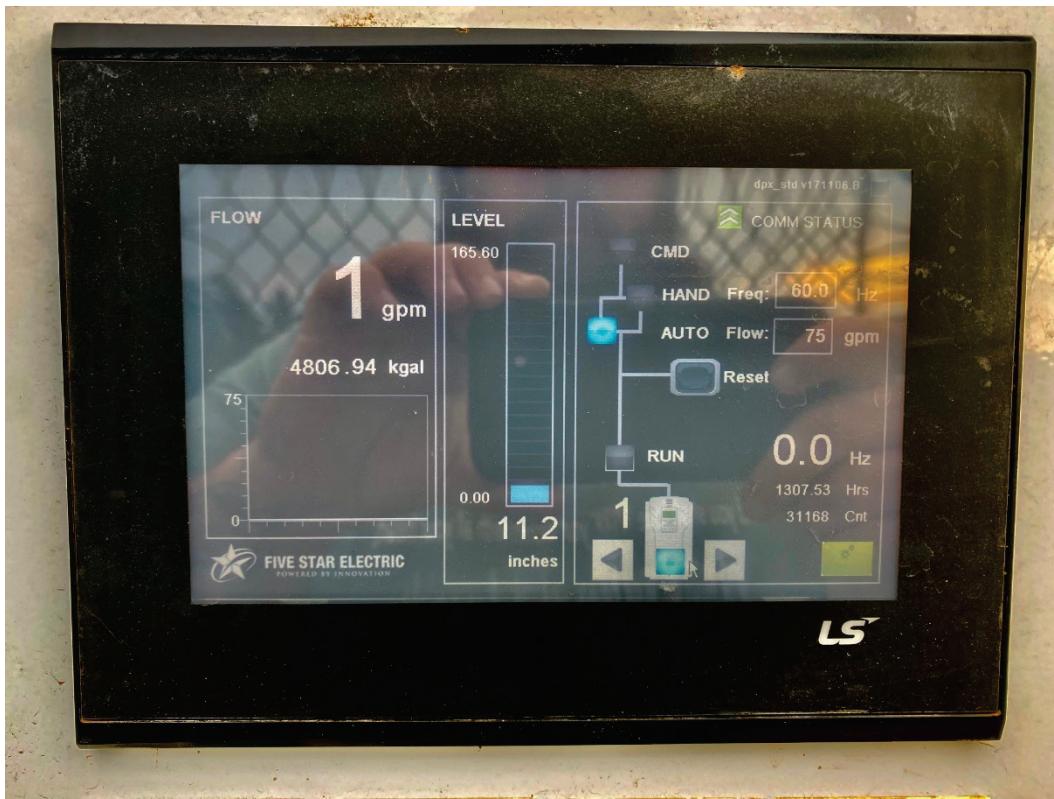
Photo 3b Cell 6 Level (April 6, 2023)
