CCP Annual Inspection Report

Brickhaven No. 2 Mine Tract A Structural Fill
DWM Permit 1910, DEMLR Permit 19-25

Charah, Inc.

February 2024

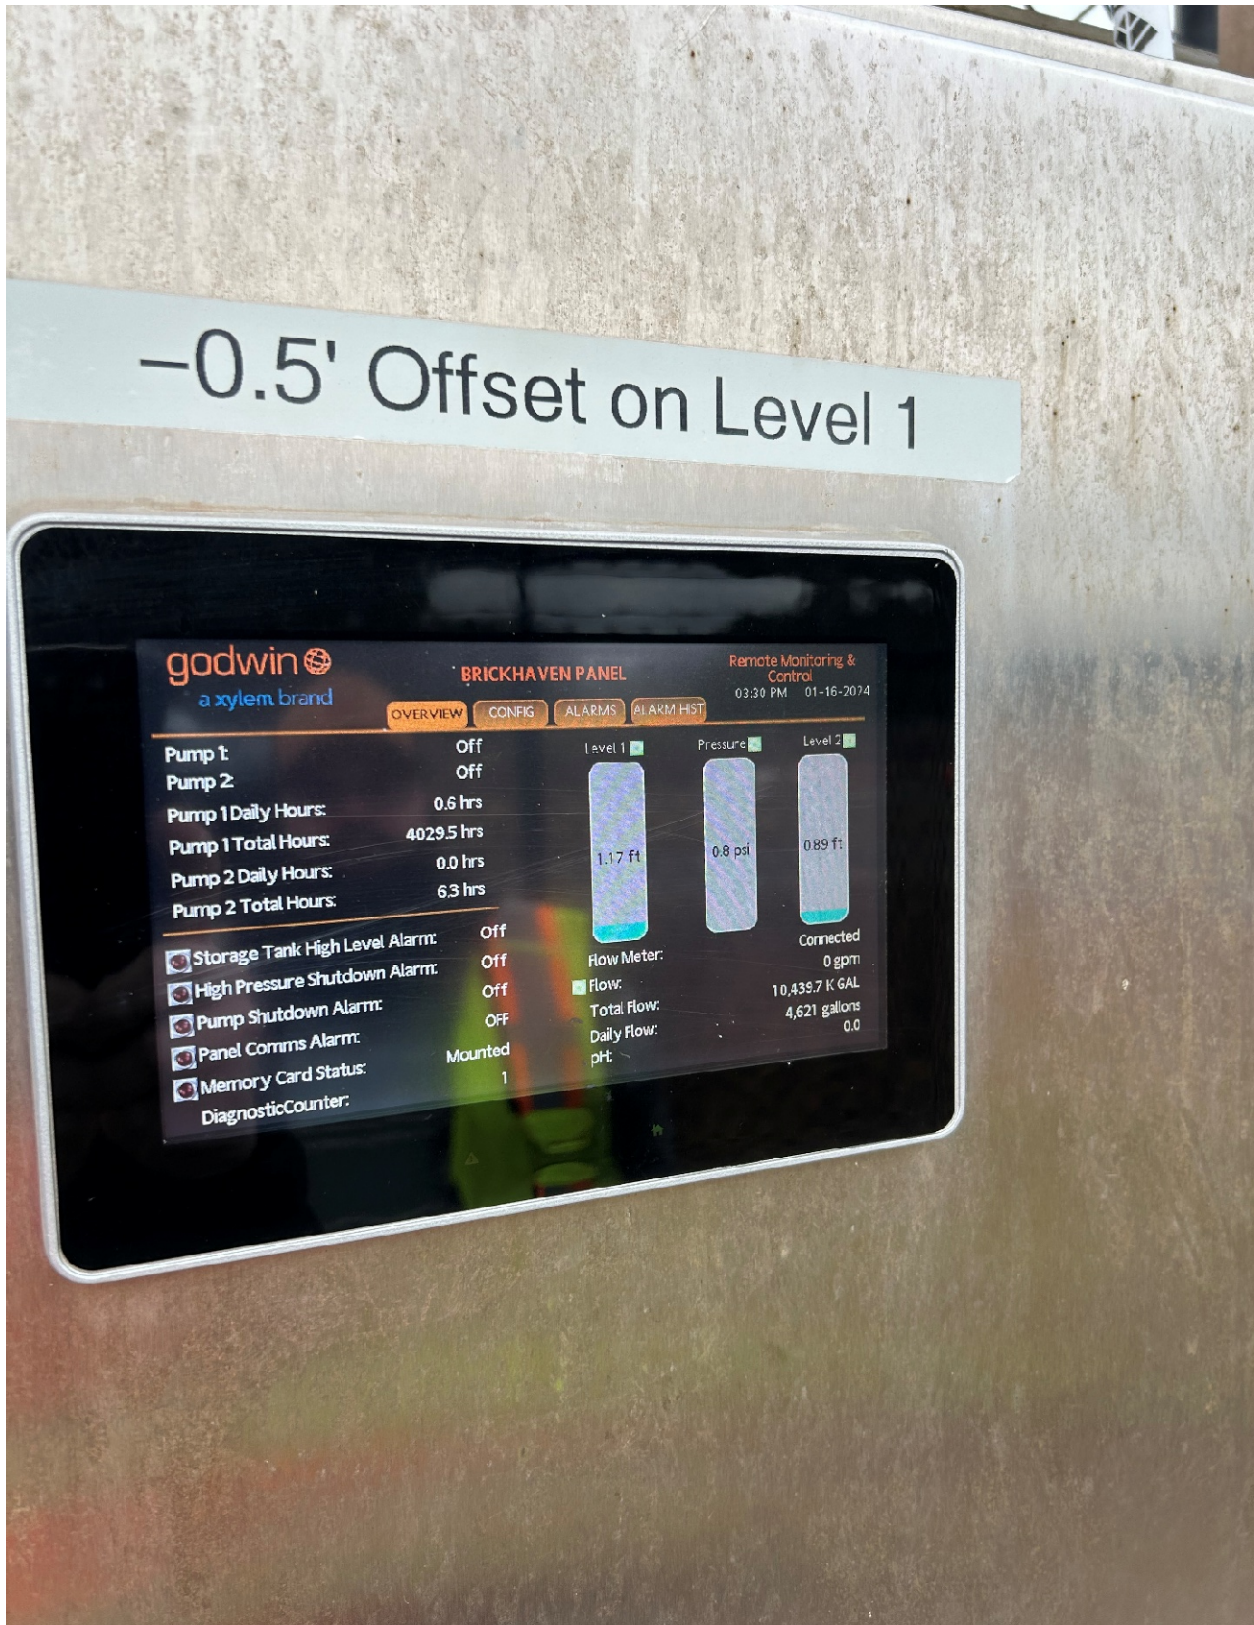
sump in Cell 6. Both sumps have two pumps installed to pump leachate to three onsite storage tanks. Site staff turned both sumps on to pump to the tanks at the time of the inspection. At the initial site inspection, the Cell 1 sump panel reported leachate levels at 1.7 ft and the Cell 6 sump reported leachate levels at 8.2 inches.

Photo 2 Cell 1 Level (January 16, 2024)

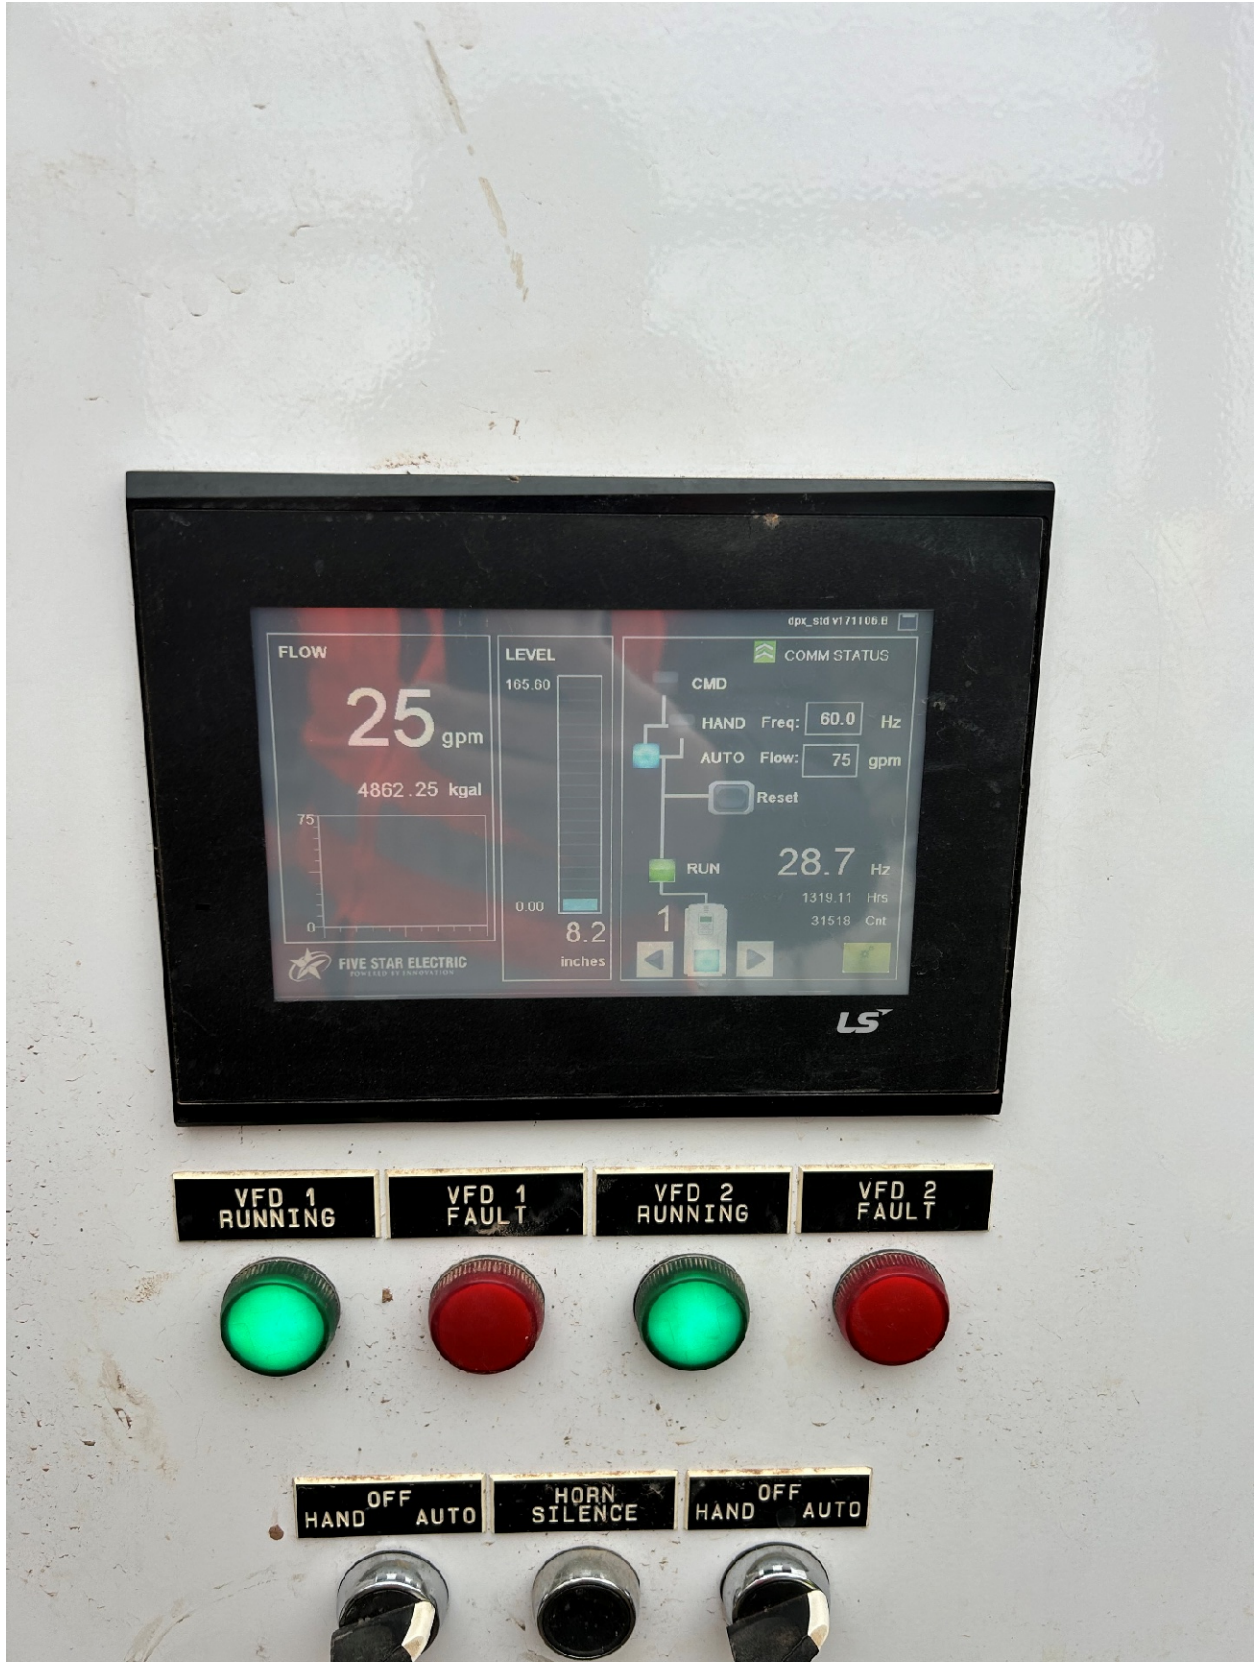
Photo 2a Cell 6 Level (January 16, 2024)

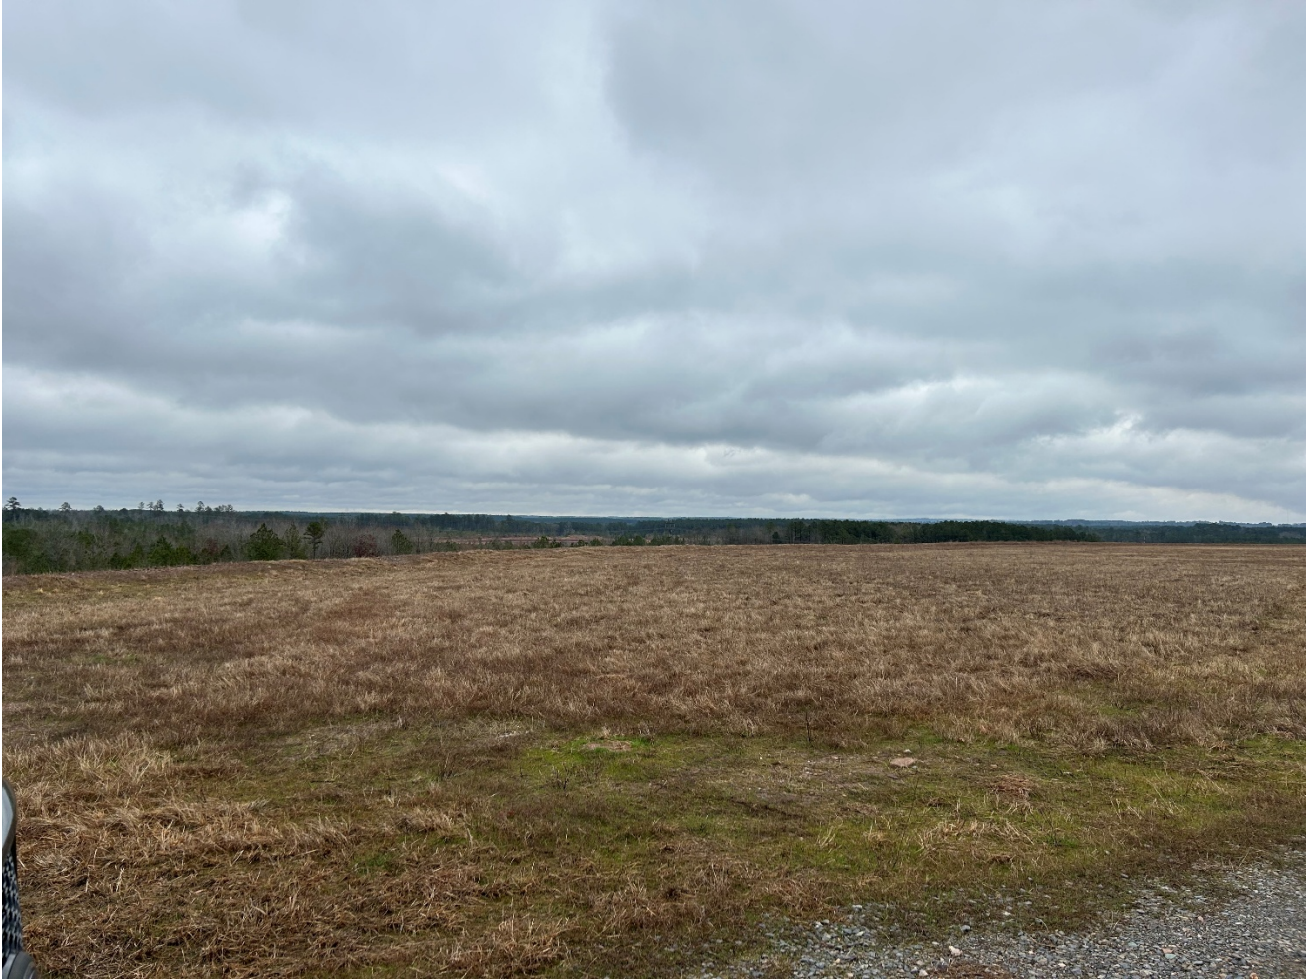
Photo 3 Top Deck

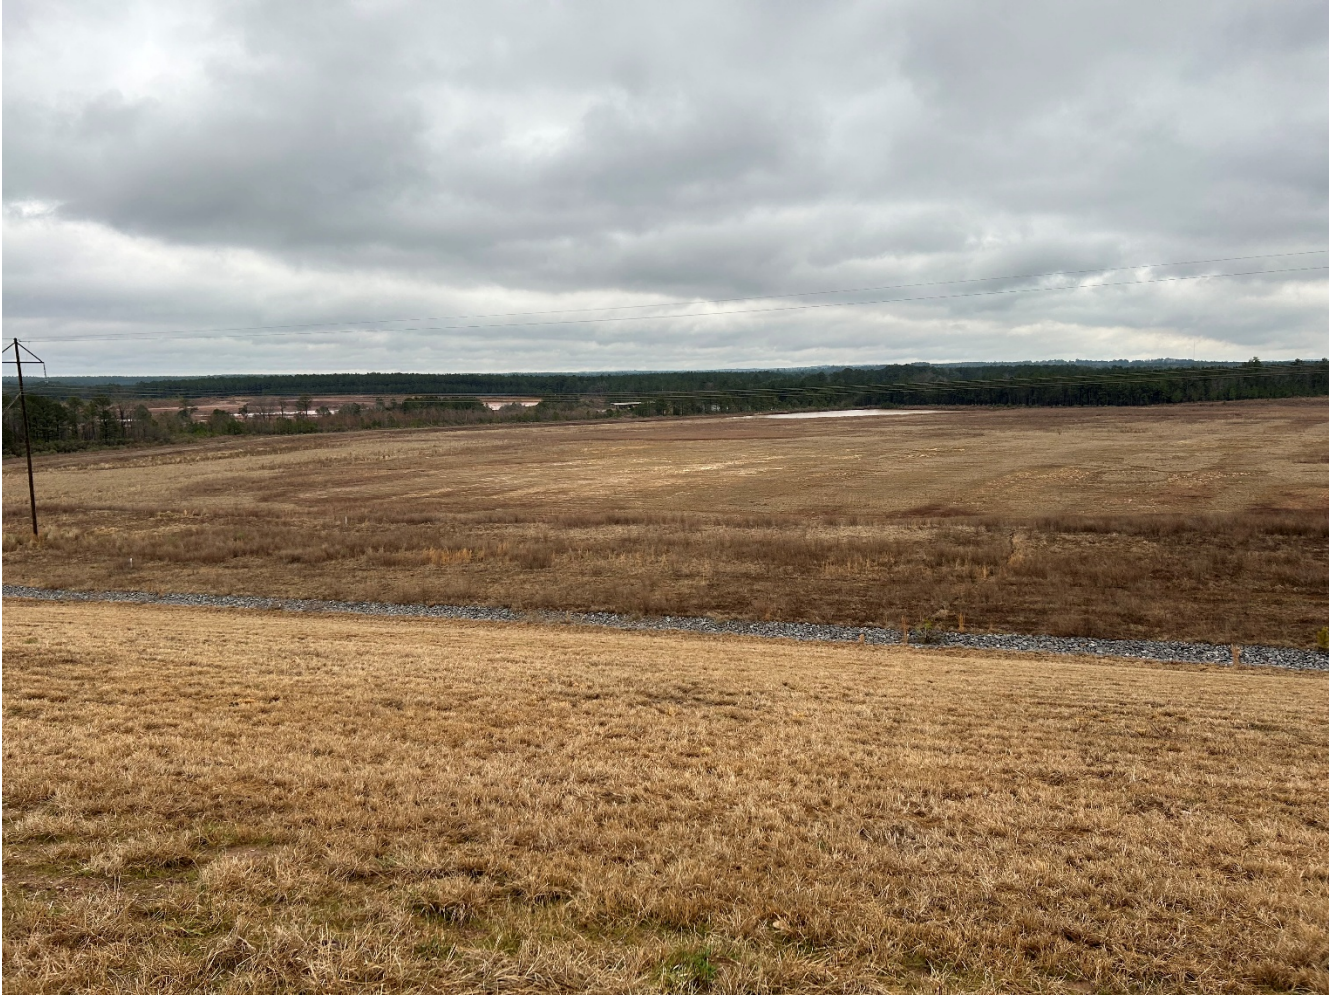
Photo 4 Top of the Closed Unit facing south

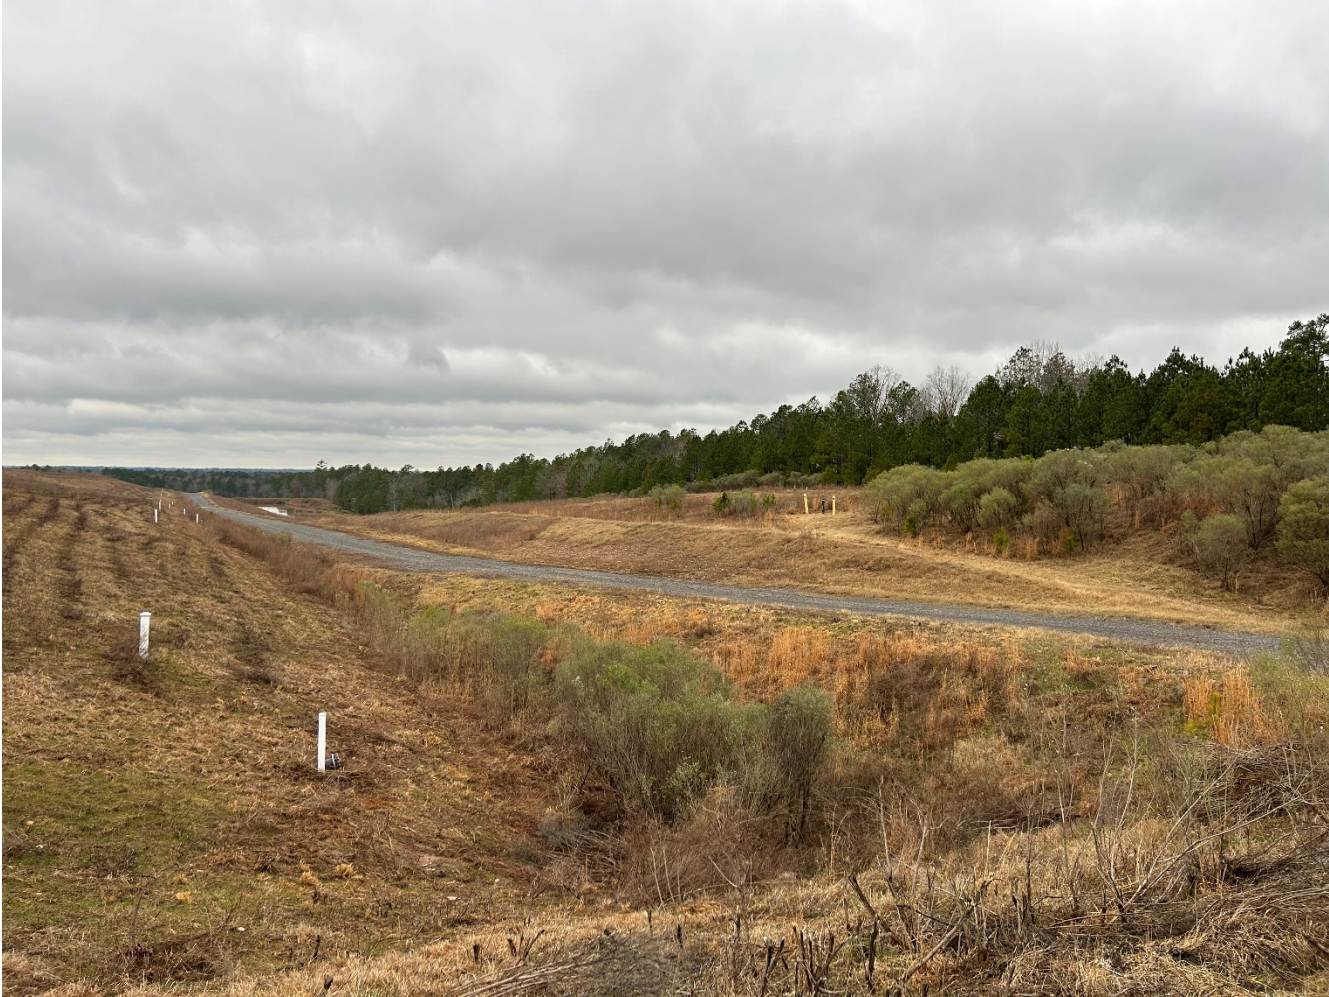
Photo 5 Top deck ramp looking west

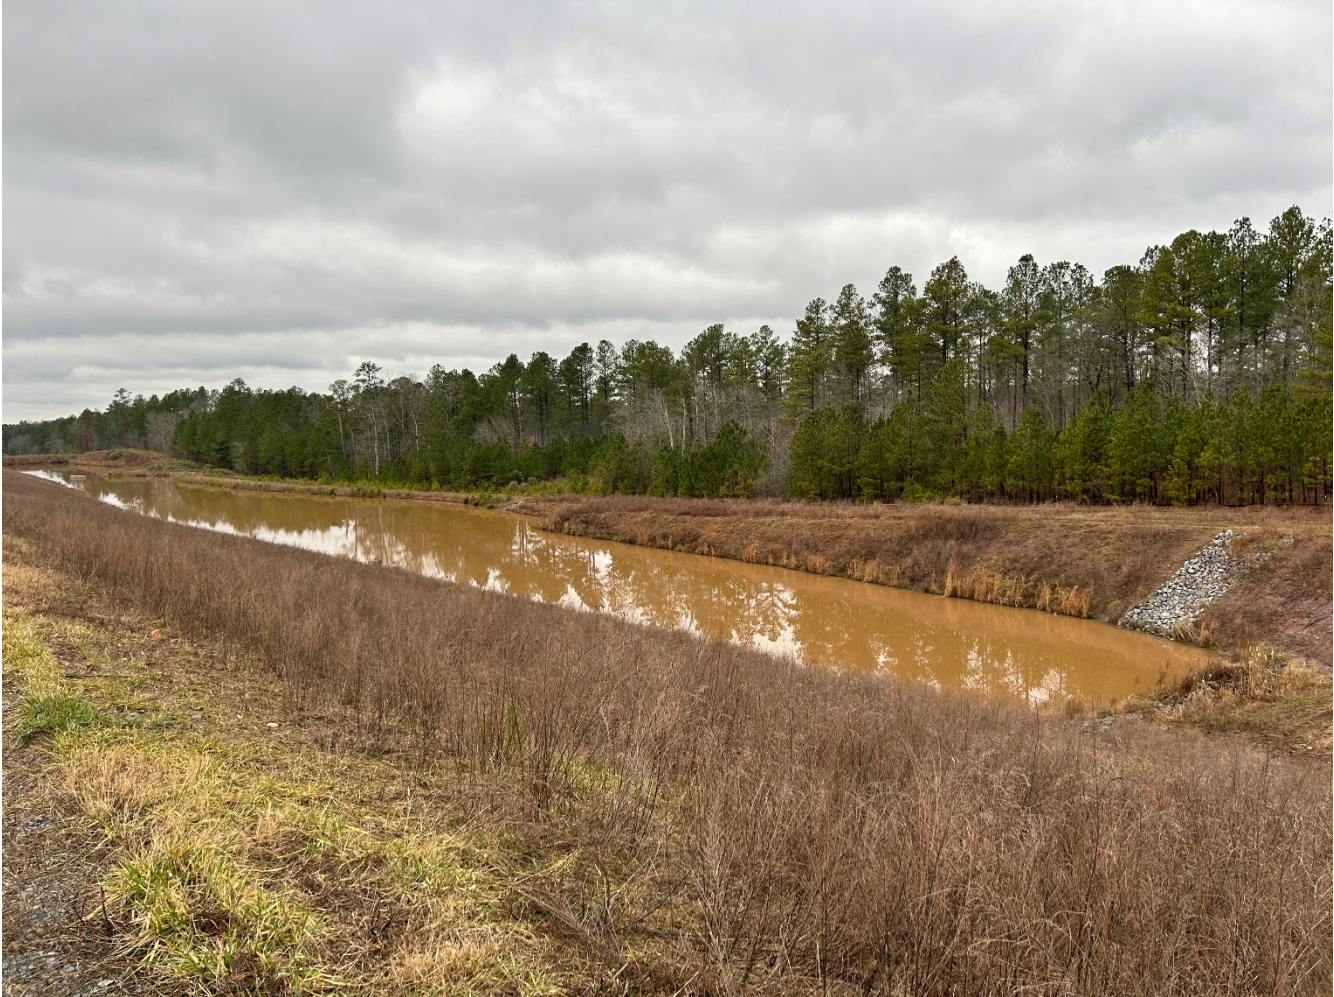
Charah converted Sediment Basins 1, 2 and 7 into stormwater retention ponds as directed by NCDEMLR for final reclamation. The other sediment basins were decommissioned and vegetated. The retention ponds that remained in place were observed to contain stormwater and function properly. Overall, the areas within the structural fill appeared to have adequate vegetation and showed no signs of structural concern. No signs of CCP release were observed.

Photo 6 Sediment Basin 1

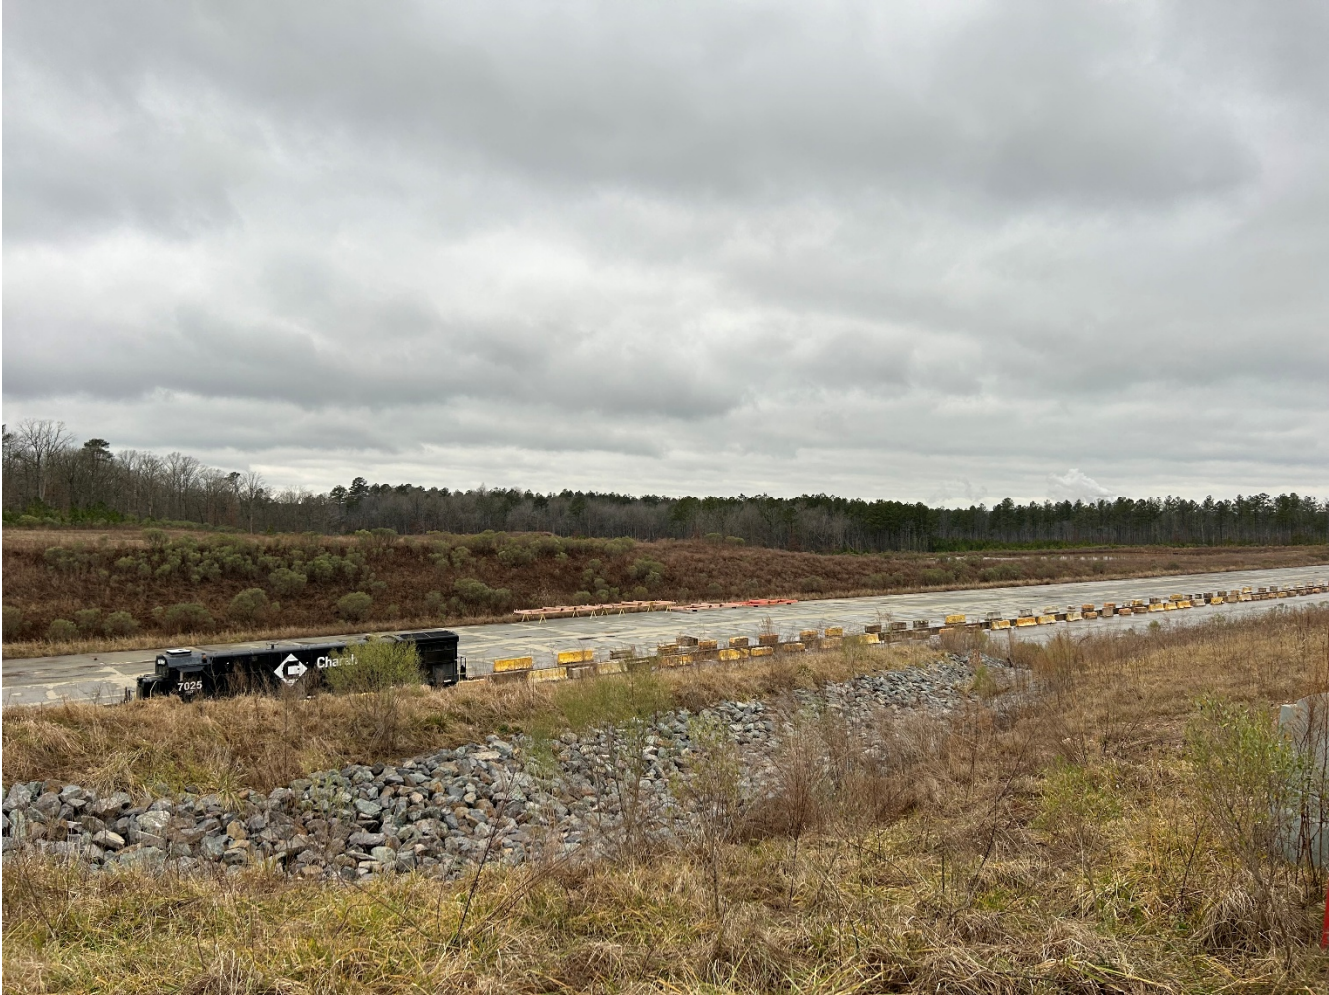
Photo 7 Unloading Area looking west

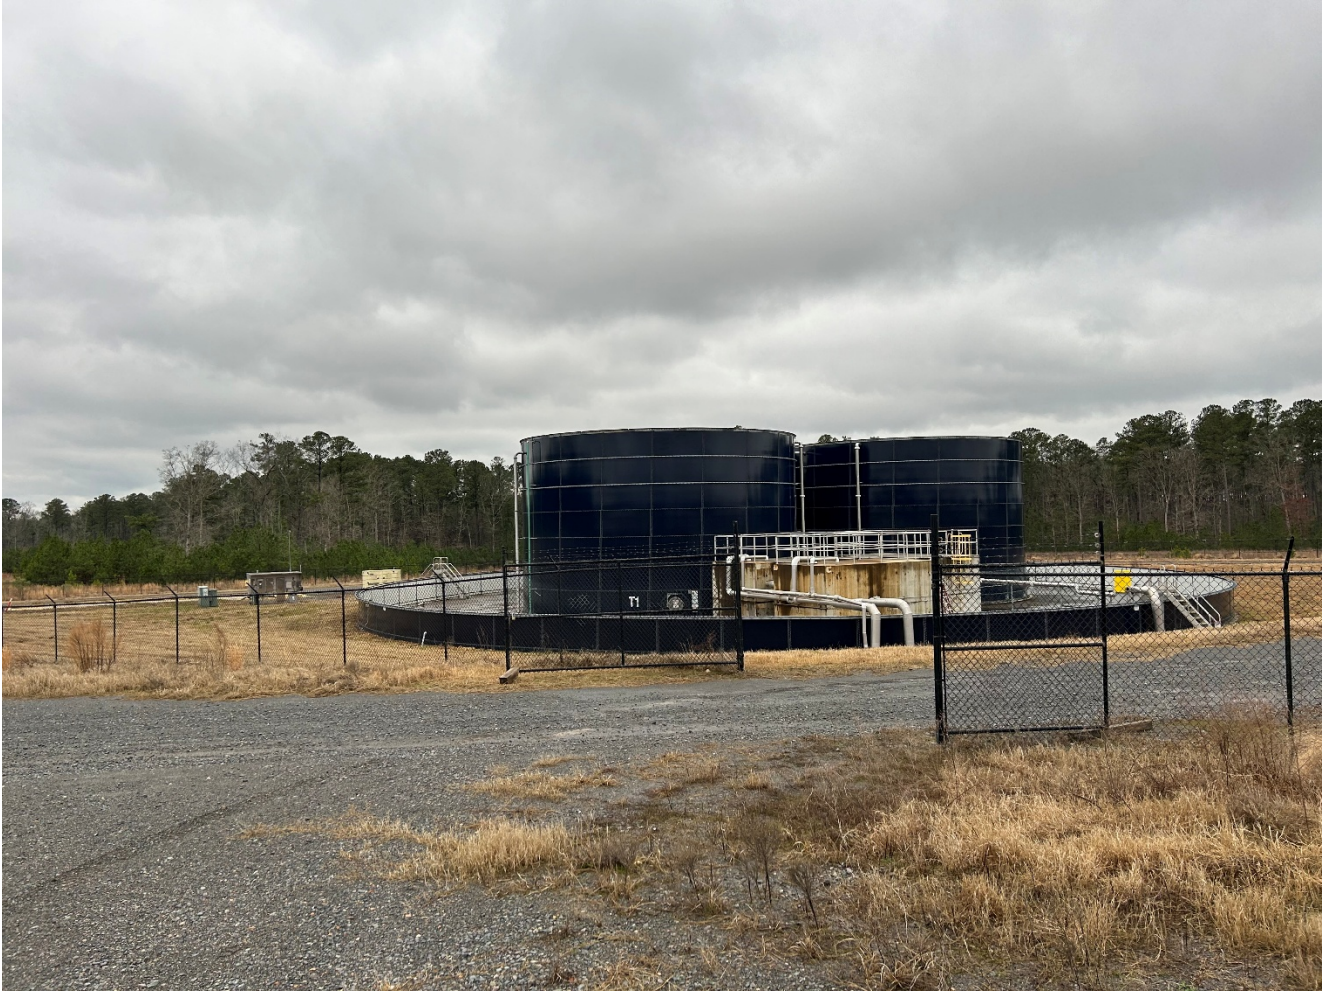
The leachate enclosures and tanks exhibited no signs of leakage at the time of the inspection. The leachate tanks contained leachate and were actively being drained into tanker trucks for transportation to one of the approved disposal locations.

Photo 8 Leachate Tank farm looking south

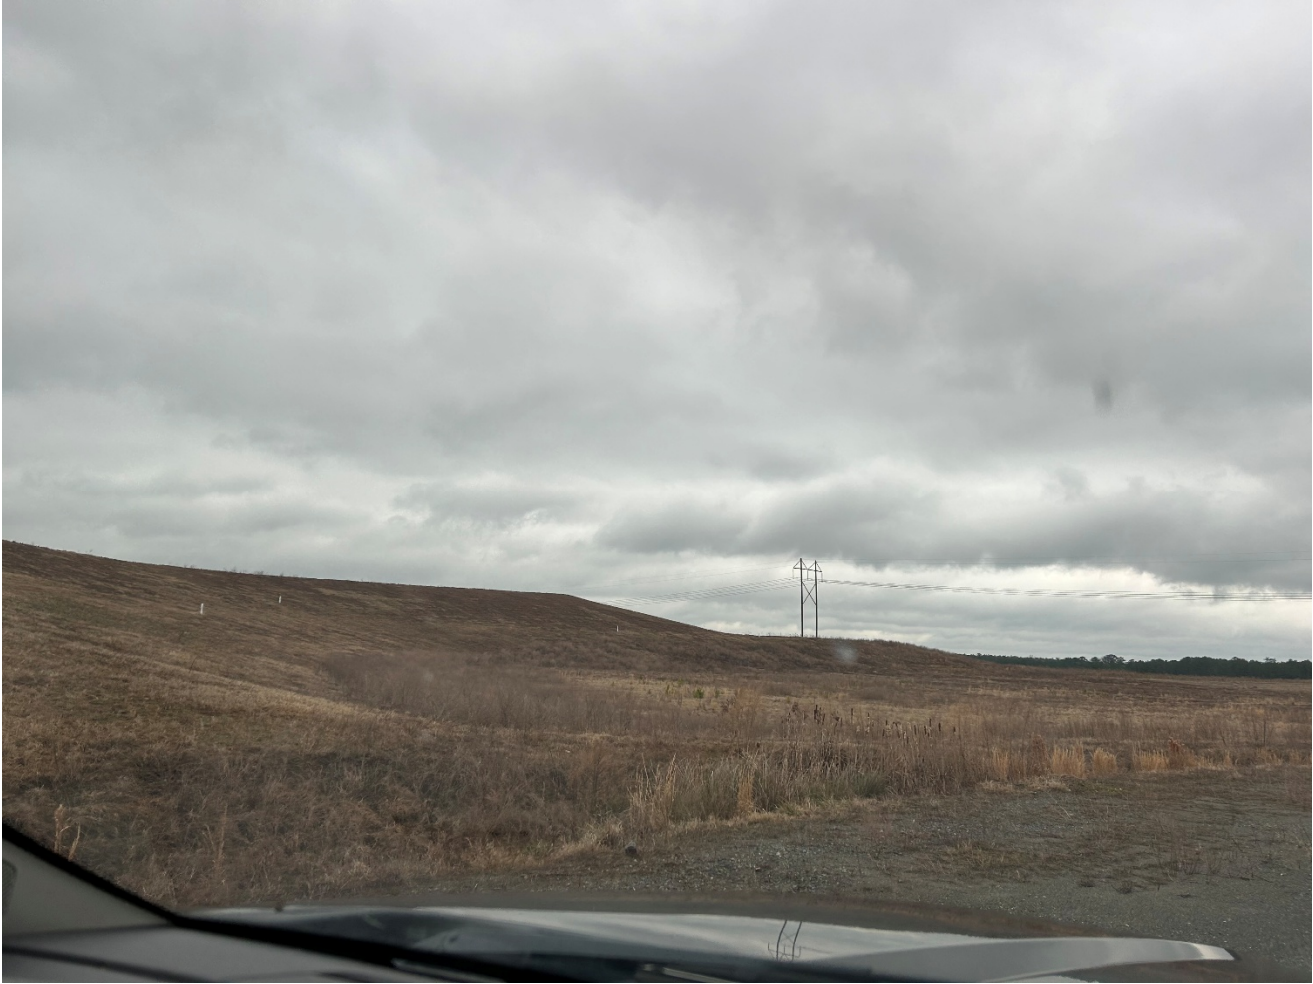
Photo 9 Cell 6 looking east

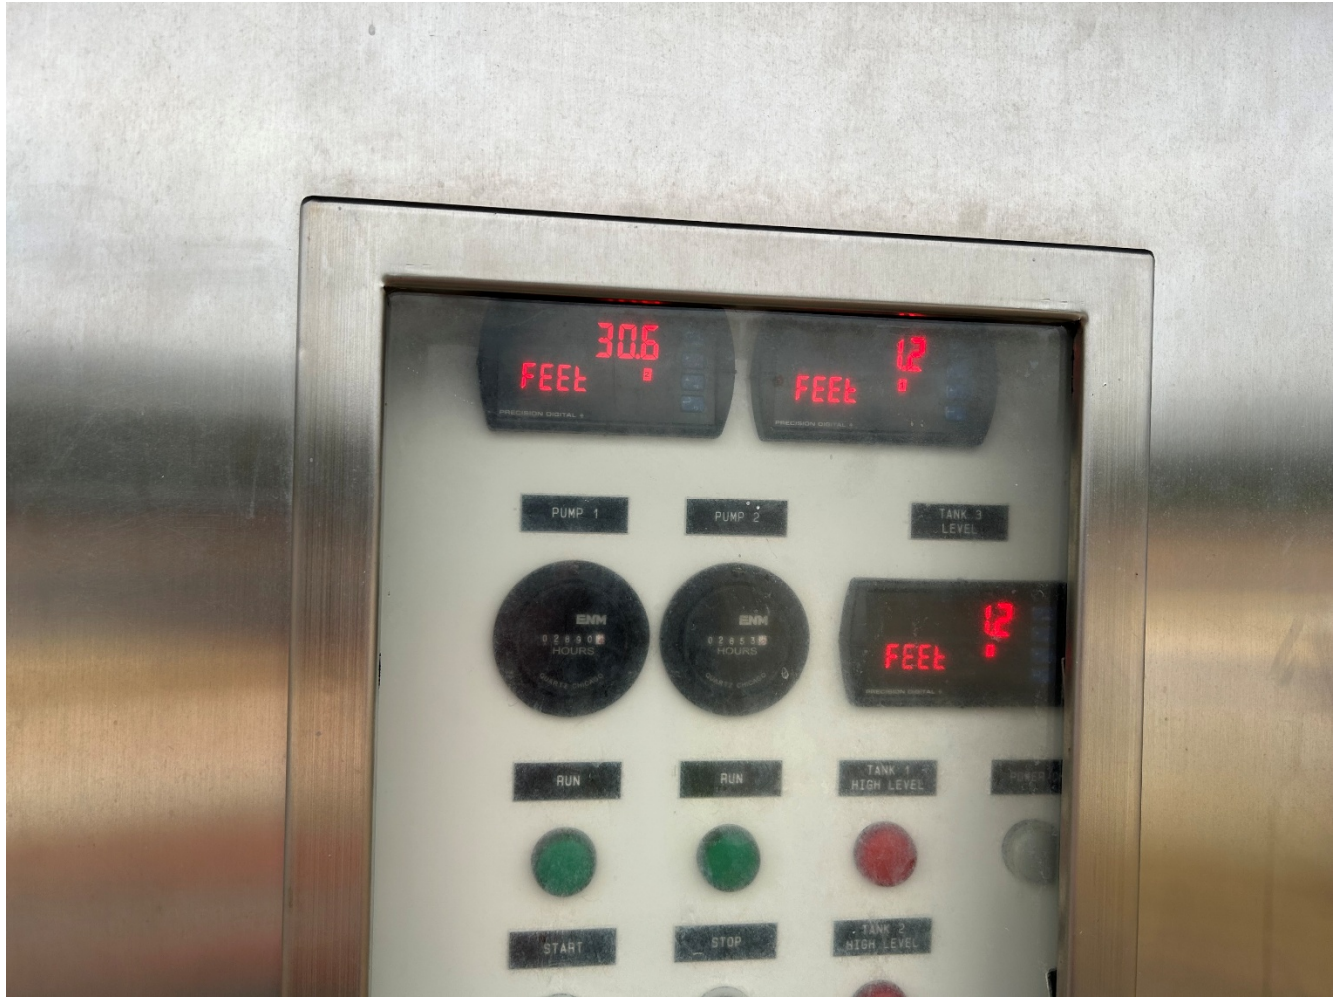
Photo 20 Leachate Tank Levels
