# CCP Annual Inspection Report

Brickhaven No. 2 Mine Tract A Structural Fill  
DWM Permit 1910, DEMLR Permit 19-25

Charah, Inc.

June 2025

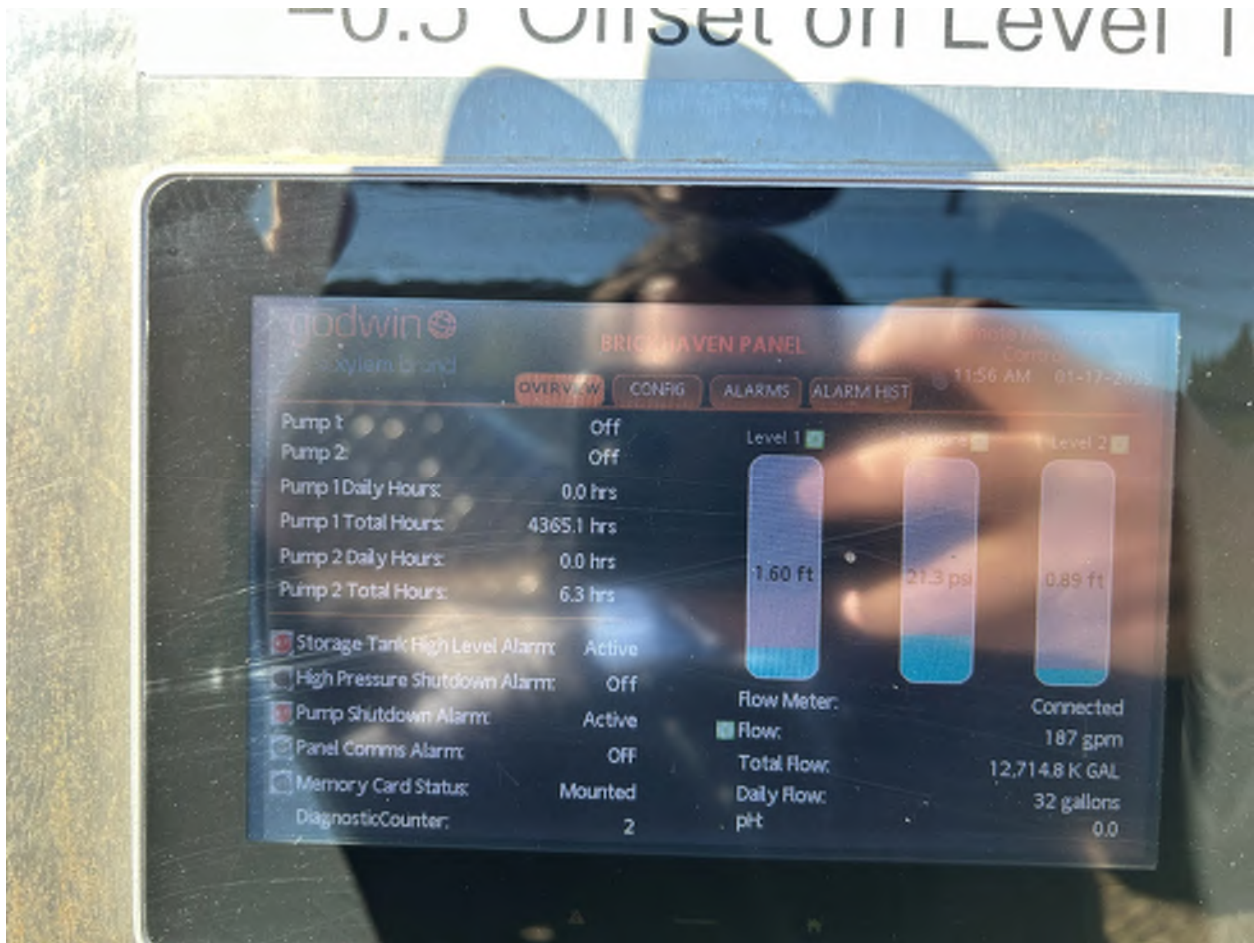
Photo 2 – Sump 1 Read Out

sump in Cell 6. Both sumps have two pumps installed to pump leachate to three onsite storage tanks. Site staff turned both sumps on to pump to the tanks at the time of the inspection. At the initial site inspection, the Cell 1 sump panel reported leachate levels at 1.56 ft and the Cell 6 sump reported leachate levels at 9.9 inches.

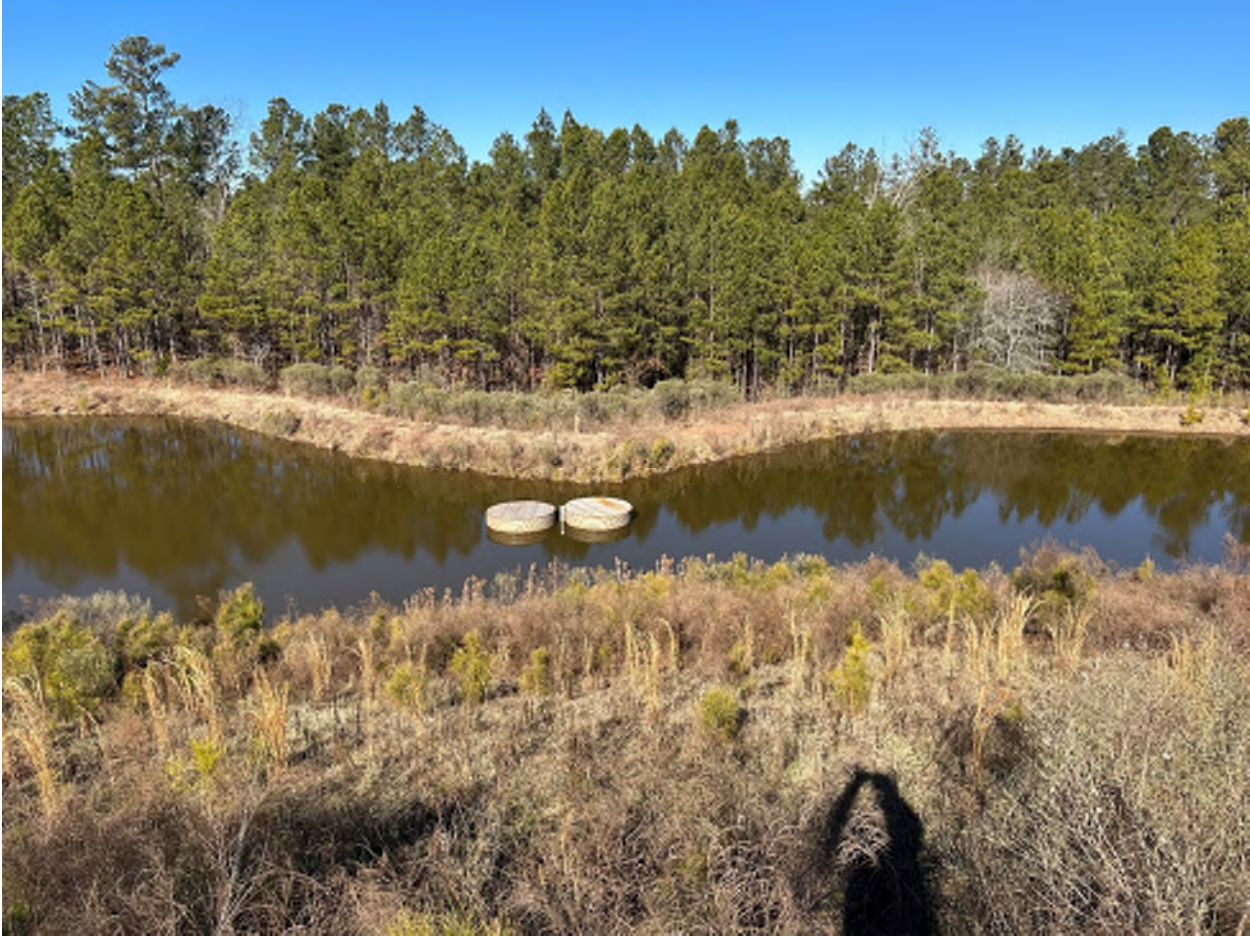
Photo 10 – Pond 1

Charah converted Sediment Basins 1, 2 and 7 into stormwater retention ponds as directed by NCDEMLR for final reclamation. The other sediment basins were decommissioned and vegetated. The retention ponds that remained in place were observed to contain stormwater and function properly. Overall, the areas within the structural fill appeared to have adequate vegetation and showed no signs of structural concern. No signs of CCP release were observed.

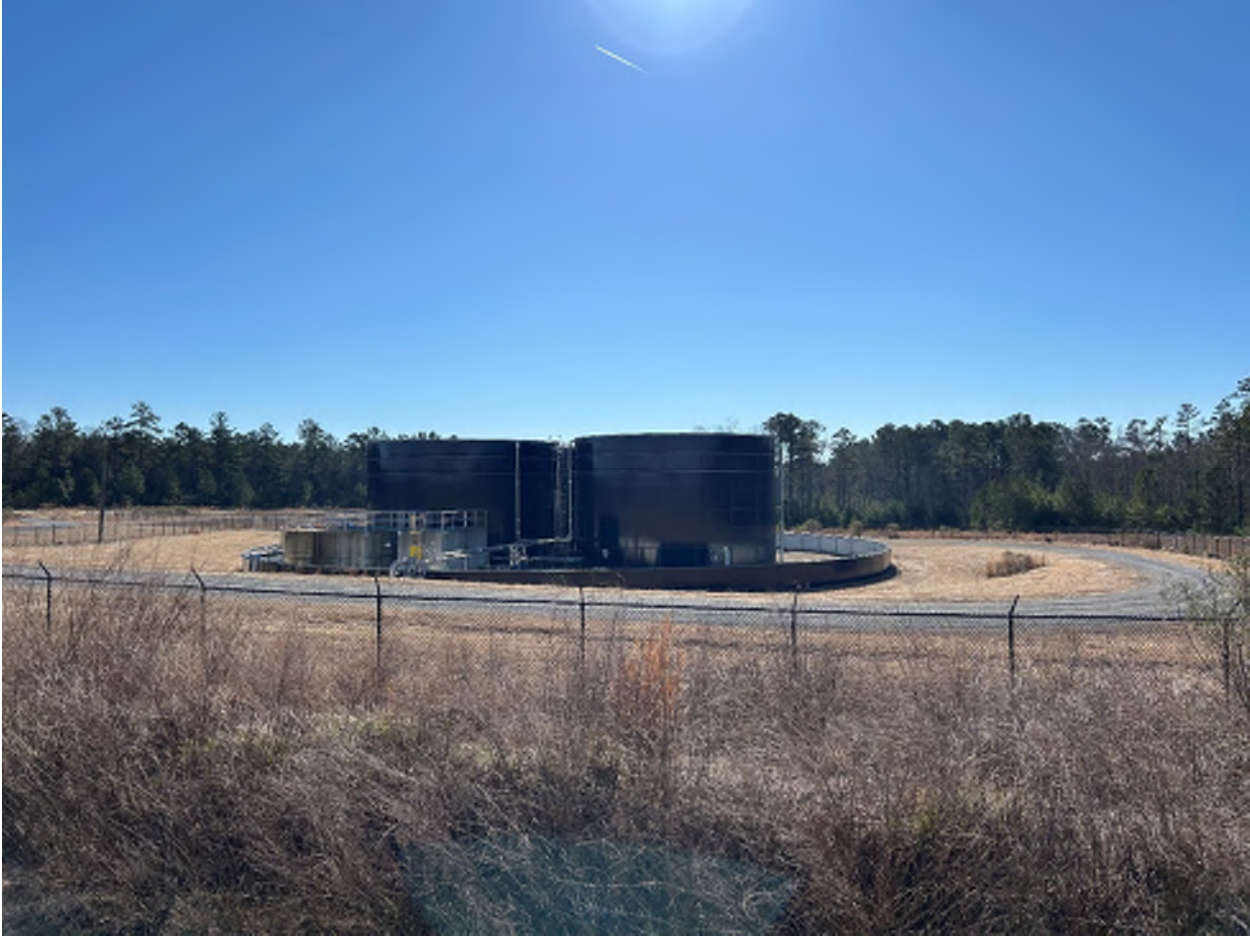
Photo 15 – Leachate Storage Tanks

The leachate enclosures and tanks exhibited no signs of leakage at the time of the inspection. The leachate tanks contained leachate and were actively being drained into tanker trucks for transportation to one of the approved disposal locations.
