CCP Annual Inspection Report

Brickhaven No. 2 Mine Tract A Structural Fill
DWM Permit 1910, DEMLR Permit 19-25

Charah, Inc.

February 2026

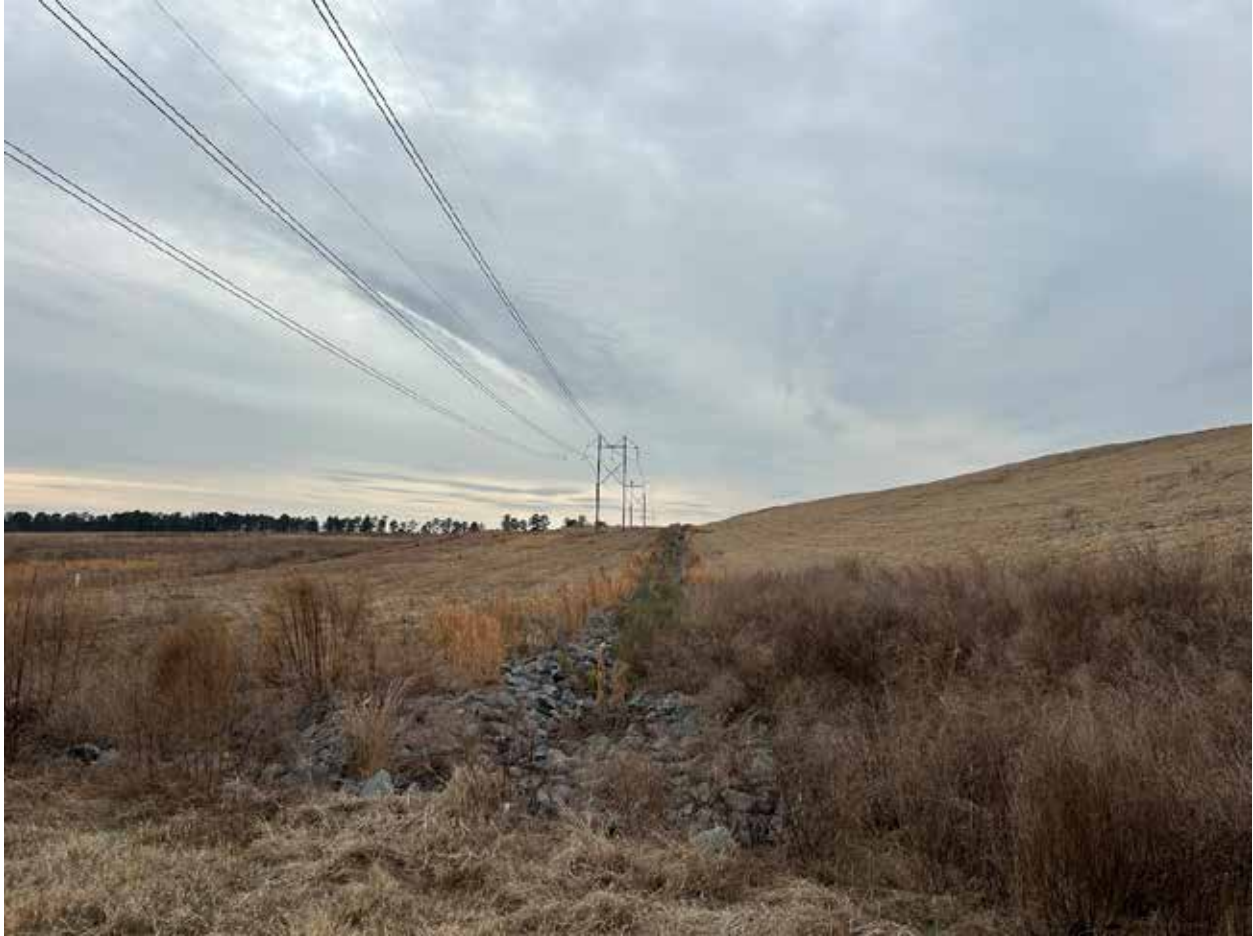
Photo 1 – Looking West at Sump 1

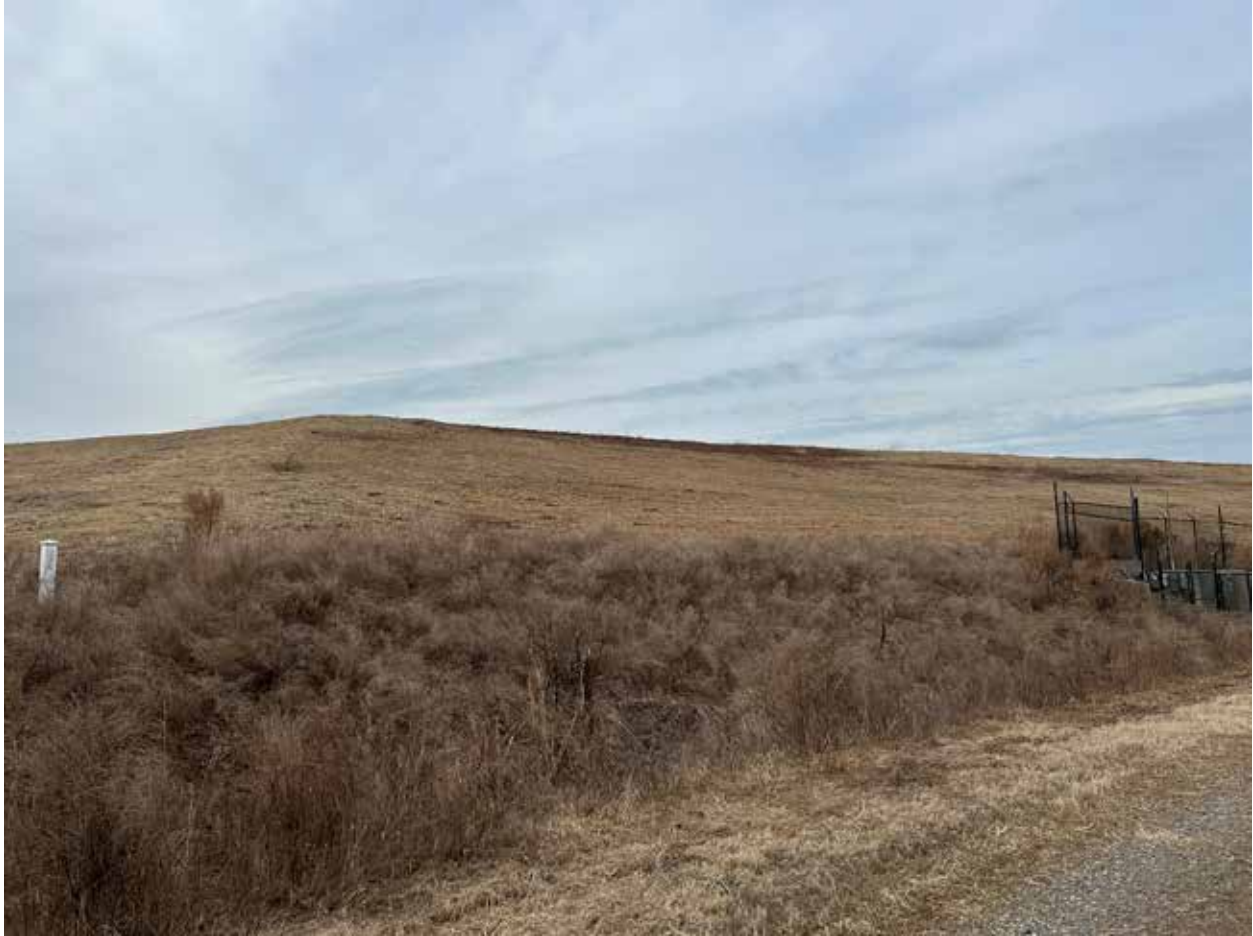
Photo 2 – Looking North at Sump 1

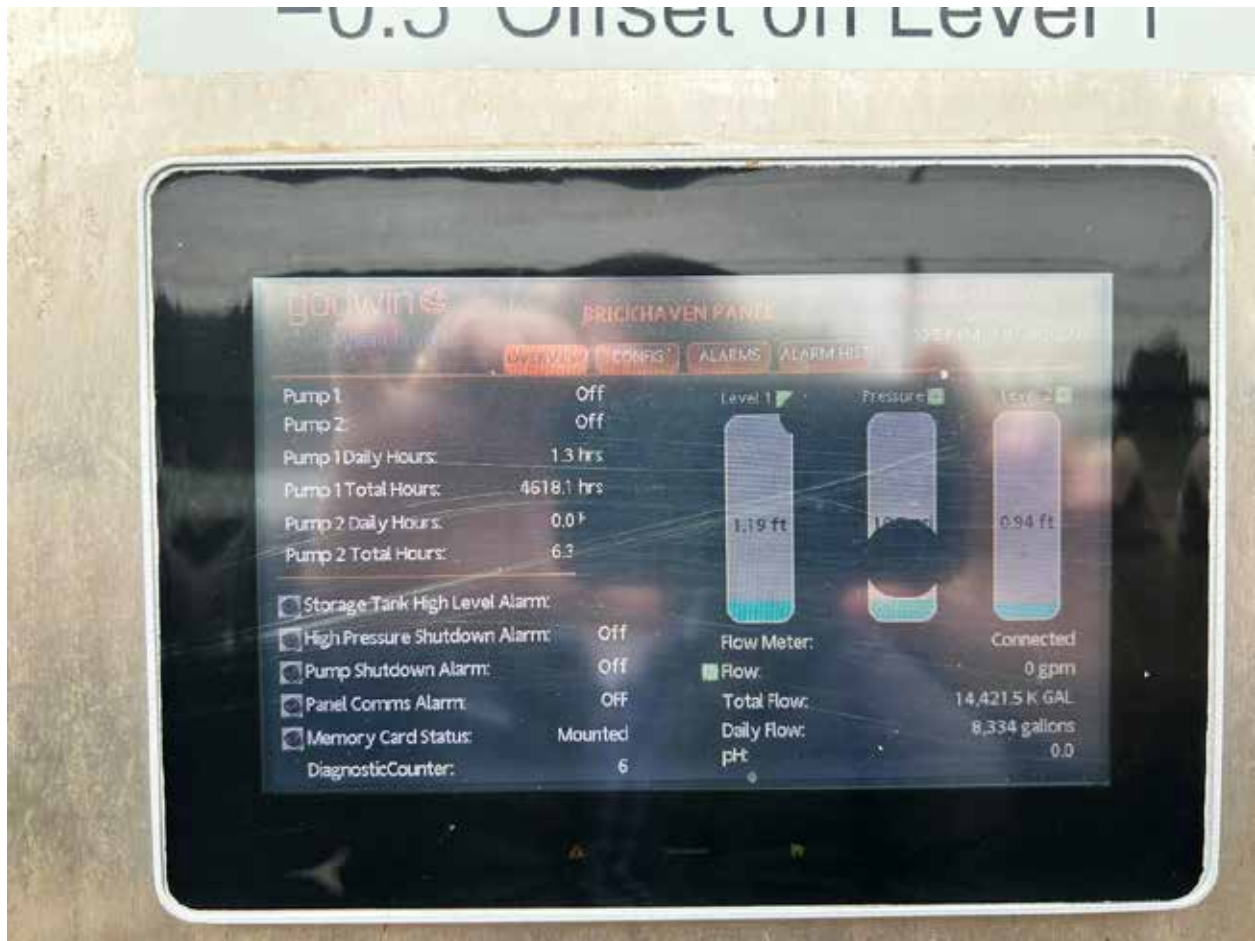
sump in Cell 6. Both sumps have two pumps installed to pump leachate to three onsite storage tanks. Site staff turned both sumps on to pump to the tanks at the time of the inspection. At the initial site inspection, the Cell 1 sump panel reported leachate levels at 1.19 ft and the Cell 6 sump reported leachate levels at 12.2 inches.

Photo 3 – Cell 1 Sump leachate level readout

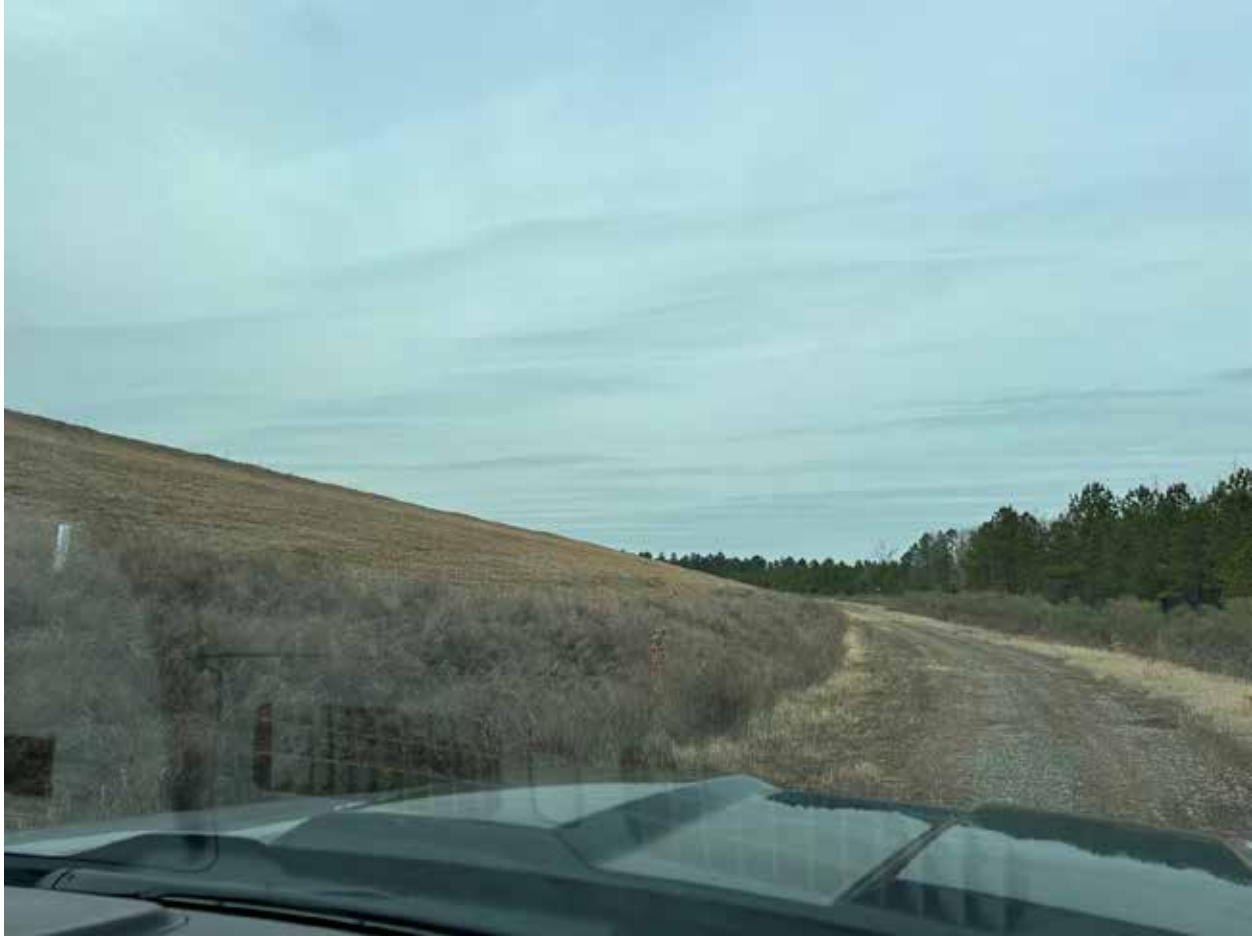
Photo 4 – Eastern side of the CCR structural fill looking north

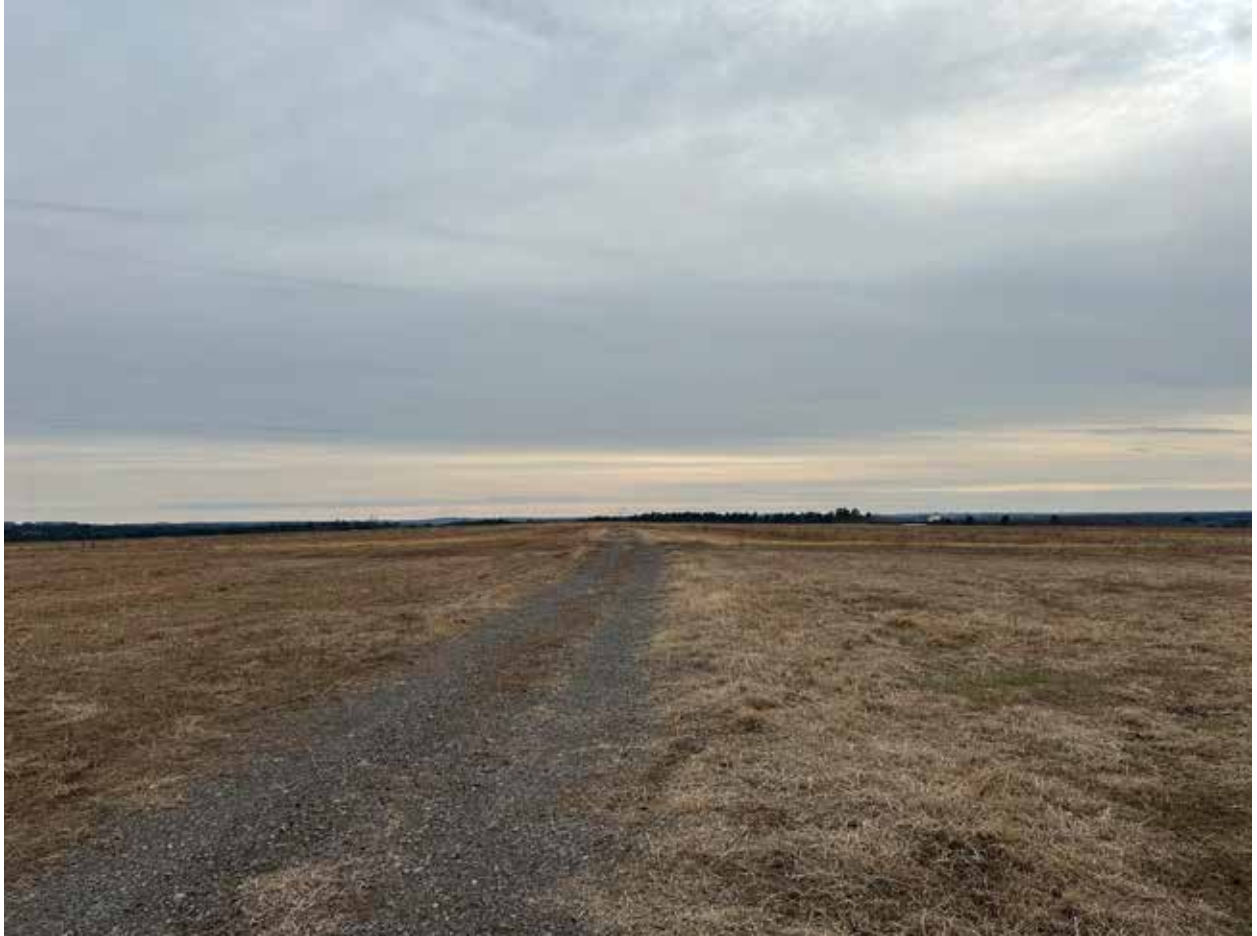
Photo 5 – On top of the CCR structural fill looking south

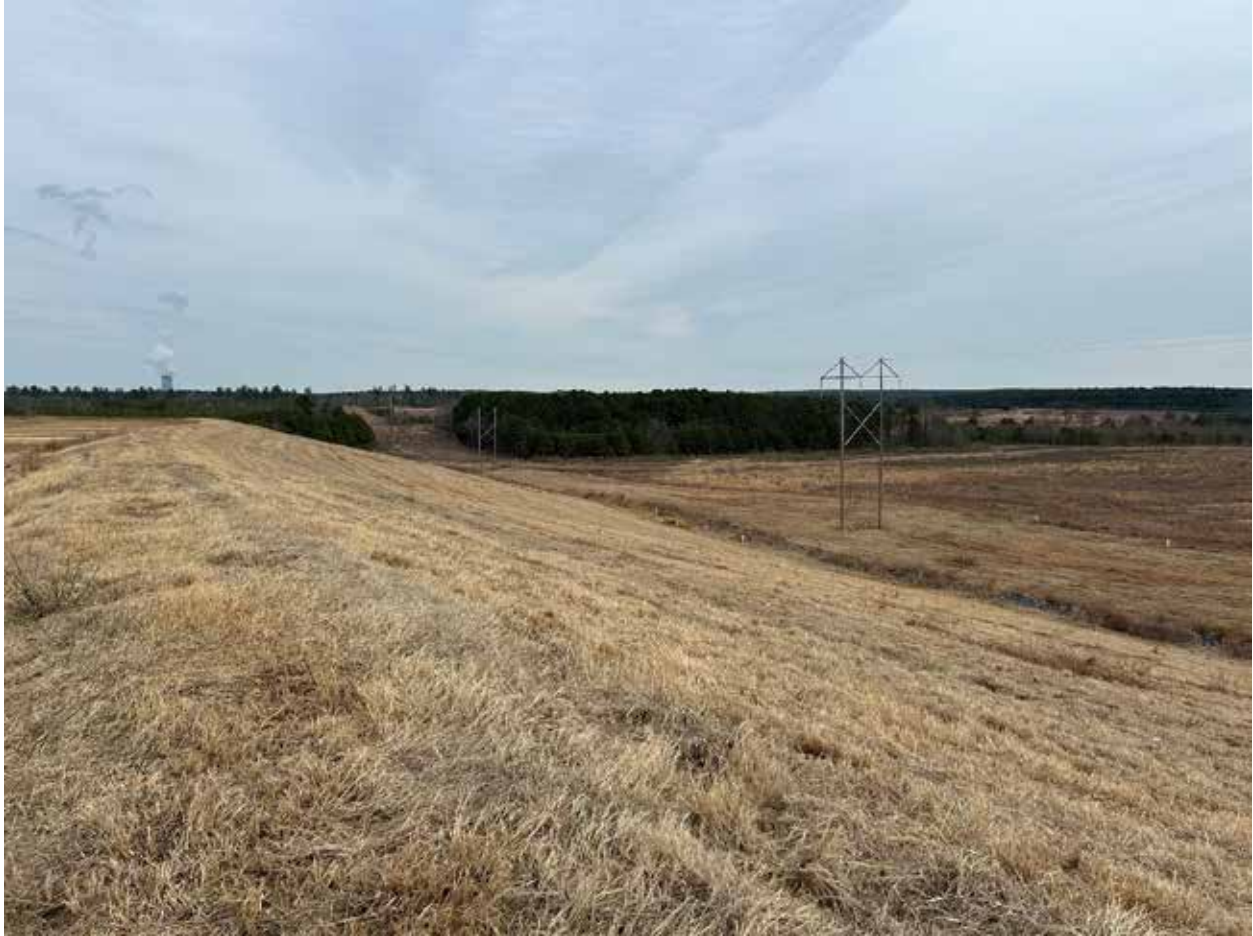
Photo 6 – Southern side slope of the CCR structural fill looking east toward sump 1

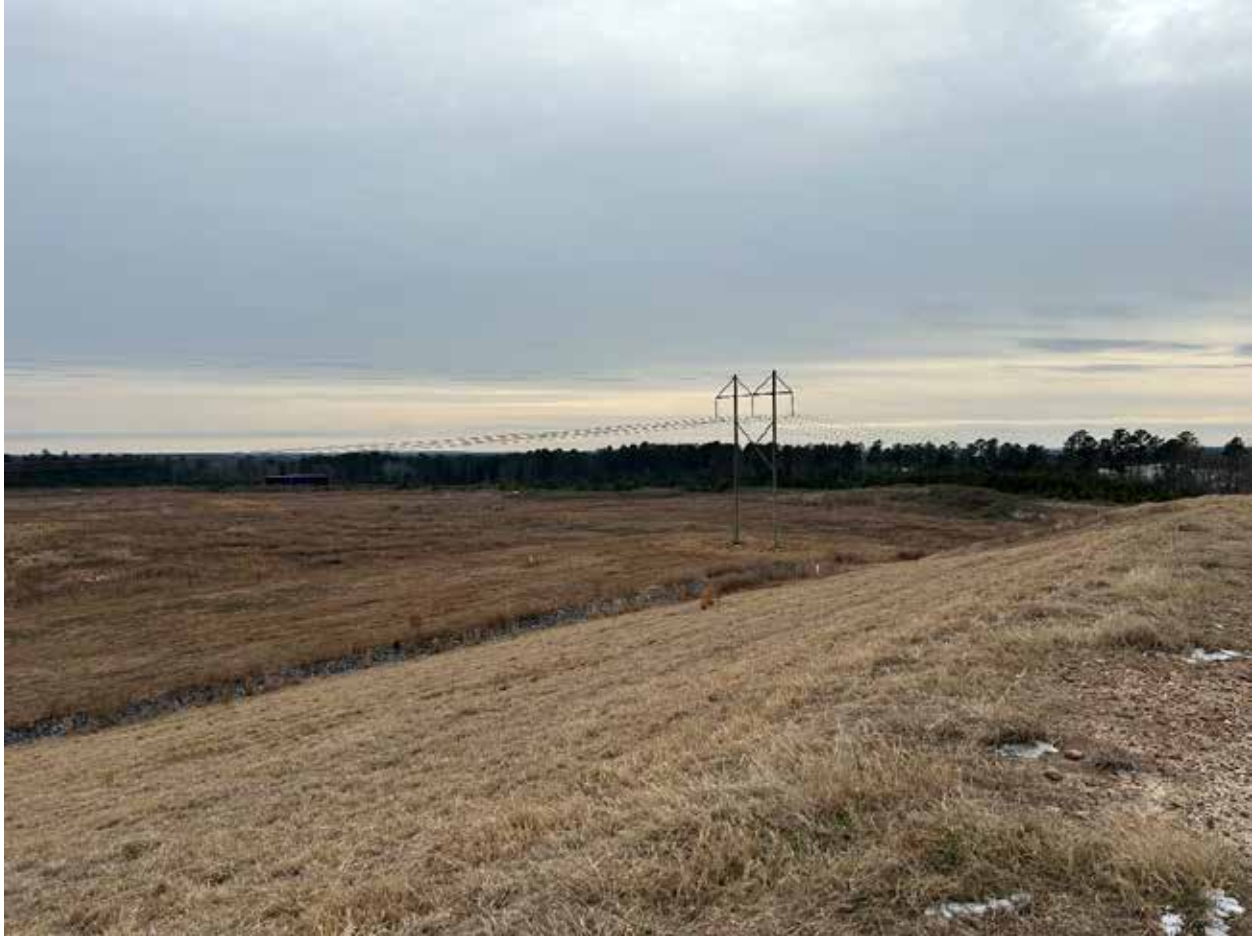
Photo 7 – Southern side slope of the CCR structural fill looking west toward the unloading area

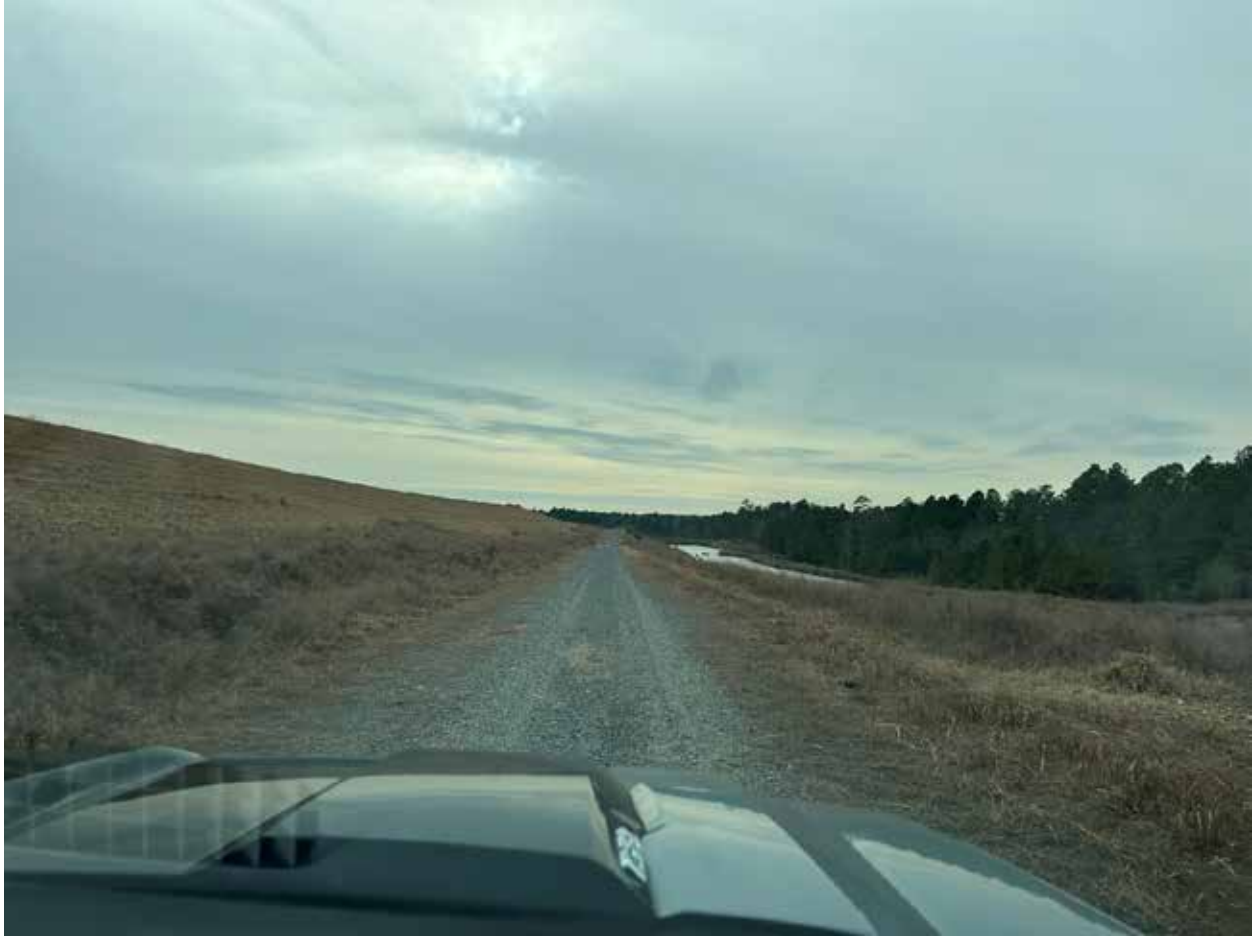
Photo 8 – Northern perimeter road looking west

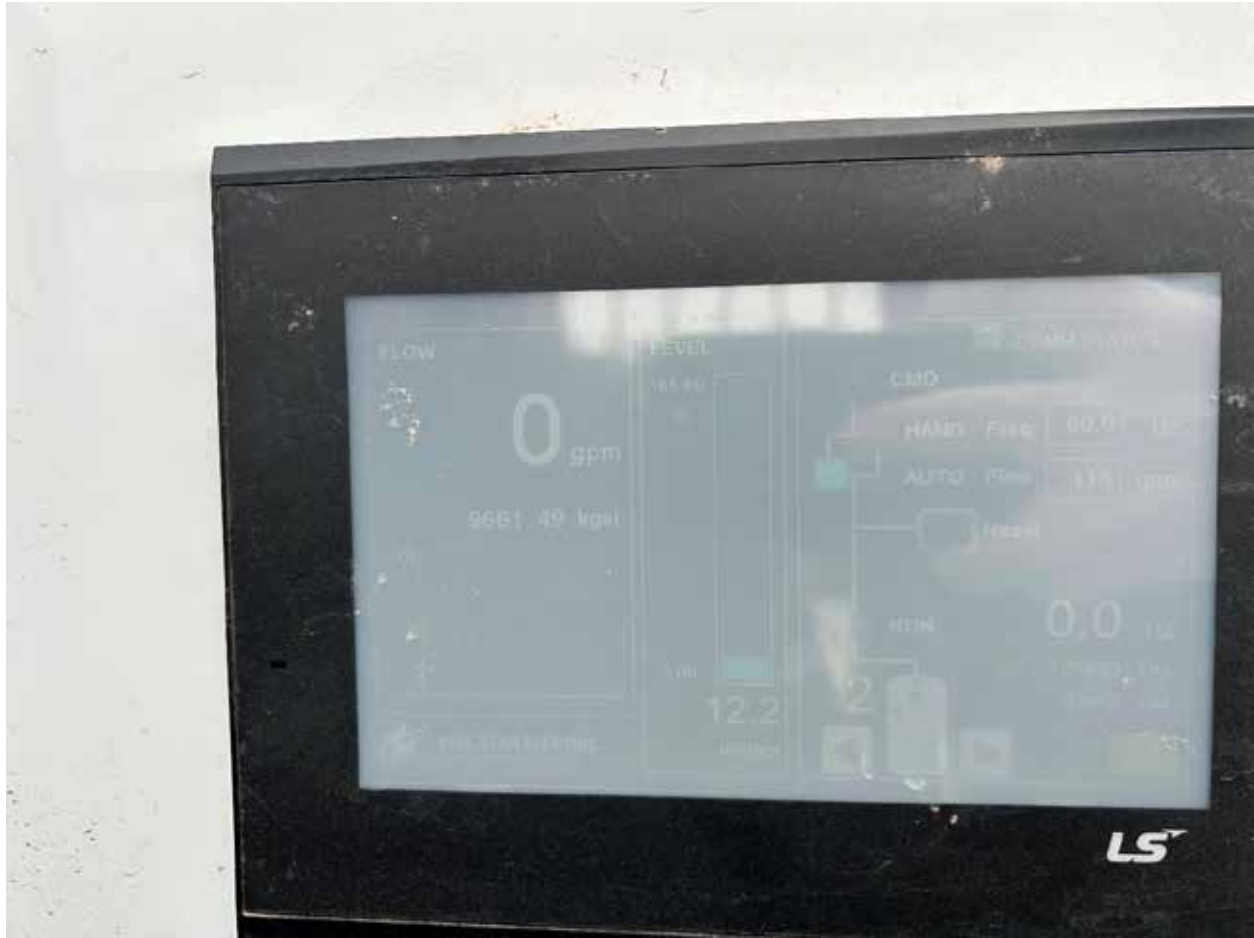
Photo 9 – Cell 6 Sump leachate level readout

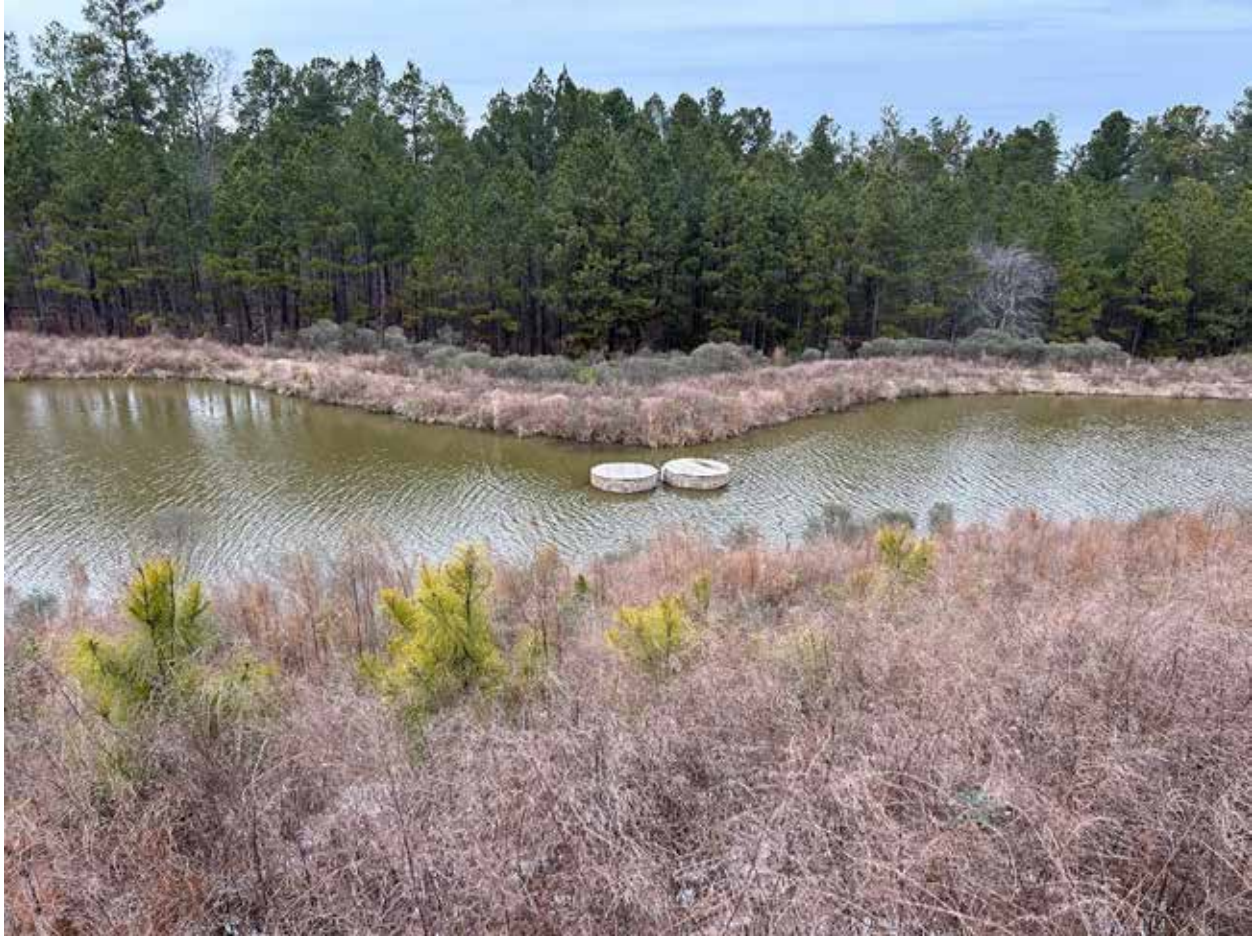
Charah converted Sediment Basins 1, 2 and 7 into stormwater retention ponds as directed by NCDEMLR for final reclamation. The other sediment basins were decommissioned and vegetated. The retention ponds that remained in place were observed to contain stormwater and function properly. Overall, the areas within the structural fill appeared to have adequate vegetation and showed no signs of structural concern. No signs of CCP release were observed.

Photo 10 – Pond 1

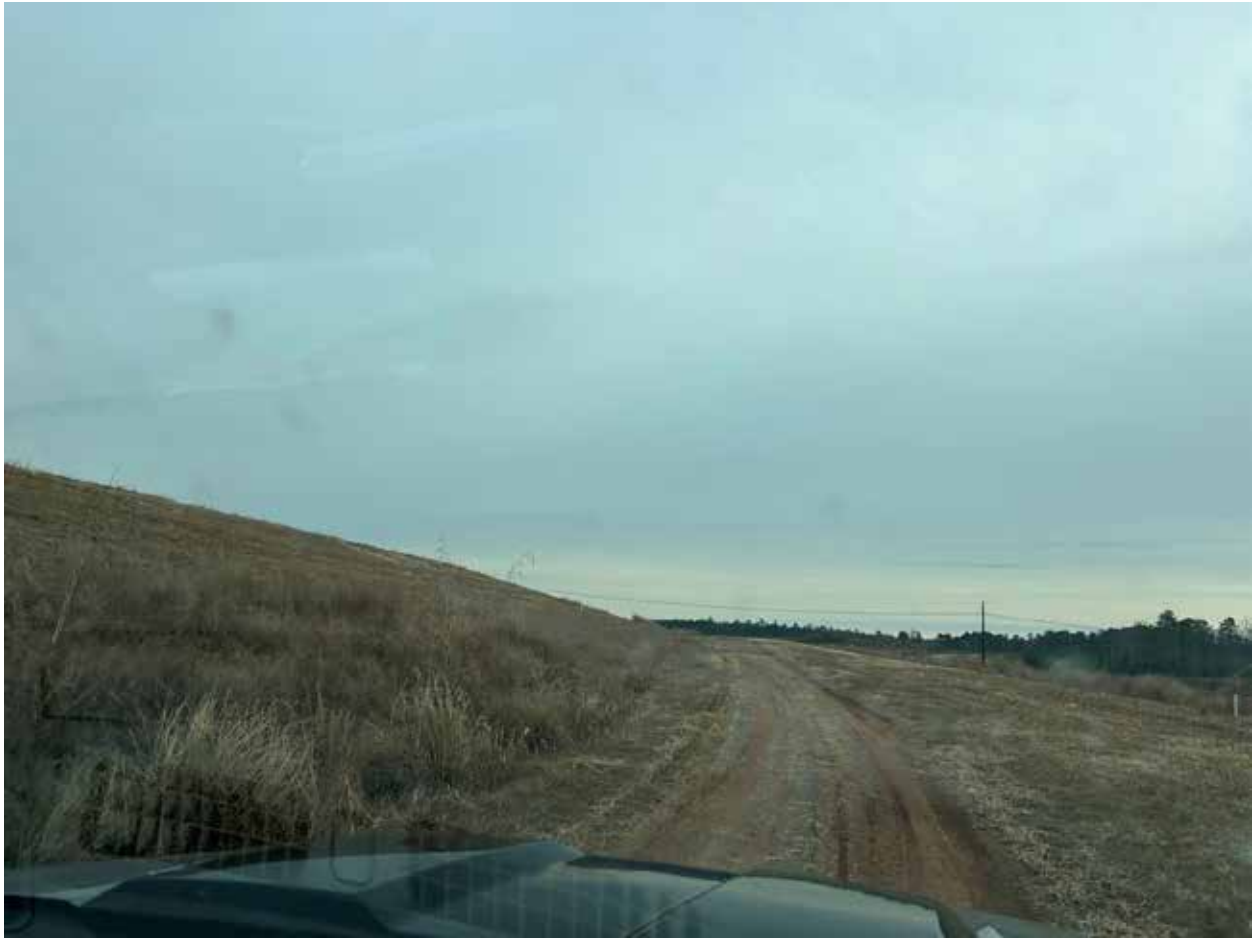
Photo 11 – Western perimeter road looking south

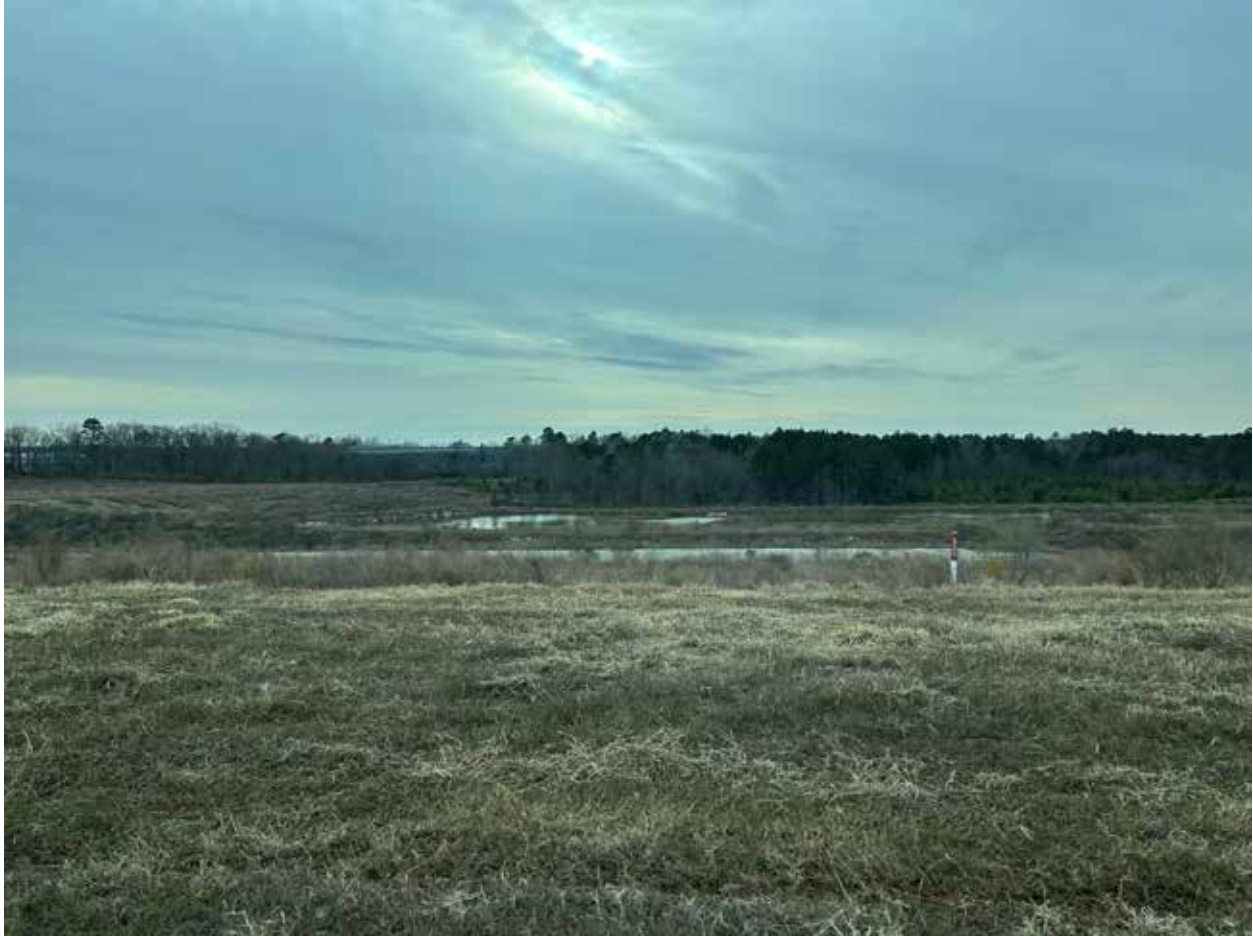
Photo 12 – Unloading Area

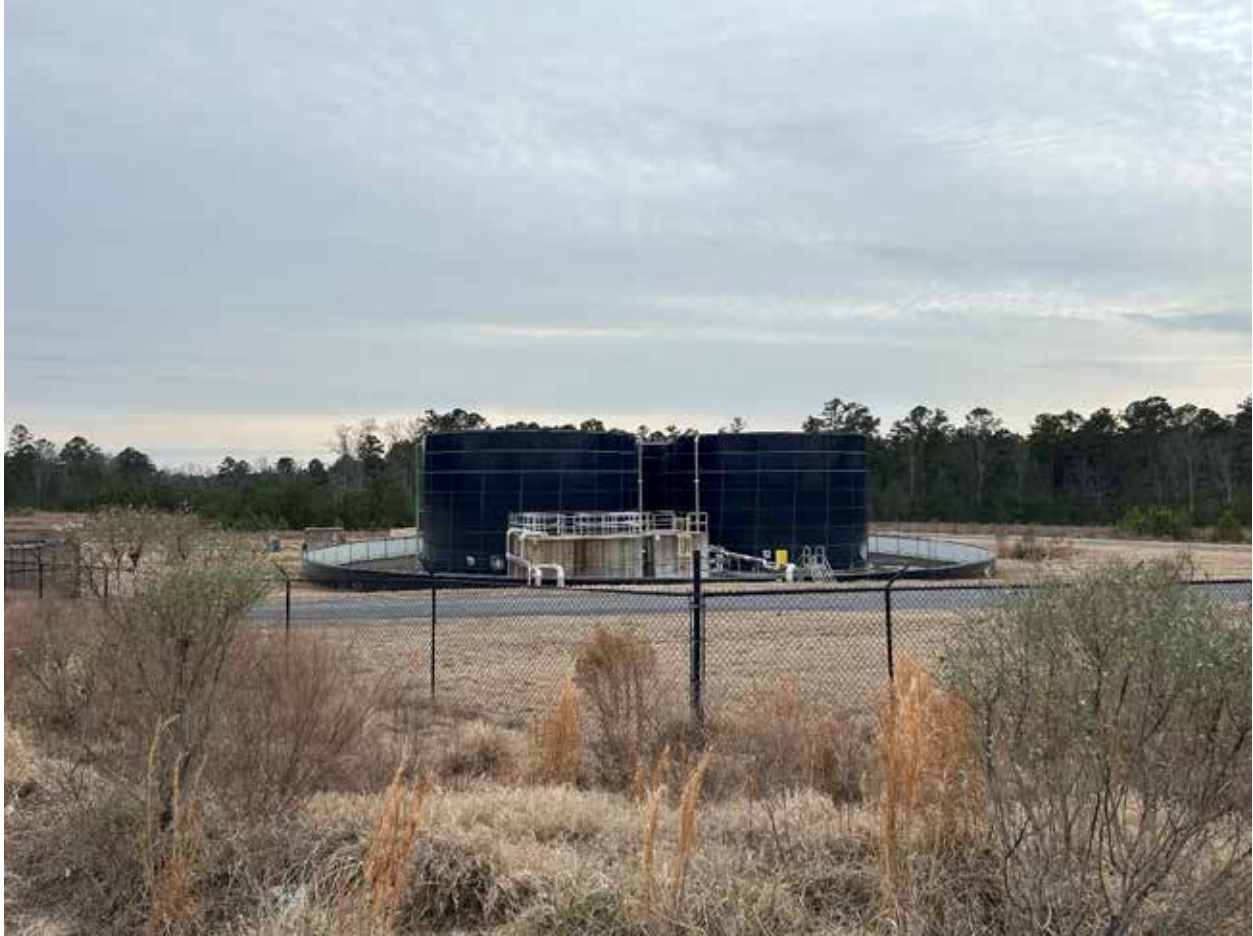
The leachate enclosures and tanks exhibited no signs of leakage at the time of the inspection. The leachate tanks contained leachate and were actively being drained into tanker trucks for transportation to one of the approved disposal locations.

Photo 13 – Leachate storage tanks

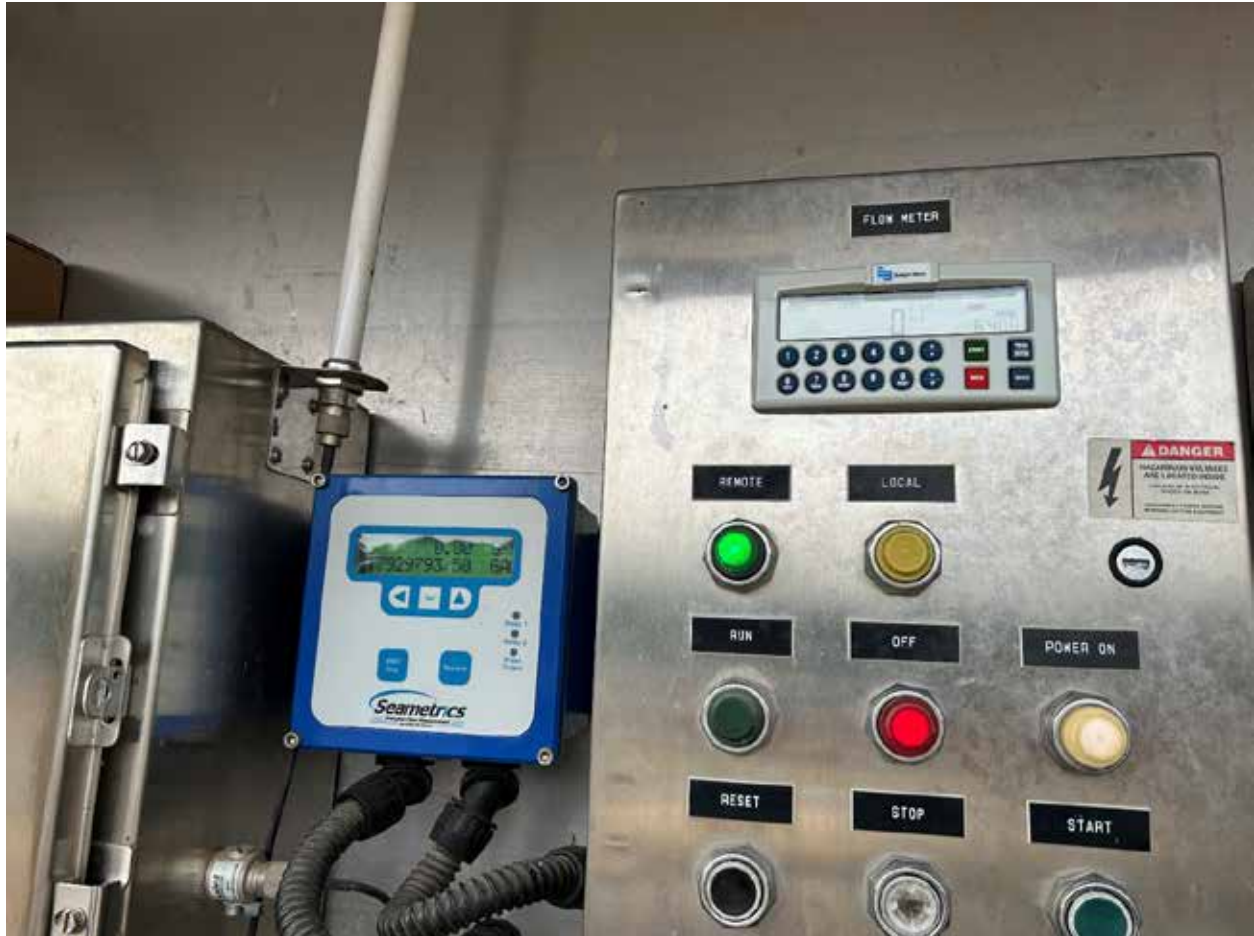
Photo 14 – Leachate tank pump station readout
