CCP Annual Inspection Report

Brickhaven No. 2 Mine Tract A Structural Fill
DWM Permit 1910, DEMLR Permit 19-25

Charah, Inc.

February 2019

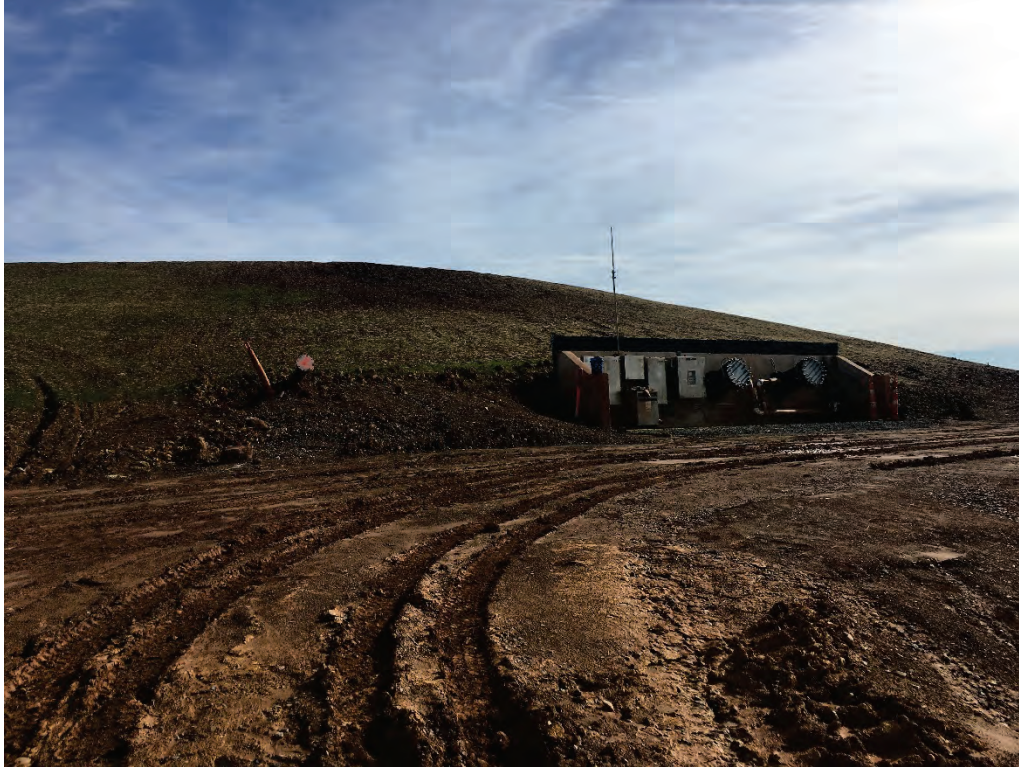
The leachate management system for the structural fill includes a series of perforated High-Density Polyethylene (HDPE) pipes within the lined area that drain to either a sump in Cell 1 or a sump in Cell 6. Both sumps have two pumps installed to pump leachate to three onsite storage tanks. At the Cell 1 sump the pump was actively pumping to the leachate storage tanks. The Cell 6 sump was not actively pumping as the liquid level in the sump was below the start elevation. Refer to Photo 3 to see the Cell 6 sump enclosure. The system was operating within its pressure range and the transducers were reading within their range.

The leachate enclosures and tanks exhibited no signs of leakage at the time of the inspection. The leachate tanks contained leachate and were actively being drained into tanker trucks for transportation to one of the approved disposal locations. Refer to Photo 4 to see an example of the leachate operations inspection form kept onsite.
